Rail Clip Failure Investigation at Sound Transit

Clip Failures – As of April 11, 2017

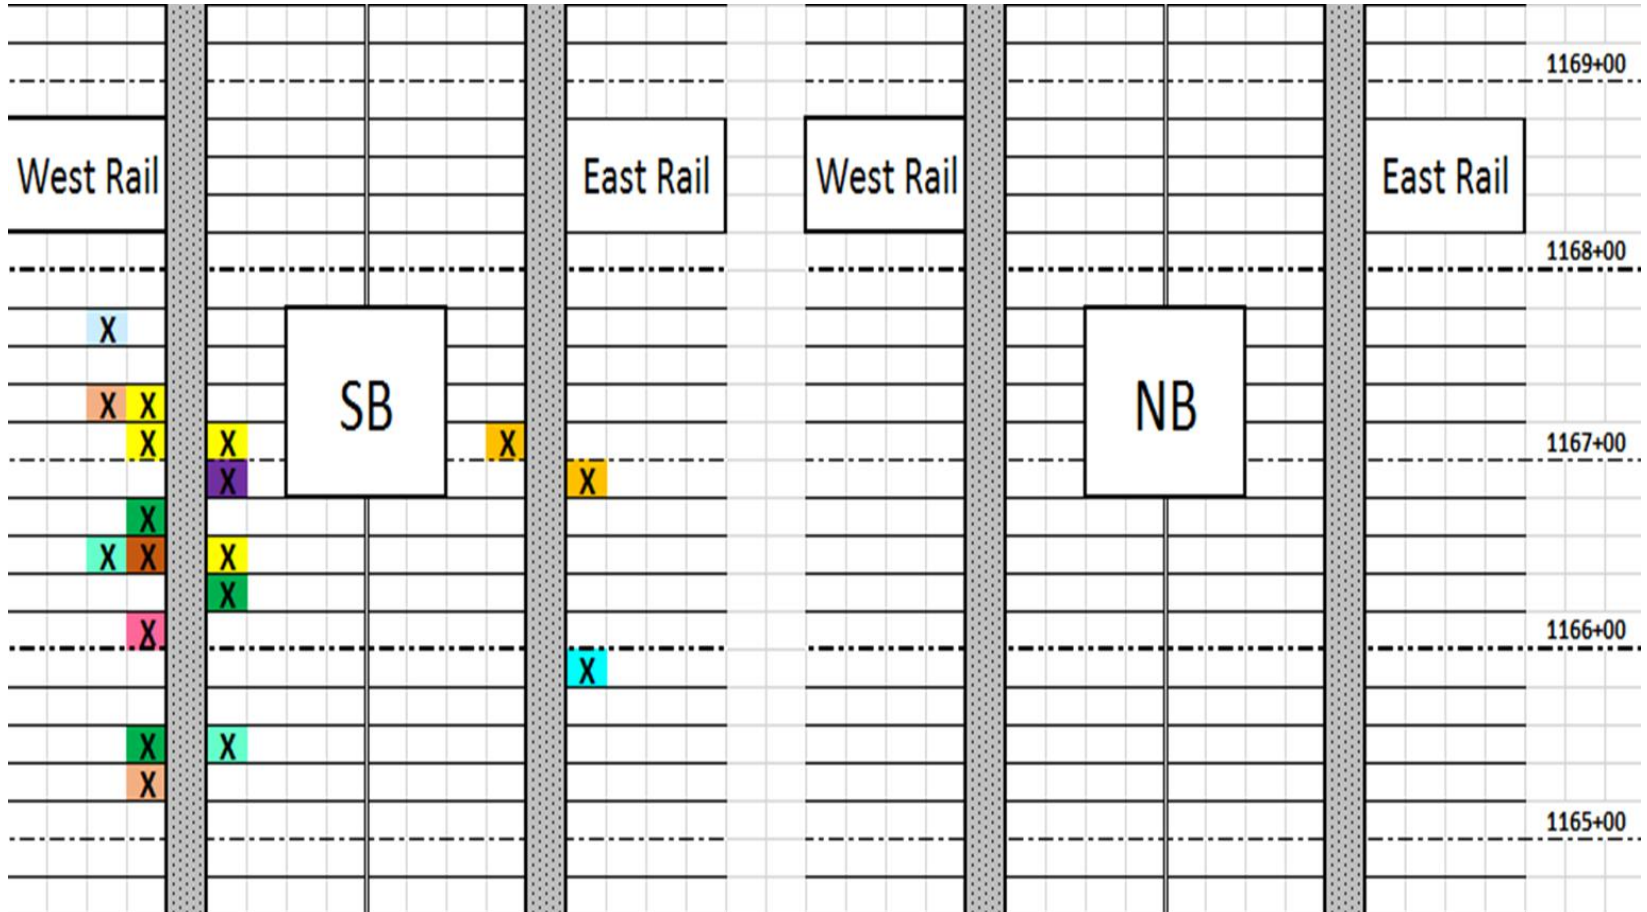
Map of Clip Failures

North Bound Track				South Bound Track			
	East Rail		West Rail		East Rail		West Rail	
	Field Side	Gage Side	Field Side	Gage Side	Field Side	Gage Side	Field Side	Gage Side
GAUGE/FIELD	4	5	5	6	18	22	36	21
EAST/WEST	9		11		40		57	
NORTH/SOUTH	20				97			
TOTAL	132

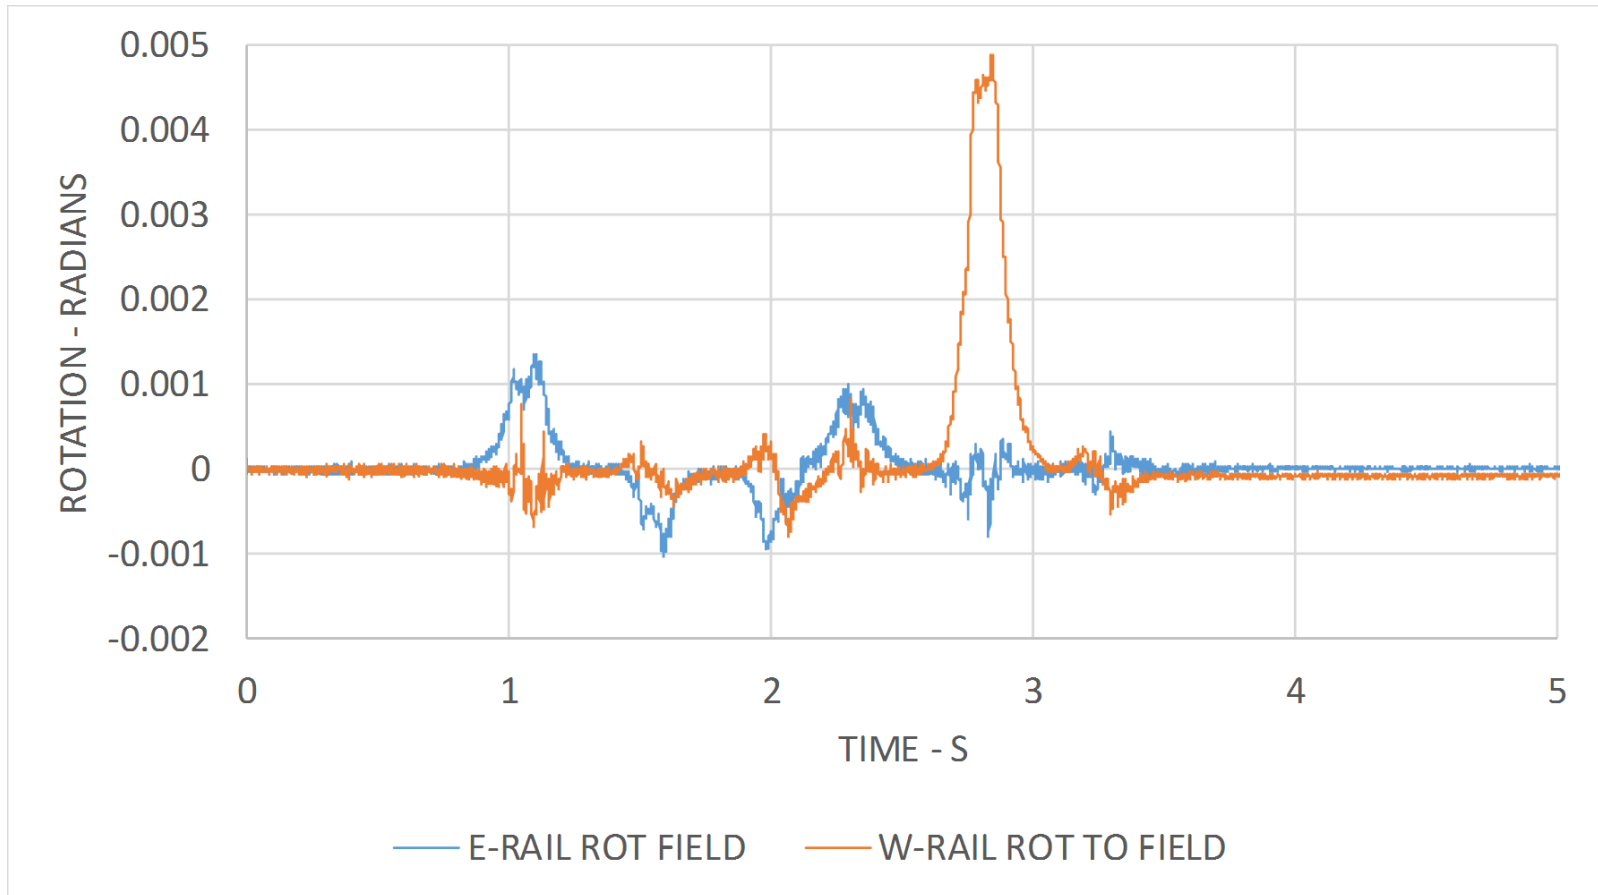
Southbound Track Rail Rotation

- Center truck produces largest rail rotation and lateral displacement
- No evidence of clip toe load being overcome
- No clear evidence of fatigue due to relative deflection of rail and fastener
- Acceleration spectrum contains strong peaks above 800Hz
- Laboratory tests indicate system resonance at about 800 to 900Hz
- Amplification of rail vibration acceleration at nominally 800 to 900Hz

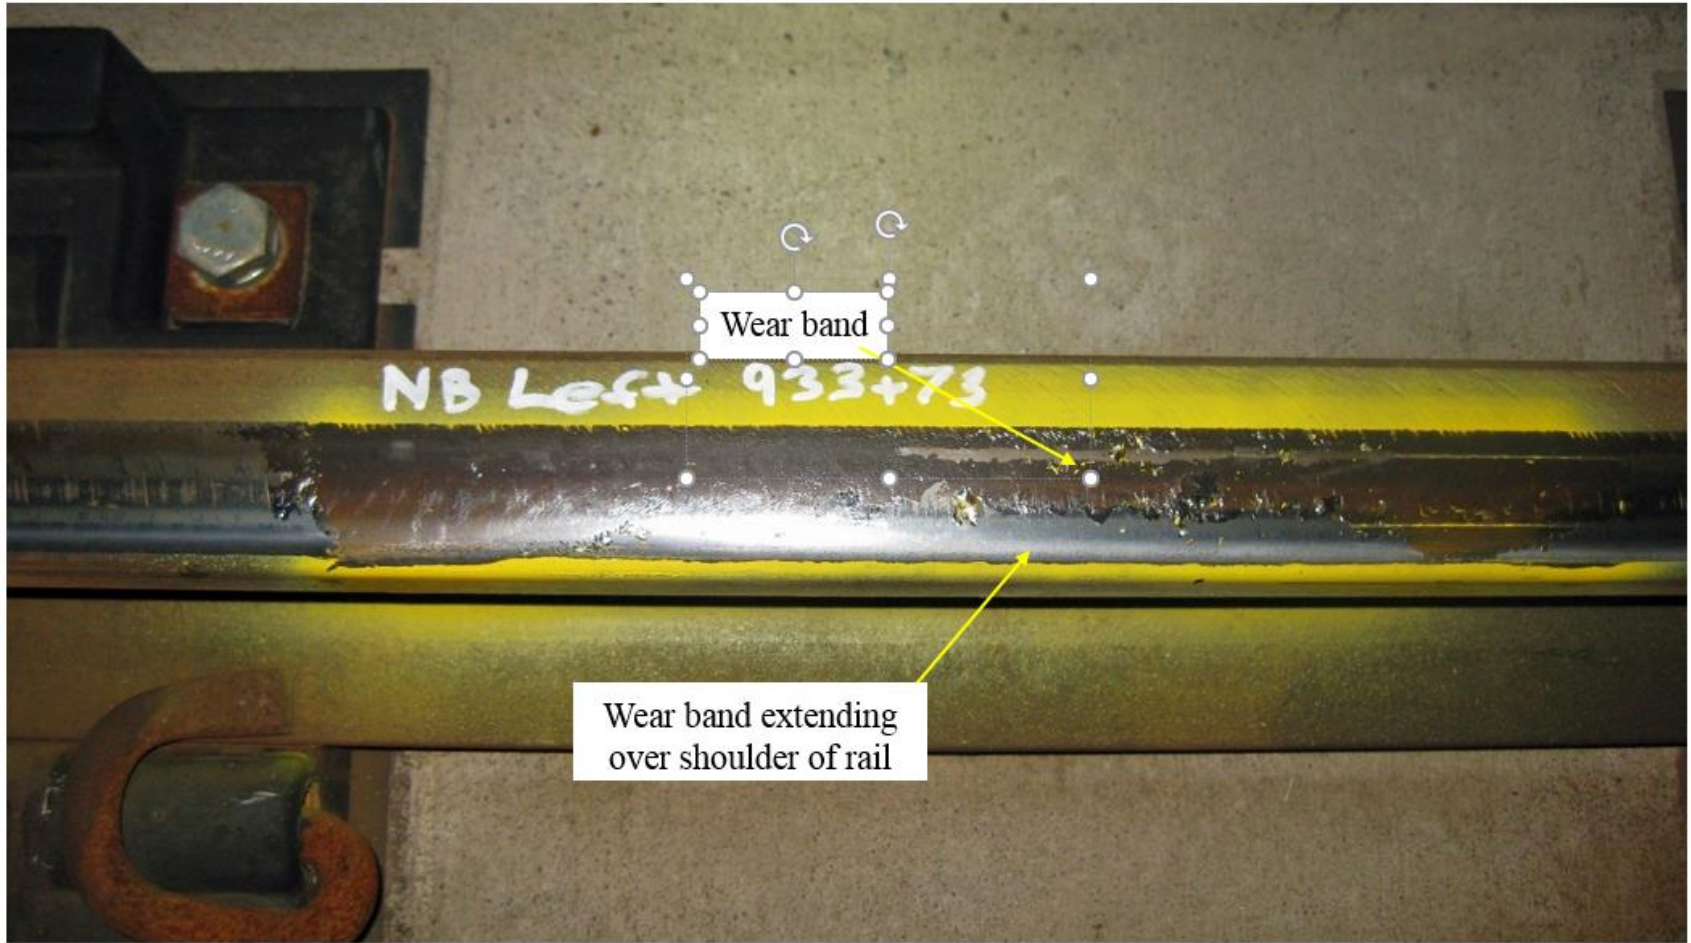
Painted rail after one day in service

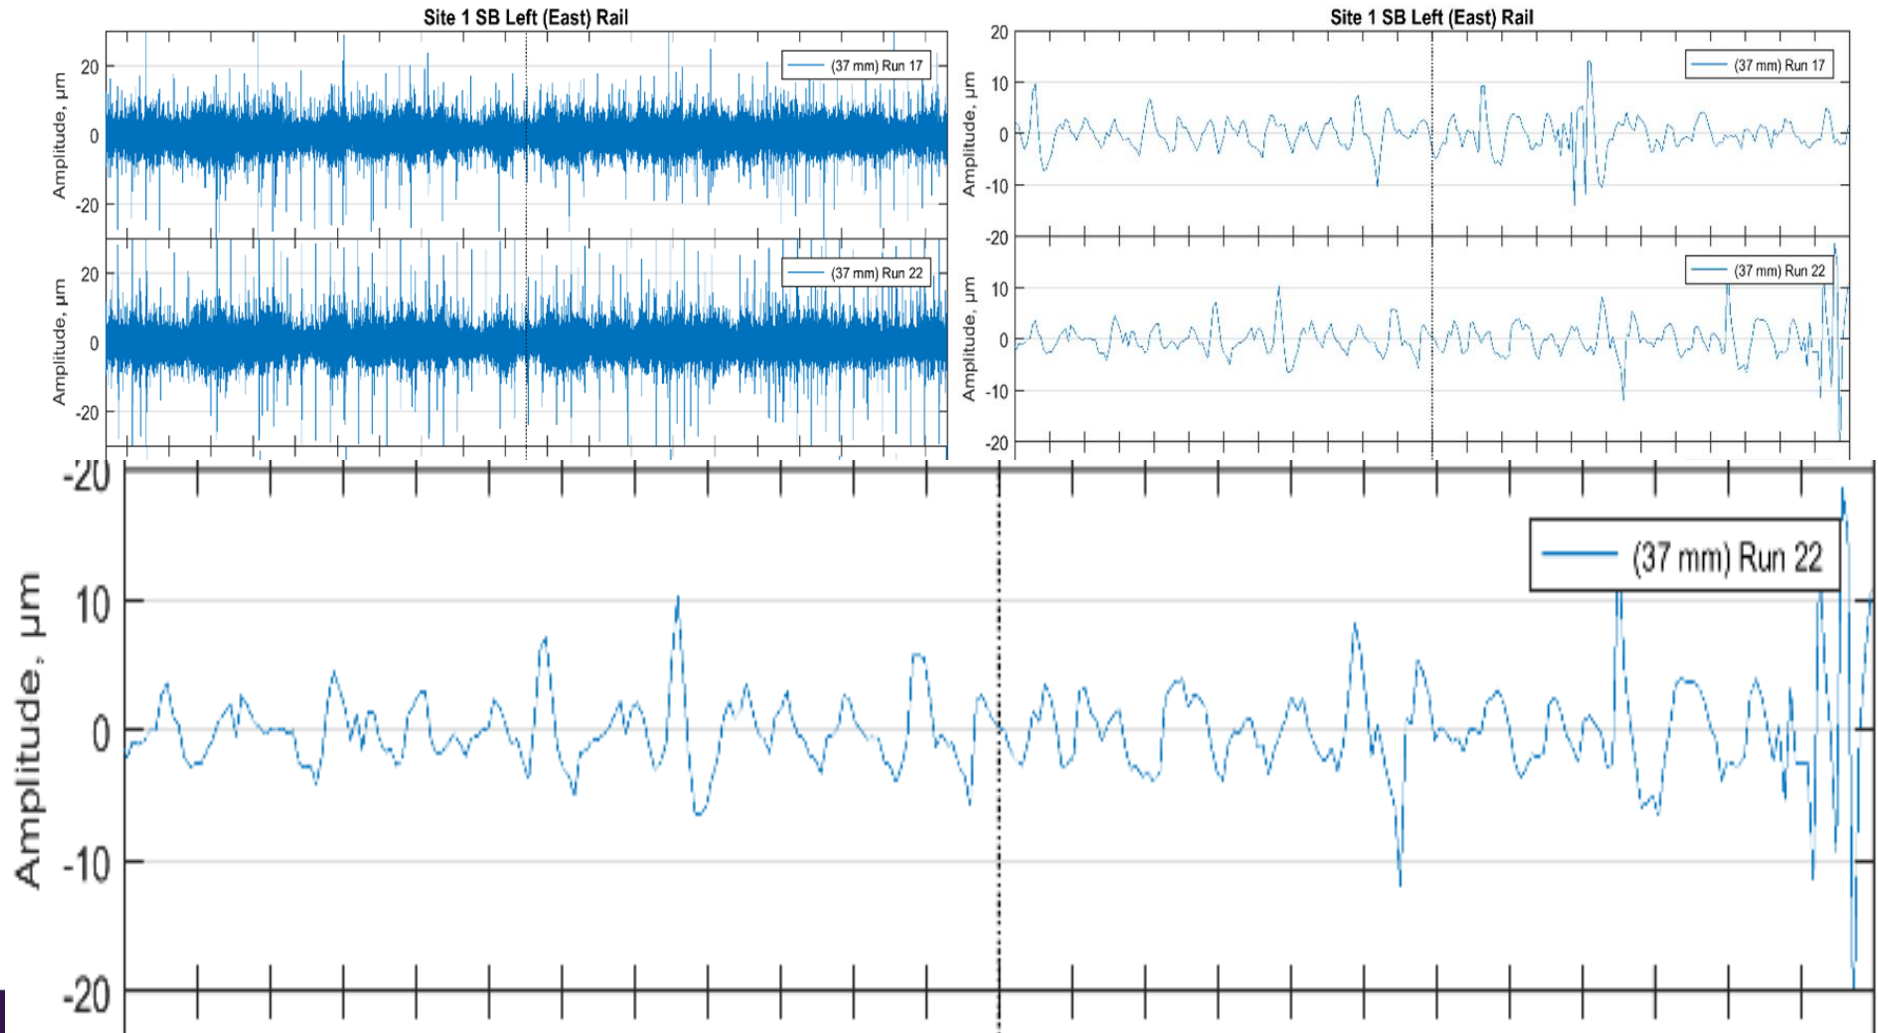
Raw Rail Roughness, UWS-CHS, 4 runs

- Rail grinding left $\sim 1.1''$ wavelength.
- At 55 mph, $1.1''$ wavelength causes vibration at 848 Hz.
- There are short segments where this wavelength disappears.
- Resonance of rail clips is 800 to 900 Hz.
- Rail clip failures appear to be greater where 800 to 900 Hz peak is stronger.
- Reducing or increasing the grinder speed would change the wavelength and could help resolve problem.

- Future measurements should include track time for follow up inspections.
- Onboard measurements can be a valuable tool for identifying problem areas.
- Rail grinding specifications should be updated to address this issue.
- Sound Transit is investigating various approaches.

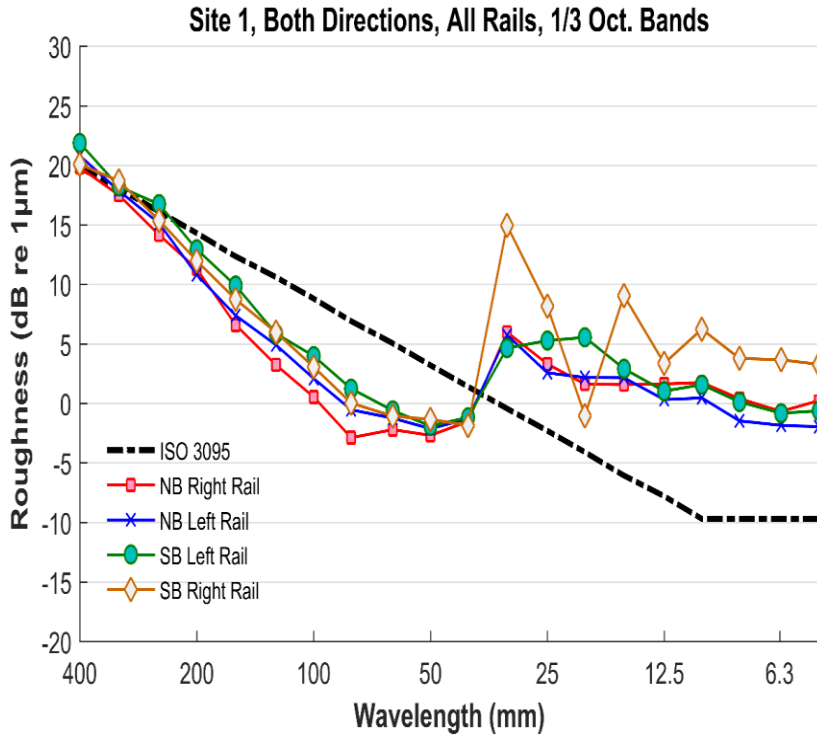
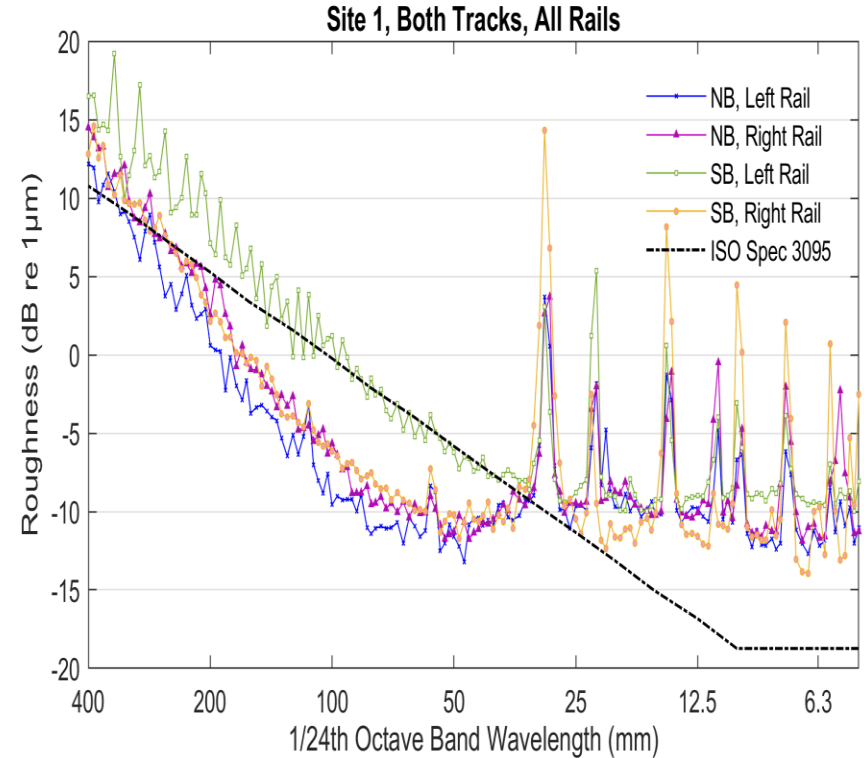
Roughness Wavelengths, Site 1

Wavelength, mm	Wavelength, in.	Frequency, Hz @ 55 mph	
28.99	1.14	848	
14.93	0.59	1647	
10.0	0.39	2459	
7.81	0.31	3148	
6.06	0.24	4057	
5.26	0.21	4674	
4.94	0.19	4977
