**APTA BTS-BC-RP-005-10, Rev. 2**

Bus Brake and Chassis Working Group

# Troubleshooting Common Transit Bus S-Cam and Air Brake Complaints

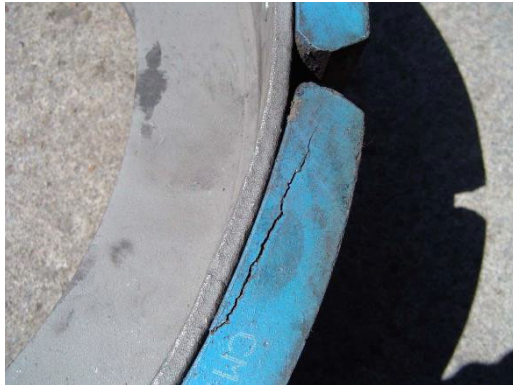
**FIGURE 2**

Brake Lining Problems

Cracked lining

- Lining/shoe (**Figure 2**):
  - Check that the block is not worn to the wear line or less than ¼ in. as measured at the center of the shoe. At no time should rivets or bolts touch the drum.
  - Check that there is no movement between the brake block and the shoe.
  - Check for missing segments of brake block.
  - Check the brake blocks for cracks, hardness and glazing.
  - Inspect for signs of block contamination, i.e., oil or grease.
  - Check shoes for damage, broken welds, worn roller pockets and/or broken shoes.
  - Make sure all components are appropriate for the application (proper length pushrod, proper brake chamber size, etc.).

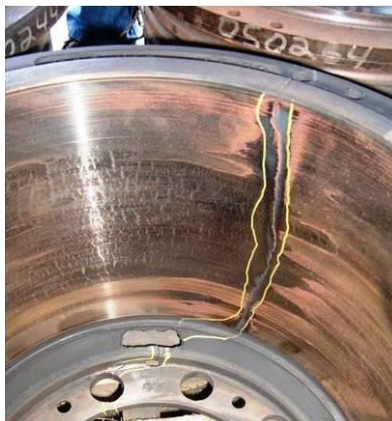
**FIGURE 3**

Brake Drum Problems

Cracked brake drum

- Brake actuator (chamber):
  - During pushrod travel measurements, listen for air leaks in the brake chambers or other foundation brake components.
  - Inspect for dents, bends, misalignment, leaks, pushrod return, corrosion and missing caps.
- Air hoses:
  - Inspect for cracks, kinks, routing, leaking, chafing and deterioration.
  - Check for proper size and material.
  - Check for different configurations side to side (different fittings, hose size and routing, etc.).
- Hardware:
  - Check the condition of the clevis, pin and yoke.
  - Check for broken or missing return springs.
  - Check brake return spring for proper installation.
  - Check drums for excessive wear or cracks (**Figure 3**).
  - Check S-cams and rollers (wear, flat spots, lift).

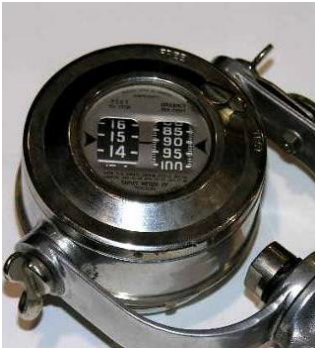
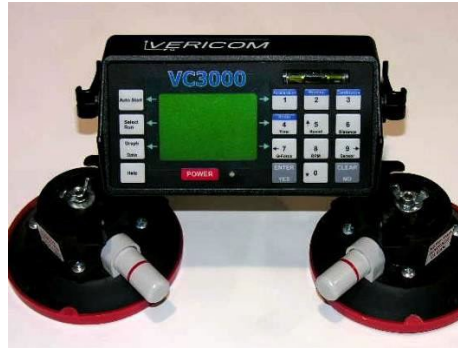
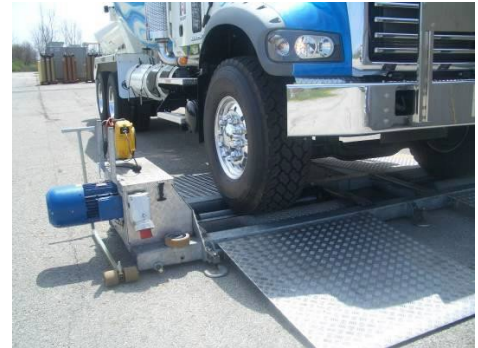
**FIGURE 4**  
Brake System Testers

Typical mechanical tester

Typical electronic tester

Performance-based brake tester

If the deceleration capability of the service brake system is tested with an electronic deceleration measurement device (**Figure 4**), an average in-stop deceleration rate of at least 0.528 g should be achieved from a speed of 20 mph to a complete stop.

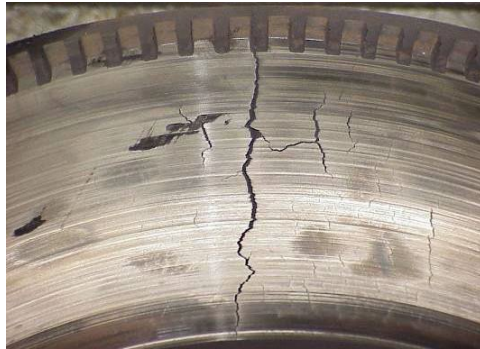
**FIGURE 5**  
Drum-Off Inspection

Excessive drum crack

- Drum:
  - Inspect drum for abnormal wear patterns, such as bell mouching, scoring, glazing, etc.
  - Inspect for cracks that go through the entire drum wall.

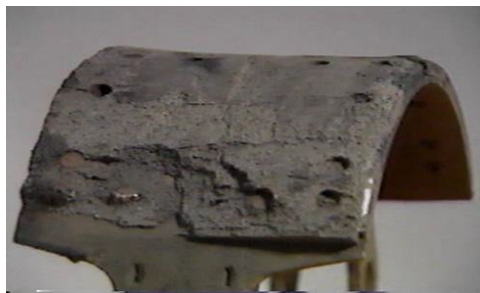
Heat damage

- Check for evidence of excessive heat such as bluing, hard spots, etc.
  - Measure the inside diameter. Check that it doesn't exceed the maximum diameter cast into the drum, or is close enough that the drum will wear past its specification before the next inspection.

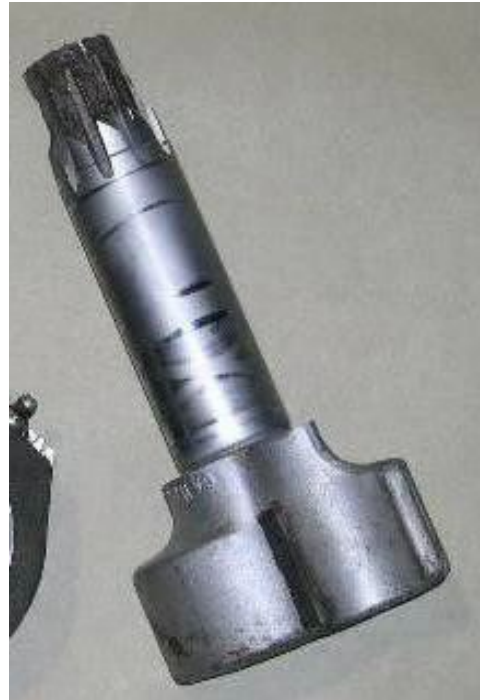
Damaged S-cam

- Check for a bent spider.
  - Check roller for binding and flat spots.
  - Check anchor pins, bushings, set screws and safety wire.
- Camshaft/roller:
  - Check for broken or twisted splines.

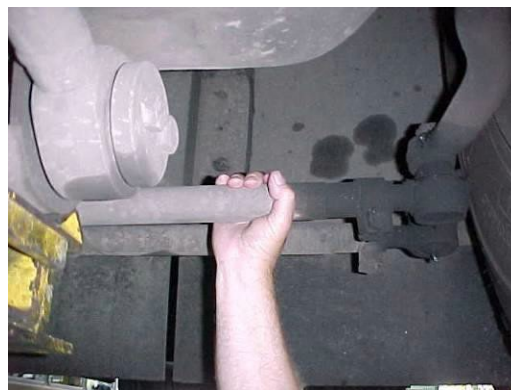
**FIGURE 6**  
Checking Tie Rod Ends

- Check wheel bearings for free, smooth, movement and excessive end play (greater than 0.005 in.). If excessive play is found, have a co-worker apply the brakes to isolate the wheel bearing from the king pin end play.
- Check king pins for excessive movement laterally and vertically.
- Using hand pressure, check the tie-rod ends and pitman arms for excessive play (**Figure 6**).
