**APTA BTS-BC-RP-008-20**

# Transit Bus Brake Valve Treadle Assembly Maintenance

**Abstract:** This *Recommended Practice* provides guidelines for maintaining, rebuilding and replacing transit bus brake valve treadle assemblies.

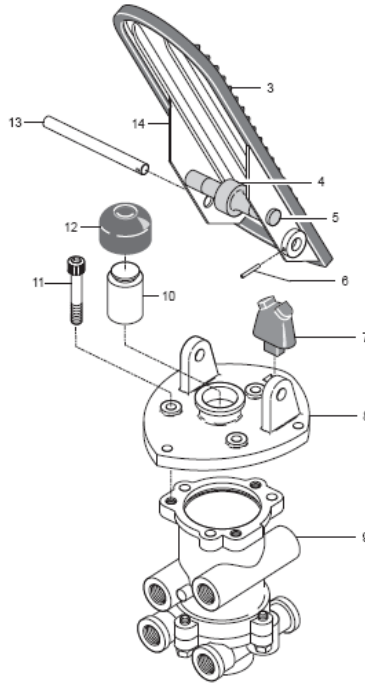
**FIGURE 1**  
 Typical Brake Treadle

- Clean any accumulated dirt, gravel or foreign material away from the heel of the treadle, plunger boot and mounting plate; and
- If needed, use a shop vacuum to clean the area under and around the throttle and brake treadles.

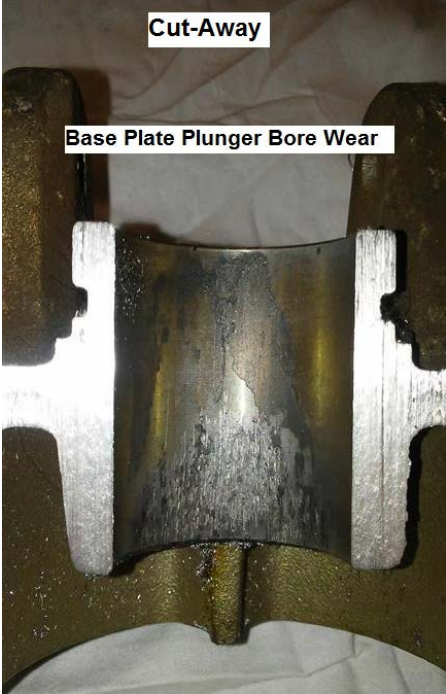
<p>Clean and inspect the treadle base.</p> <ul style="list-style-type: none"><li>• Use compressed air to remove any loose debris from bore.<ul style="list-style-type: none"><li>○ Make sure to wear safety glasses while using compressed air.</li><li>○ Wipe the bore out using denatured alcohol and lint-free wipe.</li></ul></li><li>• Inspect plunger bore for pitting, scoring or excessive wear.</li></ul> <p><b>NOTE:</b> Do not use wire wheel to clean surfaces and avoid removing any plating from surfaces.</p>	<p style="text-align: center;"><b>FIGURE 5</b> Base Plate Plunger Bore Wear</p>

<p>The image shows a cut-away view of a metal component, likely a base plate plunger bore. The central bore is heavily worn, showing a dark, pitted, and scored surface. The surrounding metal is a lighter, yellowish-brown color. A white label at the top reads "Cut-Away" and another white label in the middle reads "Base Plate Plunger Bore Wear".</p>

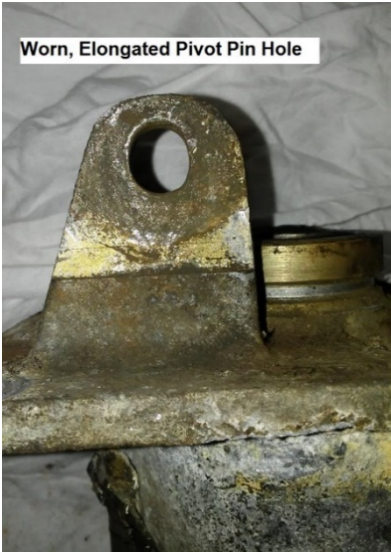
<p>Check pivot pin bore holes for excessive wear.</p>	<p style="text-align: center;"><b>FIGURE 6</b> Pivot Pin Bore Hole Wear</p>

<p>The image shows a close-up of a metal component with a circular hole. The hole is significantly worn and elongated, with a dark, pitted surface. The surrounding metal is a lighter, yellowish-brown color. A white label at the top reads "Worn, Elongated Pivot Pin Hole".</p>

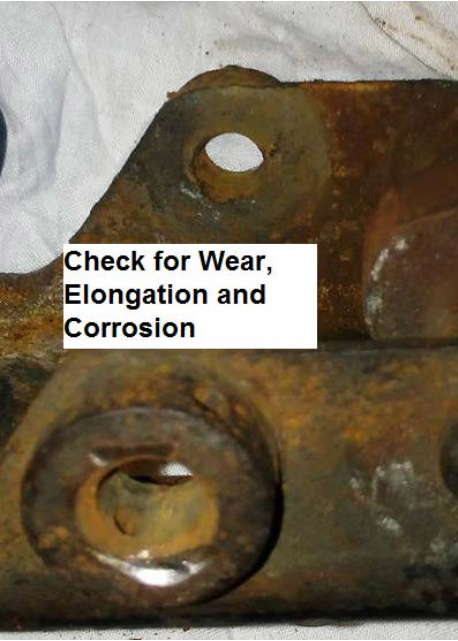
<p>Check for excessive wear on pin bores on the pedal.</p>	<p><b>FIGURE 7</b> Pedal Pin Bore Wear</p>

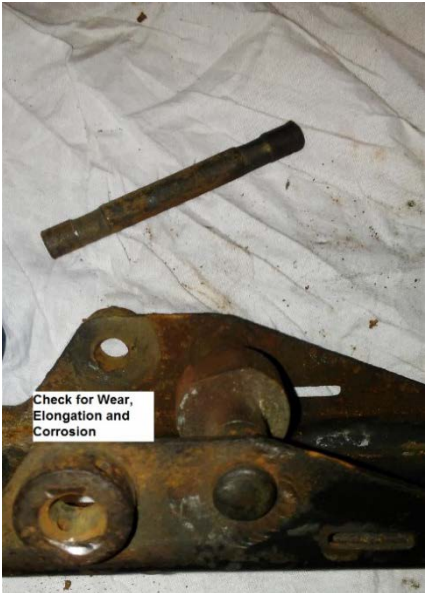
<p>Check for Wear, Elongation and Corrosion</p>
<p>Check roller and pin for corrosion, wear and signs of the roller frozen to the pin.</p>	<p><b>FIGURE 8</b> Roller and Pin Wear</p>

<p>Check for Wear, Elongation and Corrosion</p>

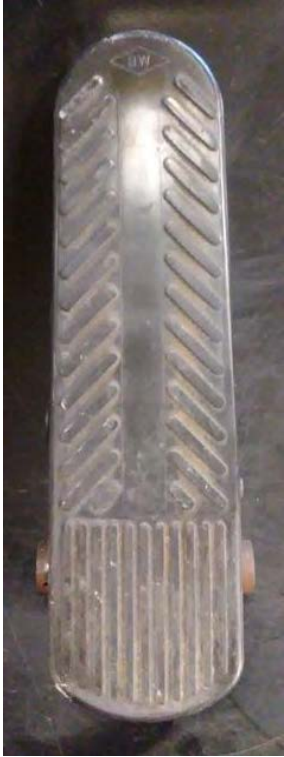
<p>Check the rubber treadle cover for excessive wear.</p> <p>Make sure there are no flat spots or holes on the treadle cover.</p> <p>Replace as necessary.</p>	<p style="text-align: center;"><b>FIGURE 9</b> Treadle Cover Wear</p>

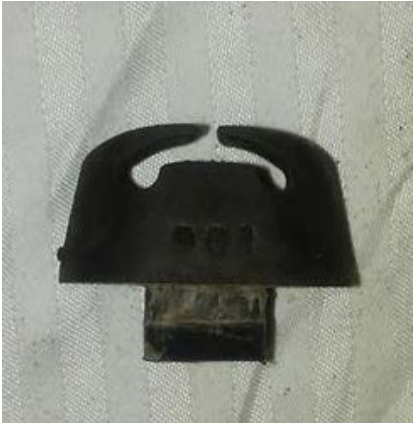
<p>Inspect rubber pedal stop button for wear.</p>	<p style="text-align: center;"><b>FIGURE 10</b> Pedal Stop Button Wear</p>

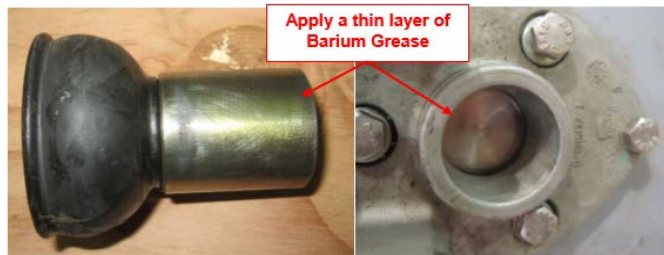
**FIGURE 11**

- All the parts use barium lubricants as recommended by the manufacturer.
- Apply a light film of lubricant to the pivot pin, roller pin, plunger and plunger bore (see Figure 11).
  - Use nitrile gloves while handling the barium grease.
  - Apply a light film of lubricant on the parts. Make sure not to over-lubricate.

Lubrication

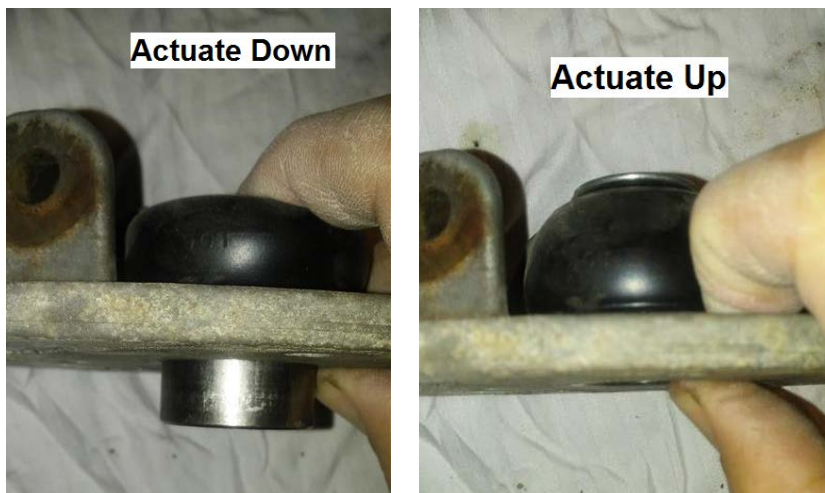
**FIGURE 12**

- Put the boot on the plunger.
- Inset the plunger into the bore hole on the base plate. Make sure the boot snaps onto the baseplate retaining ridge.
- Manually actuate the plunger to ensure proper boot installation (see Figure 12).

Actuating the Plunger

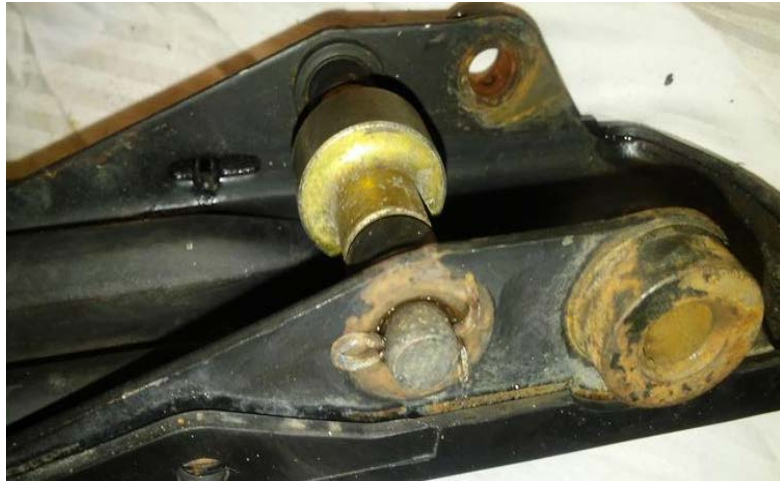
**FIGURE 13**  
Cotter Pin Installation

- Insert stop button onto the base plate.
- Assemble the pedal.
  - Insert lubricated roller pin and roller into the pedal.
  - Insert the cotter pin (see Figure 13) and bend the ends.

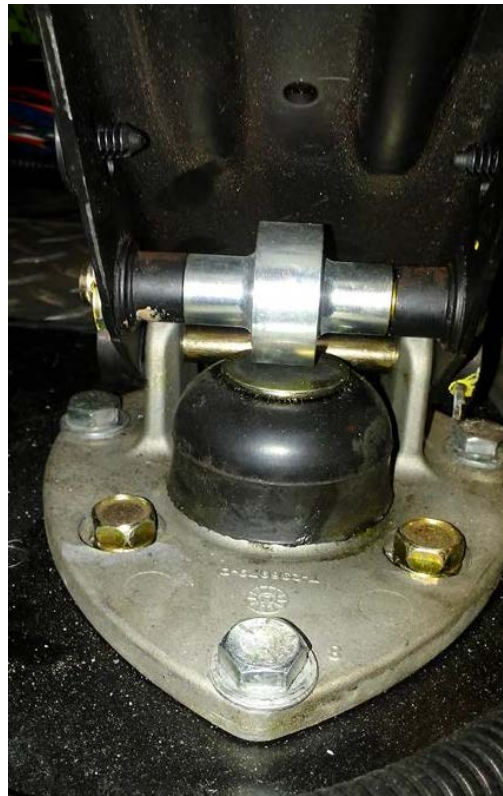
**FIGURE 14**  
Roll Pin Insertion

- Install pedal onto the base plate.
  - Insert lubricated pivot pin.
  - Insert roll pin (see Figure 14).
