APTA BTS-BC-RP-012-25

**Bus Brake and Chassis System
Working Group**

Transit Bus Air Disc Brake Reline

Abstract: This recommended practice provides guidelines for performing complete brake maintenance on a bus with disc brakes. It includes disassembly, cleaning, inspection and assembly. This document is to be used in conjunction with the manufacturer's service manual. It is recommended that all components be replaced equally on both wheel ends of the axle. Failure to do so may affect braking performance.

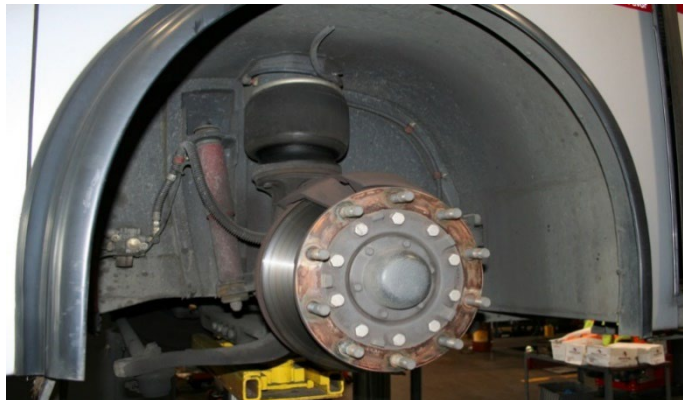
FIGURE 3
Wheels-Off Inspection

Safely raise and support the bus by the axles at an appropriate working height and remove the wheels (**Figure 3**).

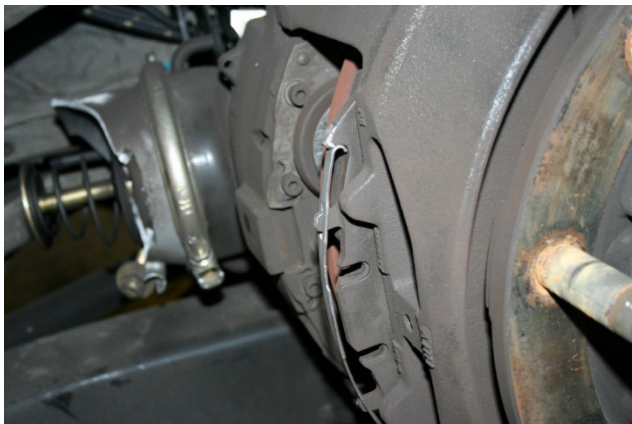
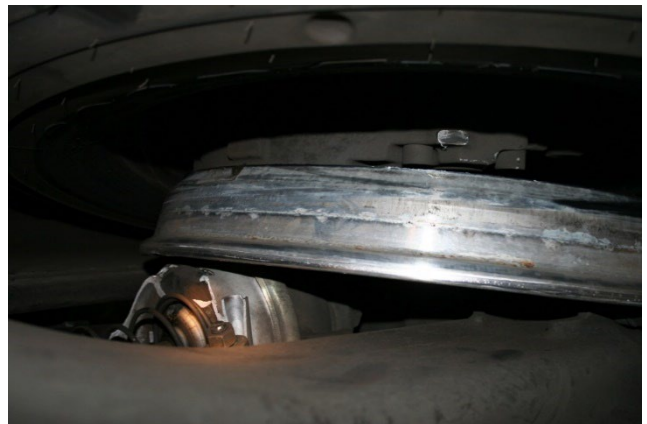
FIGURE 5

A missing pad retainer strap can allow pads to climb out of the caliper and wear on the rim, resulting in rim and brake failure (Figure 5).

Damage caused by a missing pad retainer strap

Damaged rim and brake chamber caused by a missing pad retainer strap

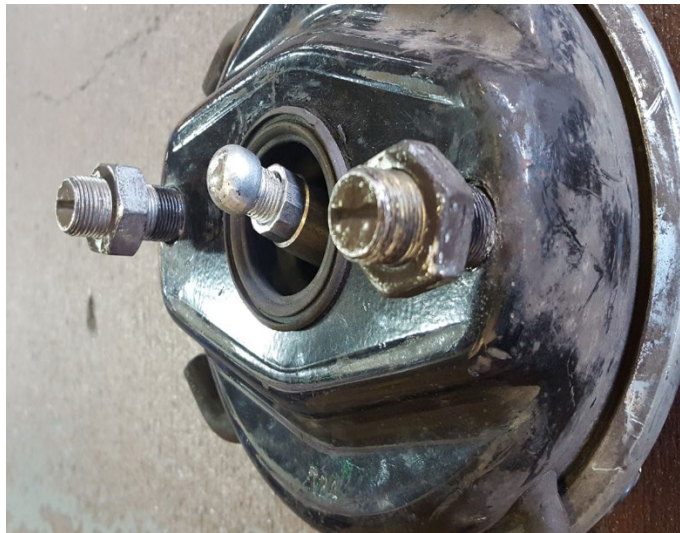
Misaligned Push Rod

Inspect the push rod for damage and alignment. A failure indicated by a chamber push rod that is not perpendicular to the housing will require a chamber replacement (**Figure 12**).

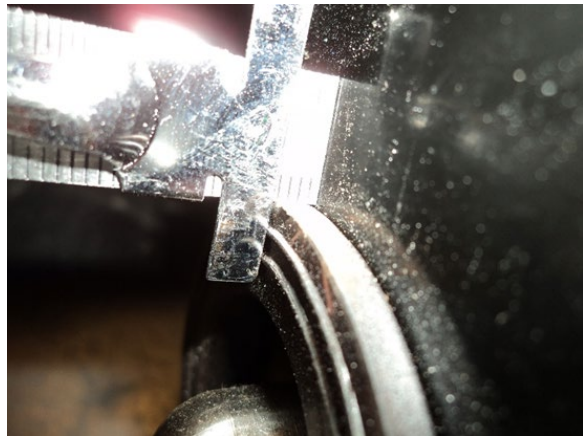
Brake Chamber Seal Protrusion

For chambers used on the Knorr-Bremse caliper, minimum tolerance is 3 mm of seal protrusion (**Figure 14**). If the seal protrudes less than 3 mm, then the chamber must be replaced.

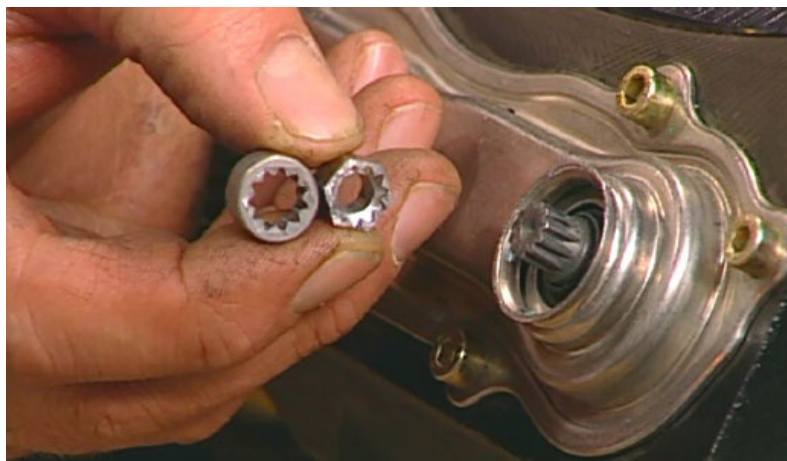
Broken Shear Adapter

If the shear adapter fails, check for free movement of the pads and caliper slide pins before attempting a second time. Replace the shear adapter and make a second attempt. If the adapter fails on the second attempt, and the caliper slide pins or brake pads are not stuck, then the adjuster mechanism is seized, and the caliper must be replaced. The shear adapter is designed to shear if excessive torque is required to turn the adjuster (**Figure 22**).

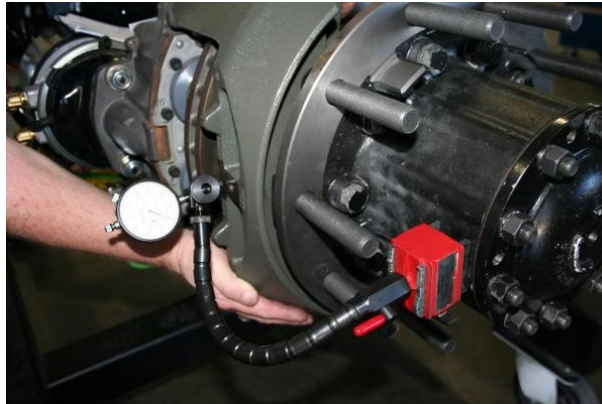
Checking Meritor EX225 Slide Pin Bushing Clearance

Attach a dial indicator onto the vehicle hub and set it against the caliper. Position the brake caliper in the center position as it would be when the brake pads are installed. This is set when a gap of approximately 0.8 in. (20 mm) exists between the rotor and the bridge (**Figure 26**). Hold the caliper at the outboard pad edge and by the air chamber. Push the brake caliper down by hand as far as possible with approximately 10 lb of force and set the gauge to zero. Pull the caliper up as far as possible with approximately 10 lb of force without allowing the caliper to slide. The maximum acceptable reading is 0.100 in. (2.5 mm). If the reading is more than 0.100 in. (2.5 mm), then replace the bushings and slide pins, or the caliper assembly.

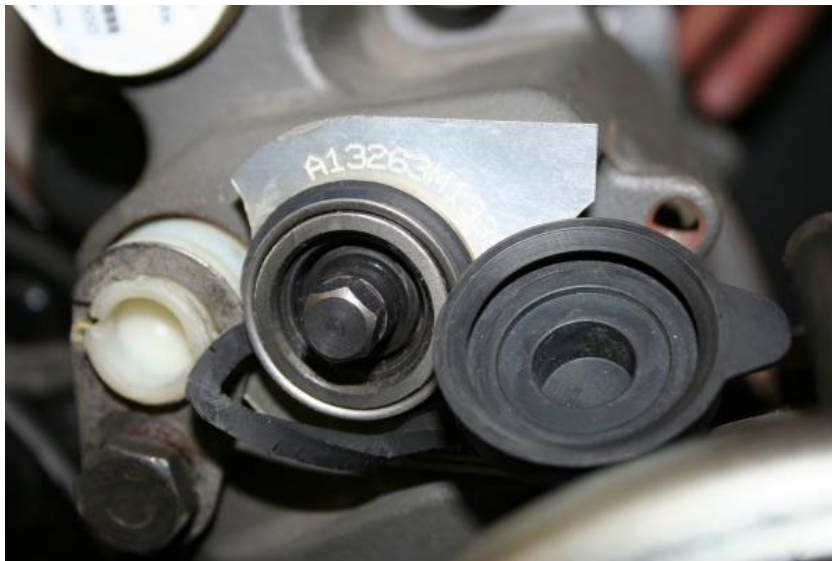
Meritor EX225 Dust Cap with Adjuster and Seal Visible

Check that the adjusting screw cap is properly installed and is not torn or loose. Remove the cap and visually inspect the adjusting screw seal for damage (**Figure 27**).

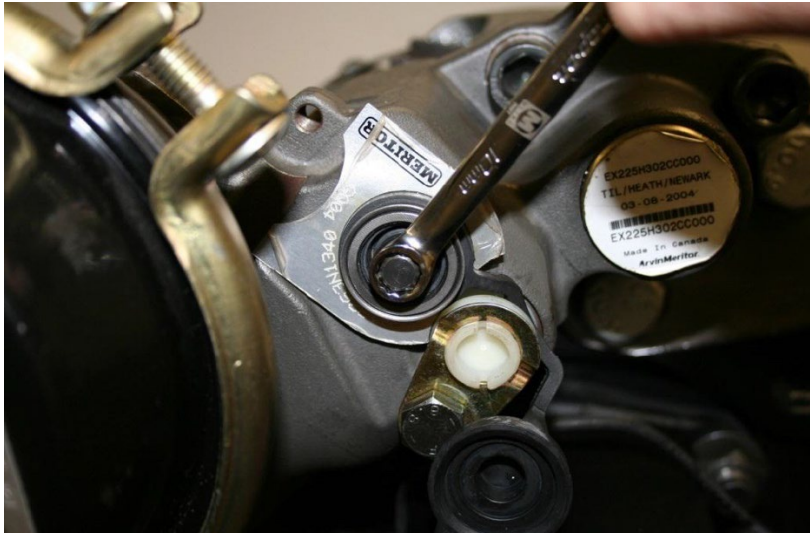
FIGURE 28
Checking Meritor EX225 Adjuster

Make sure the bus has at least 95 psi (6.55 bar) air pressure, and if applicable make sure the spring brake is released. Using a 10 mm box wrench, de-adjust the brakes one quarter turn. Do not exceed 30 ft-lb (40 Nm) of torque. Leave the box wrench on the adjuster, and make sure it can move in the clockwise direction without obstruction. Apply the brakes with about 30 psi (2 bar) pressure 5 to 10 times. The wrench should turn clockwise as seen from the actuator side (**Figure 28**). If the wrench does not turn or turns forward and backward with each application, then the automatic adjuster has failed, and the caliper must be replaced.

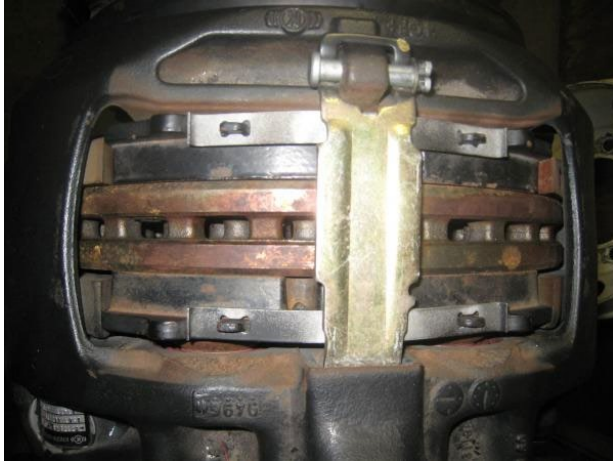
FIGURE 31
Brake Pad Removal

Ensure that the spring brake is caged. Disconnect and remove wear sensors where applicable. Visually inspect the brake pad retainer for damage or wear. Replace if wear or damage is evident and when brake pads are replaced. Remove the brake pad springs (**Figure 31**). Follow the de-adjustment procedures identified previously for the appropriate caliper. Remove the bolt (Meritor) or clevis pin (Knorr-Bremse) securing the pad retaining strap. Remove the retaining strap from the caliper.

Knorr-Bremse pad retainer with clevis pin

Meritor EX225 caliper pad retainer secured with a bolt

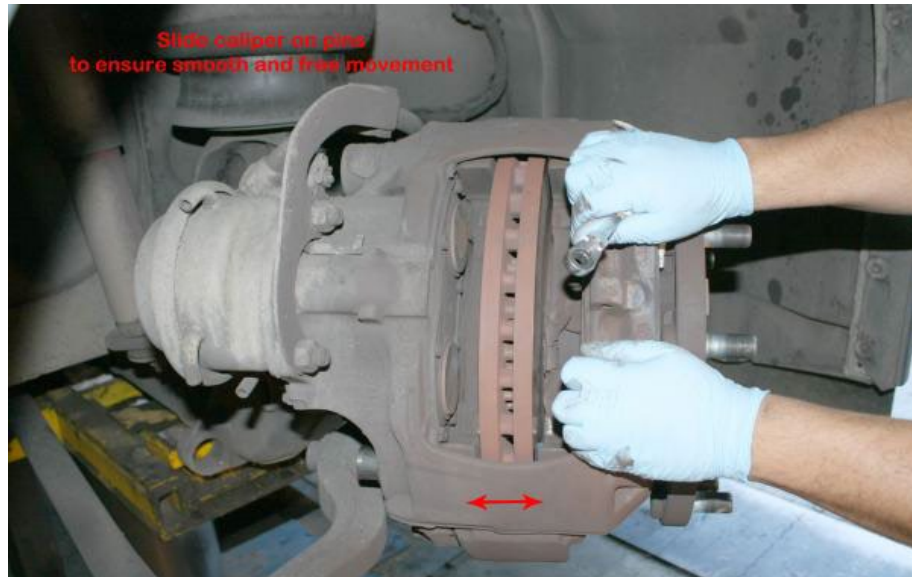
FIGURE 32

This test is used for both the Meritor EX225 and Knorr-Bremse calipers. Clean the exposed part of the guide pin before moving the caliper in and out to prevent bushing contamination. Using hand pressure only, with the brake pads removed, make sure the caliper slides freely along the whole length of the guide pins ([Figure 32](#)). Replace the guide pins and bushings if the caliper does not slide freely.

Checking for Smooth Caliper Movement on the Guide Pins

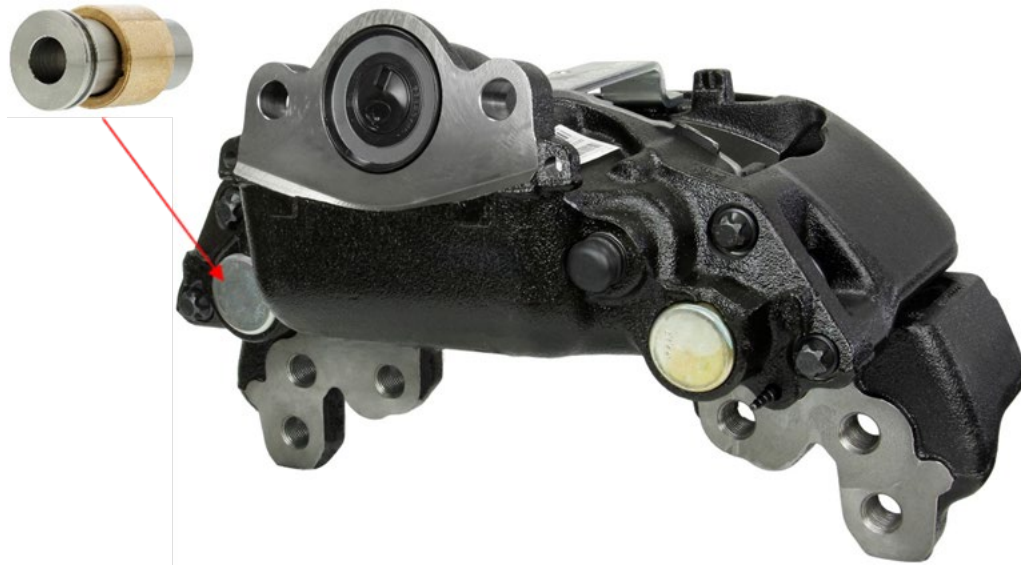
FIGURE 33

When the caliper is removed, visually inspect the caliper slide pin bushings for proper installation and positioning. Some bushings are round, and others are oval. Oval bushings should be installed with the oval shape in the horizontal position. Meritor EX225 has a combination of round and oval bushings, and Knorr-Bremse has round and elastic rubber bushings. On the Knorr-Bremse setup, the long pin is guided with a solid bushing and the short one with an elastic rubber bushing.

Meritor EX225 Short Slide Pin with Oval Bushing

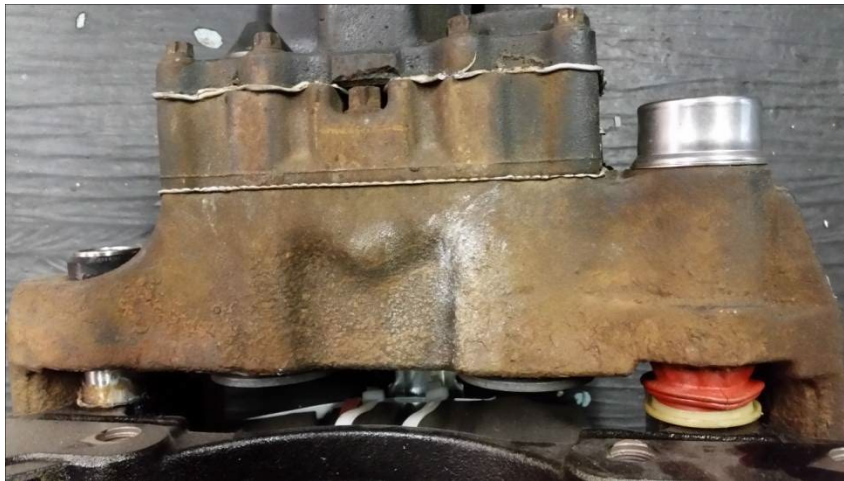
FIGURE 34

All slide/guide pin boots should be free from damage and should be correctly seated. To check boot condition, push the bridge inboard and the boots should collapse (be sucked inward). When the bridge is

moved outboard, the boots should expand. If any whistle or air movement sound is heard, or if the boots do not collapse and expand as described, the boots will need to be replaced. When a damaged or leaking slide pin seal is identified, the caliper should be removed for replacement of the bushings and seals (**Figure 34**). When replacing boots, inspect the guide pin condition. If guide pins show signs of corrosion, then replacement of the pins is recommended.

Guide/Slide Pin Boot Inspection

Knorr-Bremse guide pin boot

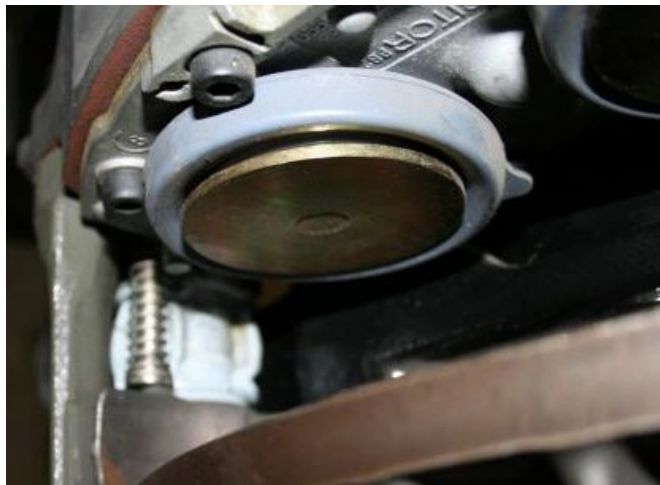
Meritor EX225 slide pin boot and tappet boot

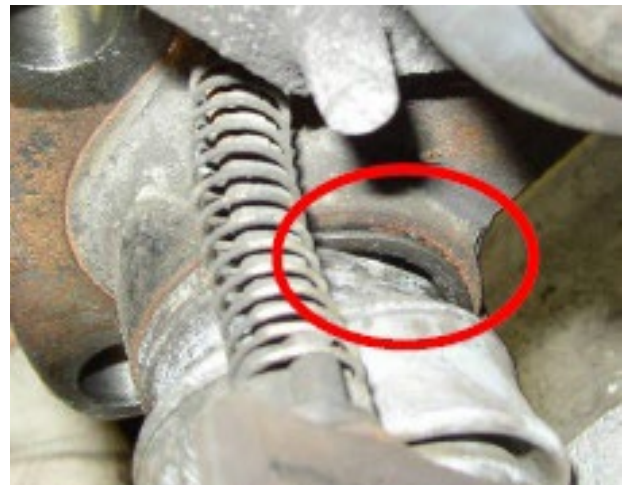
Improperly installed slide pin boot

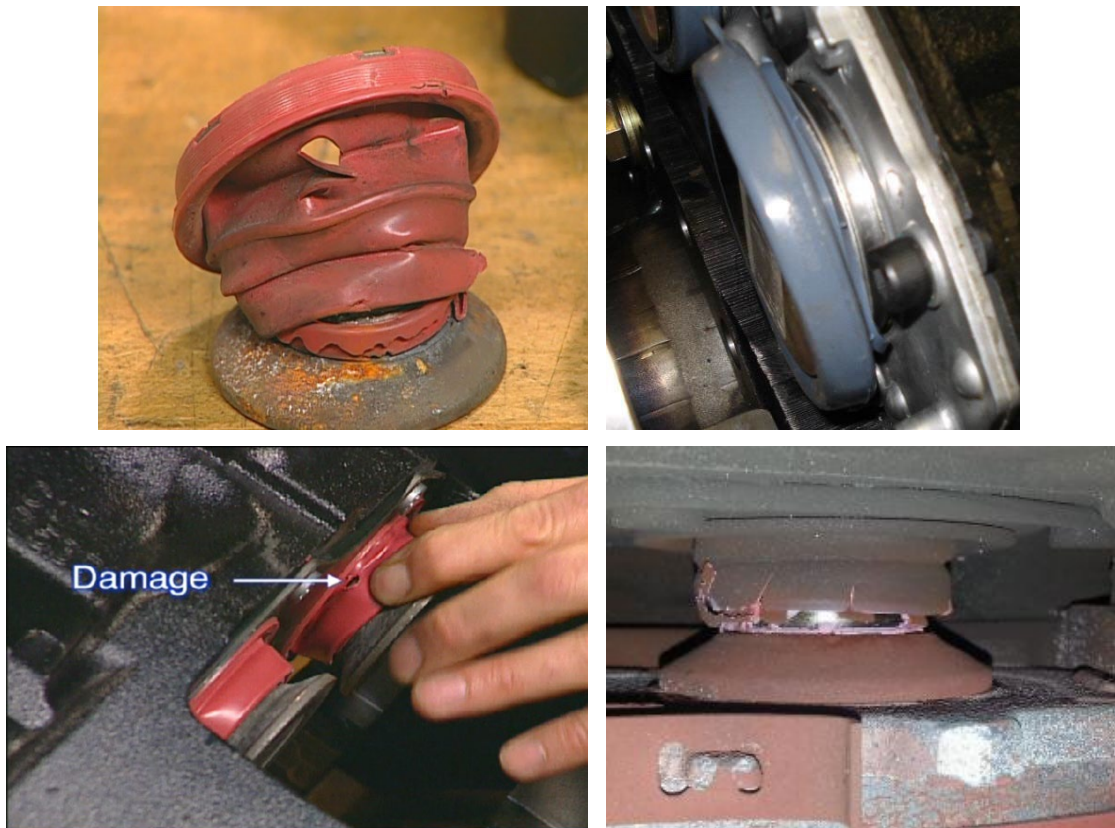
FIGURE 37

Damaged, improperly seated, loose or worn boots and seals (**Figure 37**) can allow moisture and contamination into the internal mechanism of the caliper. These contaminations can cause the caliper to malfunction and not adjust or release properly, resulting in dragging or slack brakes. Inspect all tappet boots and sealing surfaces for damage, looseness and improper seating.

Examples of Damaged or Improperly Installed Tappet Boots

Damaged tappet boots must be replaced prior to installing brake pads. Knorr-Bremse has a replaceable inner tappet seal that is accessible when the tappet and boot are removed (**Figure 38**). Calipers suspected as contaminated must be replaced.

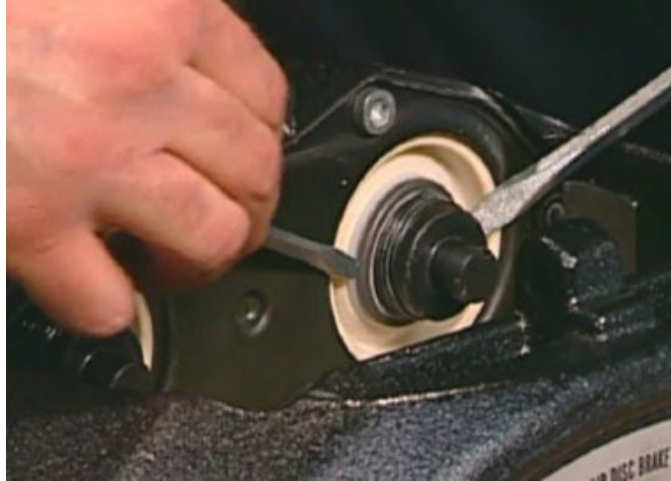
FIGURE 38

Knorr-Bremse Inner Tappet Seal Replacement

It is recommended that tappet seals be replaced during each wheels-off inspection to improve caliper life and performance (contingent on how often wheels-off inspections are done, or whether calipers are replaced as part of the reline). Tappet and seal assemblies should always be replaced as a set. Replace inner tappet seals on Knorr-Bremse calipers whenever tappets and outer seal assemblies are replaced.

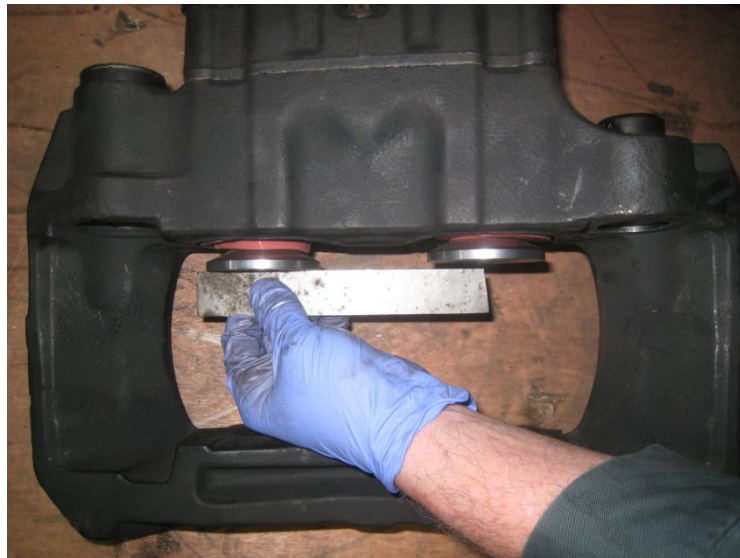
FIGURE 39

Clean the tappet pad contact surfaces. Using a straight edge, measure tappet height to ensure that both tappets are at equal height (**Figure 39**). Uneven tappet height indicates that tappet synchronization is lost and the caliper must be replaced.

Straight Edge Showing Uneven Tappet Height

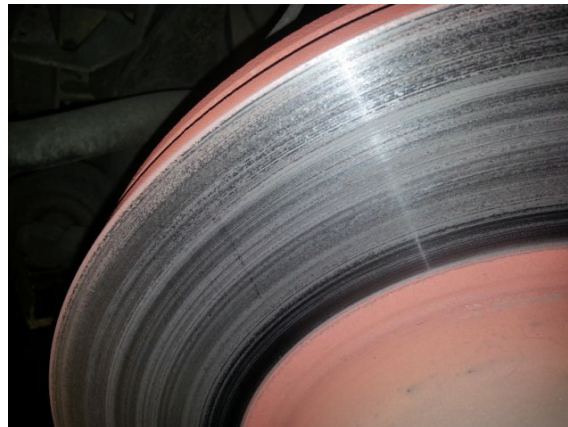
FIGURE 42
Evidence of Overheating

Blue bands along the swept part of the rotor and rust color on the housing are indicators of a brake that has overheated (**Figure 42**). The cause must be identified and corrected. Rotors and pads must be replaced after identifying and repairing the cause of the hot brakes.

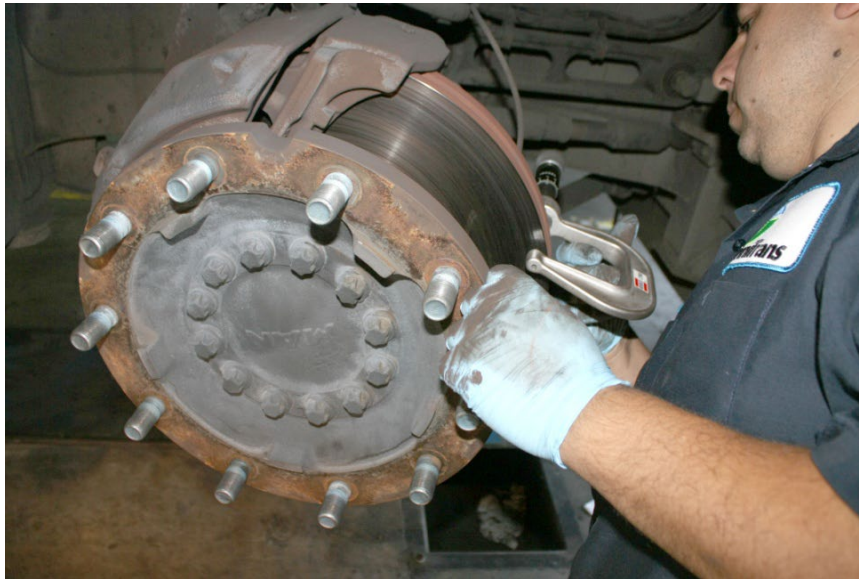
FIGURE 43

Use a brake rotor micrometer to measure thickness at 90 deg intervals at the thinnest portion of the rotor (**Figure 43**). Avoid measuring near the edge of the rotor, as minor burrs may result in inaccurate measurement. If unsure of the thinnest point, measure at three points. Point one is about 10 mm below the outer friction diameter. Point two is at the friction surface center. Point three is about 10 mm above the inner

Measuring Brake Rotor Thickness with a Brake Rotor Micrometer

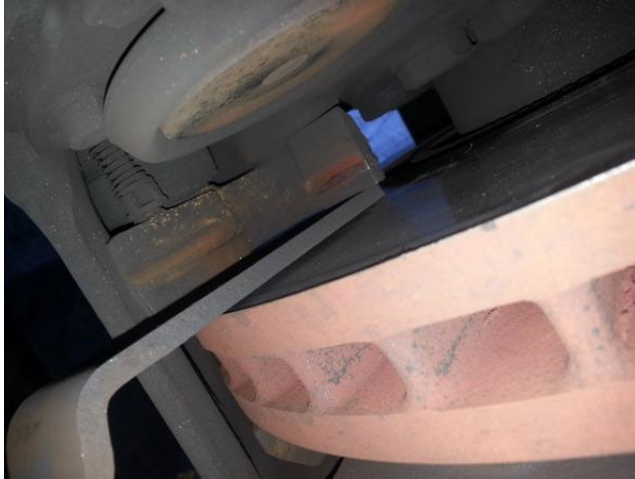
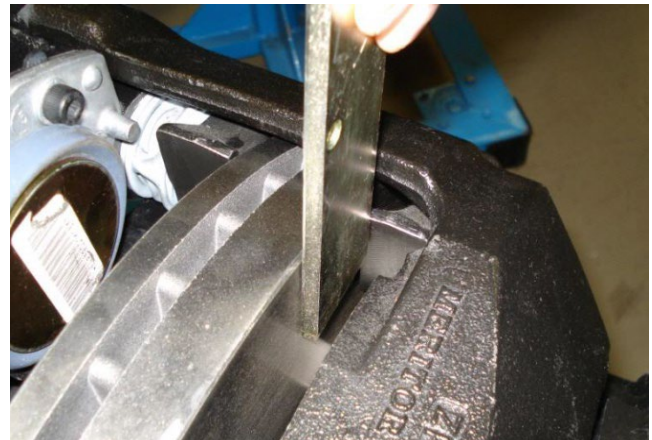
FIGURE 44
Rotor Wear

Meritor EX225 pad retainers can be used as a gauge to help identify worn rotors. To check wear, place the retainer between the rotor surface and the carrier pad abutment. Make sure that wear is checked on both the inboard and outboard sides of the rotor. See **Figure 44**.

Uneven Meritor EX225 rotor wear indicated by angular gap between pad retainer and carrier. The rotor will need to be replaced.

Worn Meritor EX225 rotor indicated by gap between the pad retainer and the carrier. The rotor will need to be replaced.

Acceptable Meritor EX225 rotor thickness indicated, as the pad retainer will not fit between the rotor and the carrier.

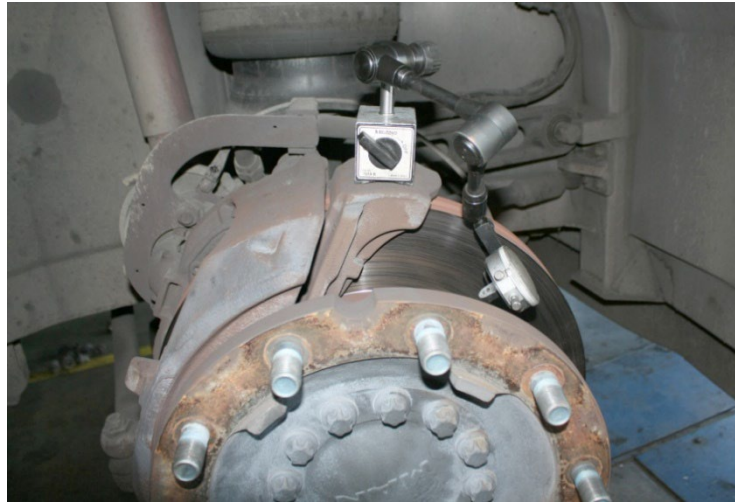
Checking Rotor Run-Out

If rotor run-out is beyond recommended specifications, they will need to be replaced or machined (**Figure 46**). If the rotors fall below 39 mm during machining, they will fall below minimum discard thickness during the life of the new pads, so they will need to be replaced.

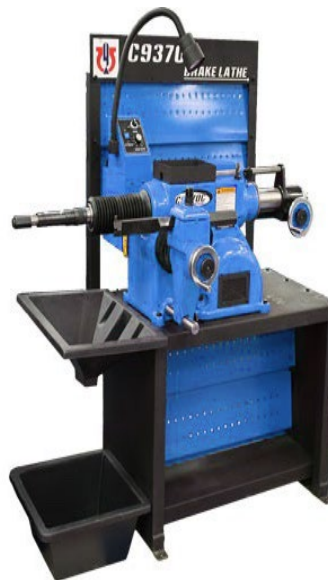
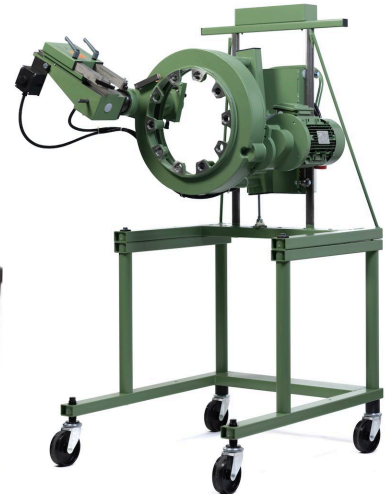
FIGURE 46

Brake Rotor Lathes

Options exist to turn rotors both on and off the vehicle.

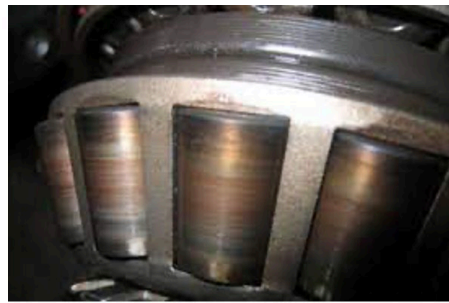
Point Surface Origin (PSO) spalling

Spalling is the result of metal fatigue and also associated with improper lubrication.

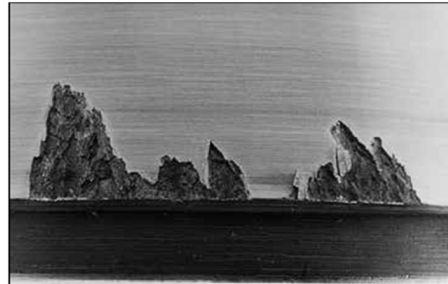
Geometric Stress Concentration (GSC) spalling

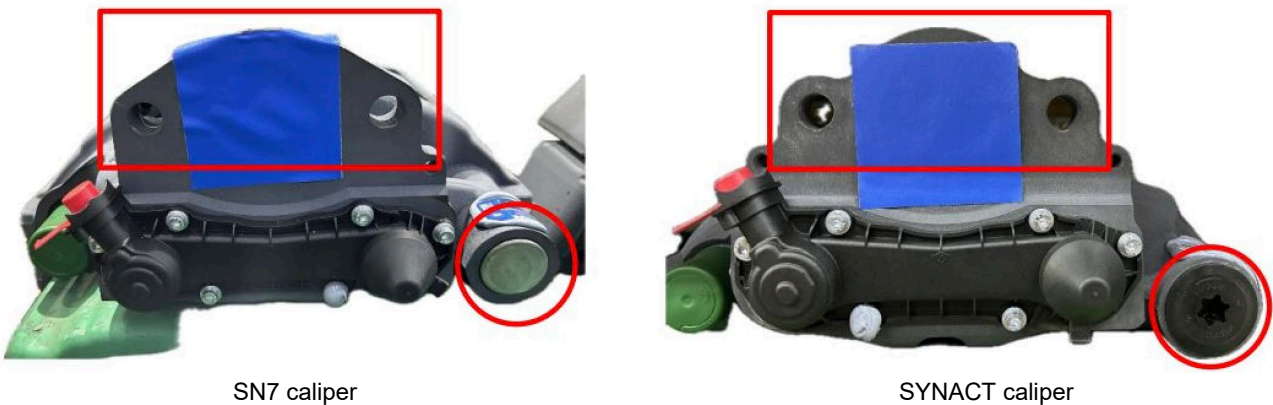
FIGURE 52

Brake pads must be changed as an axle set and not individually. Before installing the pads, make sure that the tappets are fully retracted and that all surfaces are clean. Install the new pads so the friction material faces the rotor. Note that on Knorr Bremse SYNACT calipers, the brake lining and the longer friction surface must be fitted in the outer brake lining cavity and the brake lining with the shorter friction surface in the inner brake lining cavity ([Figure 52](#)).

SN7 vs. SYNACT Caliper

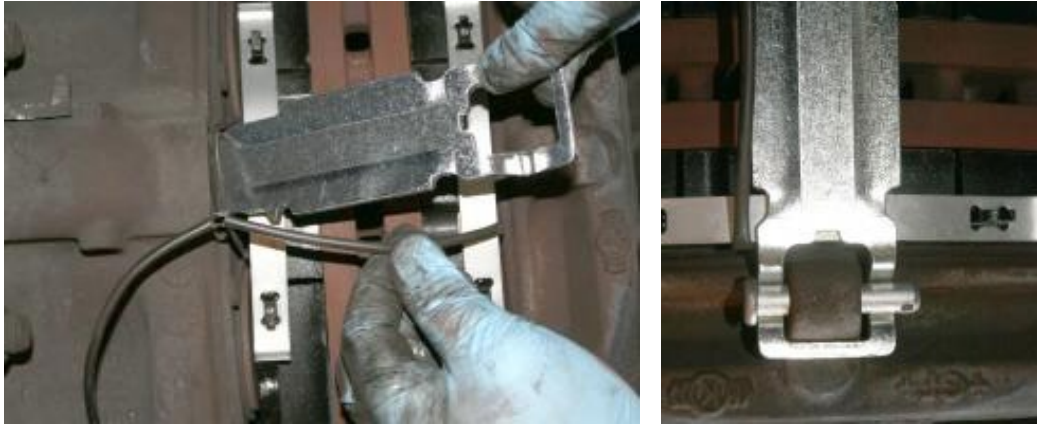
FIGURE 55
Pad Retainer Straps

Knorr-Bremse pad retainer installation

If equipped, properly secure Knorr-Bremse wear sensor harness.

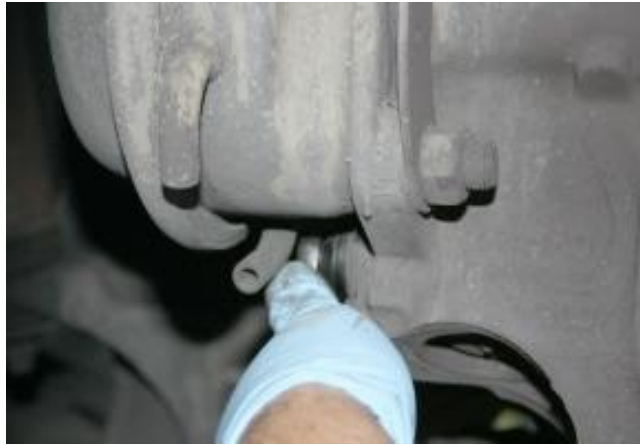
FIGURE 56
Setting Initial Clearance

Adjusting the brakes to set the initial clearance
