Conducting a Root Cause on Run Away Buses

Using Data to Avert a Disaster

King County Metro

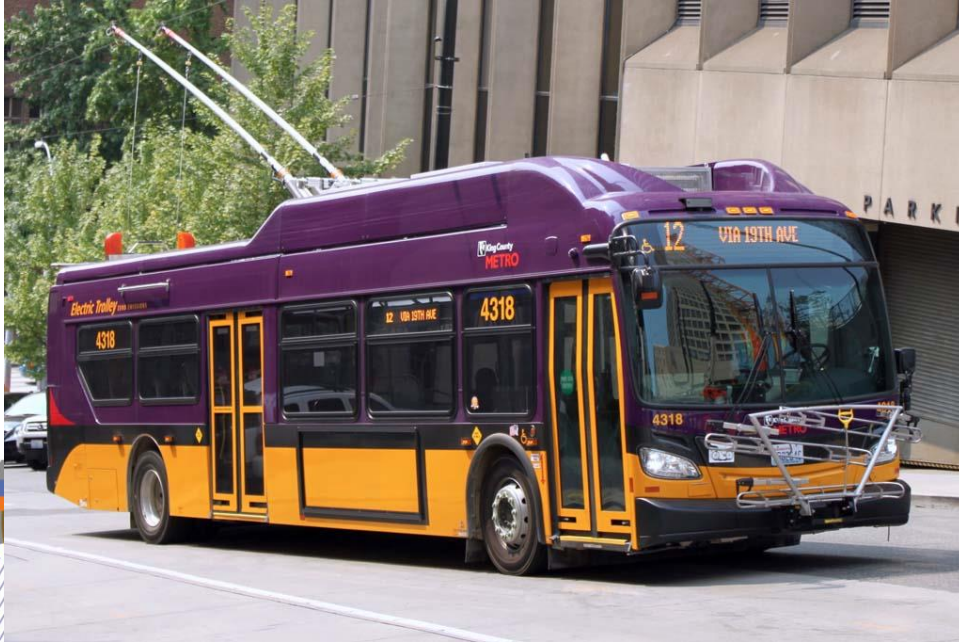
Rolling Buses

- Over 4 month period
 - 4 buses rolled while re-wiring
 - 1 hybrid diesel rolled while at transit center
 - 2 others rumored but not confirmed.

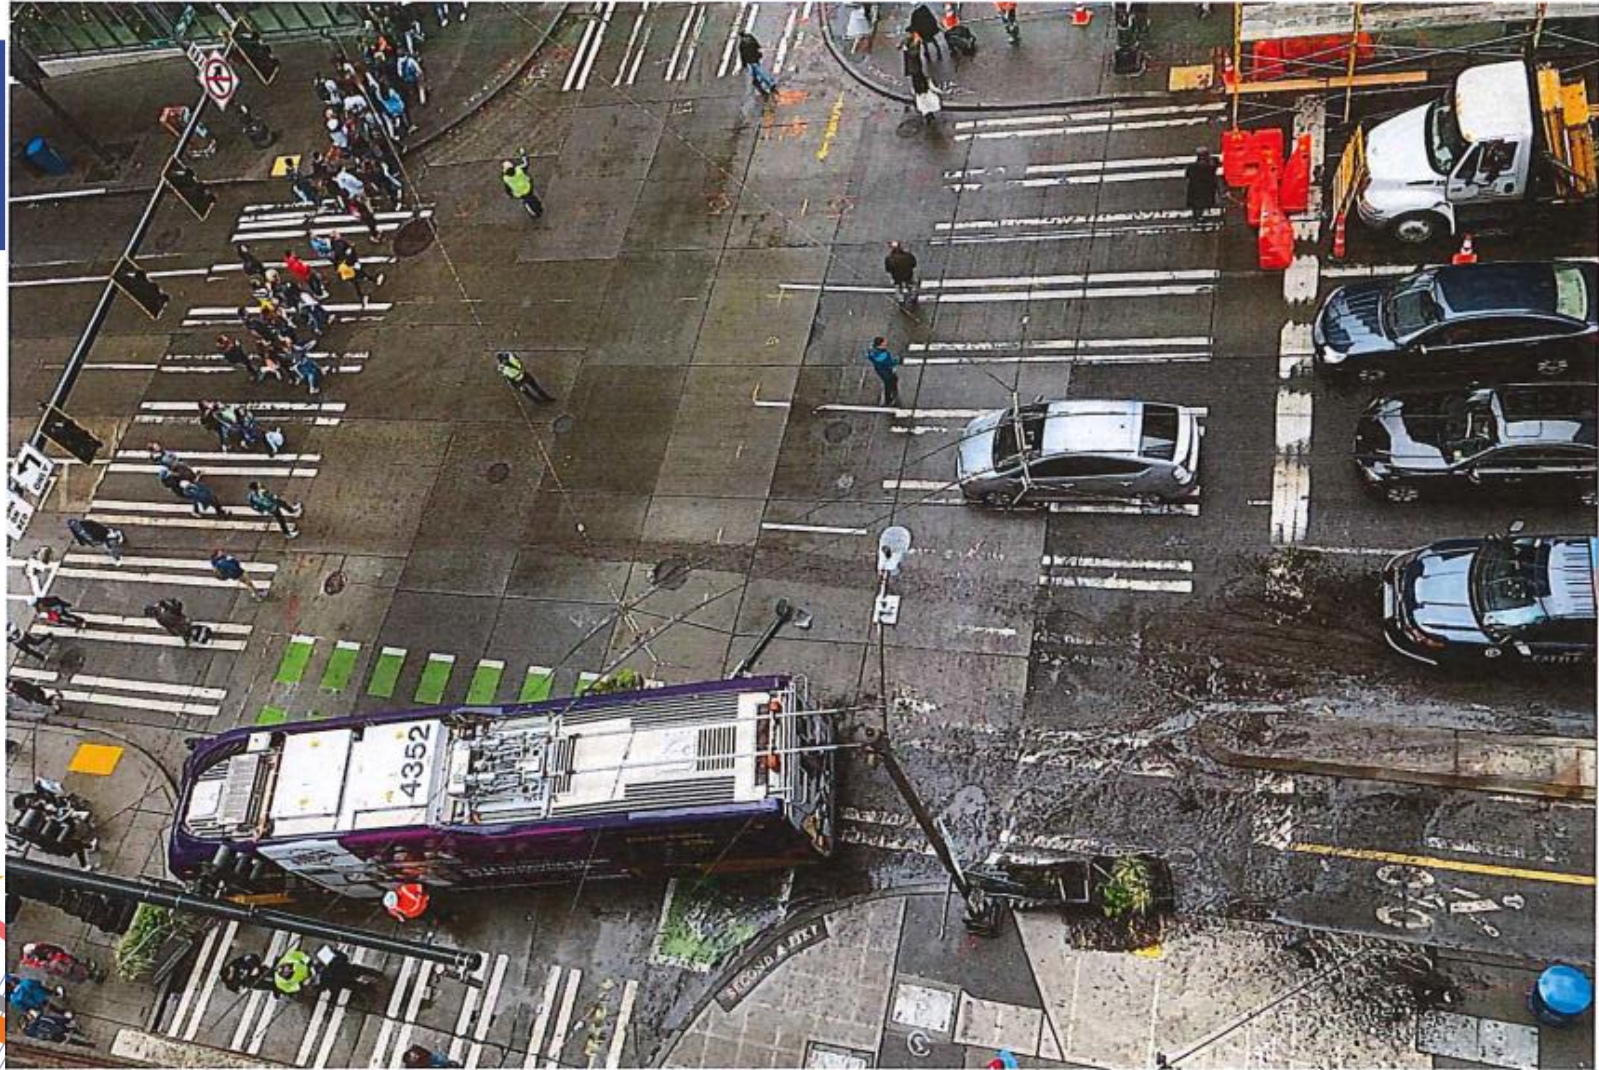
Electric Trolleys - First Observation

- Operator not setting the parking brake (PP1 Valve)
- Leaves seat to reset poles at rear of coach
- Pole reset function releases brake interlock
- Bus rolls with direction of downward grade
 - 1 case passenger brings the vehicle to a stop
 - 3 cases buses stop after colliding with fixed object

Note: Brake interlock was designed by OEM as a protection mechanism to prevent damage to overhead catenary and current collection systems to prevent damage when a de-wiring event occurred. The system was not intended to be a safety system or a means to secure the coach.

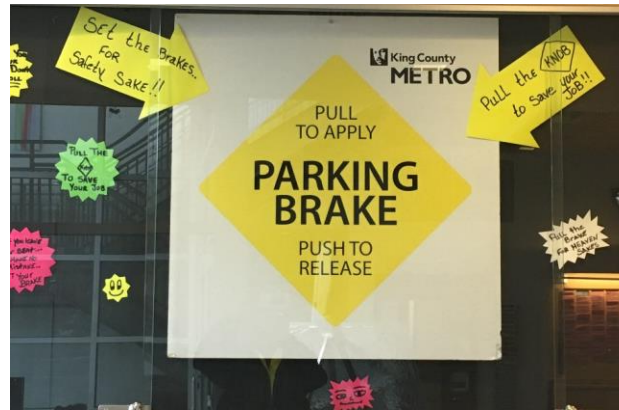
Verification – Root Cause

- Audio on video where operators admits not setting the brake.
- Inspection by field supervisor at the scene verified that the brake was not set.
- Telemetric data verified:
 - The parking brake was not set.
 - All systems on the vehicles were working as they should be.
 - e.g. the door was open, engine in neutral, etc.
