Baltimore LRV Case Study

Braking Functionality and Operator Vigilance System Improvements

Prepared jointly with the
Maryland Transit Administration

May 26, 2017

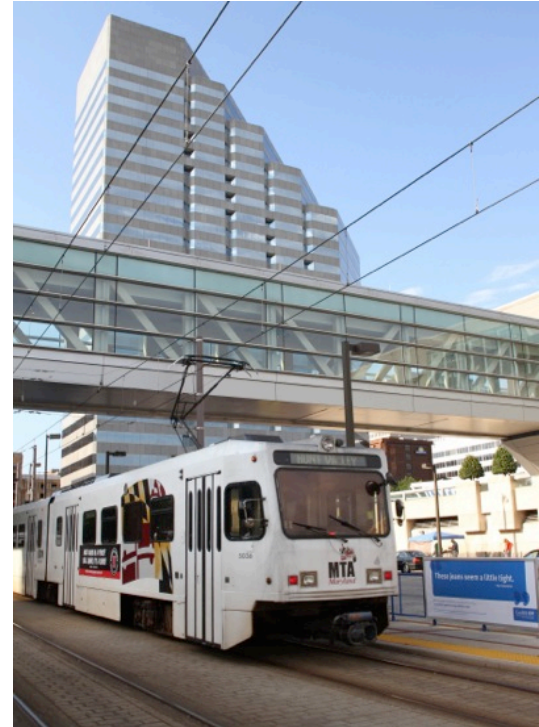
MDOT-MTA's LRVs are quite large—much larger than traditional streetcars and bigger even than those used on San Francisco's Muni Metro or Boston's Green Line. The LRVs are comprised of two articulated cars; measure 95 feet (29 m) long (over coupler faces), 9.5 feet (2.9 m) wide, and 12.5 feet (3.8 m) high with lowered pantographs. Each LRV can accommodate 84 seated passengers, 177 standing passengers and 260 passengers with a crush load (one person per square foot). These vehicles operate on standard 4 ft. 8 1/2 in. (1,435 mm) gauge track. One, two and three vehicle trains are routinely seen in service. LRVs are powered by an overhead catenary system and have a maximum speed of 60 miles per hour (97 km/h). When delivered, they were the first transit rail vehicles in the United States to employ A/C propulsion. Each LRV is powered by four 275 HP motors for a total of 1100 HP-- the center truck is unpowered.

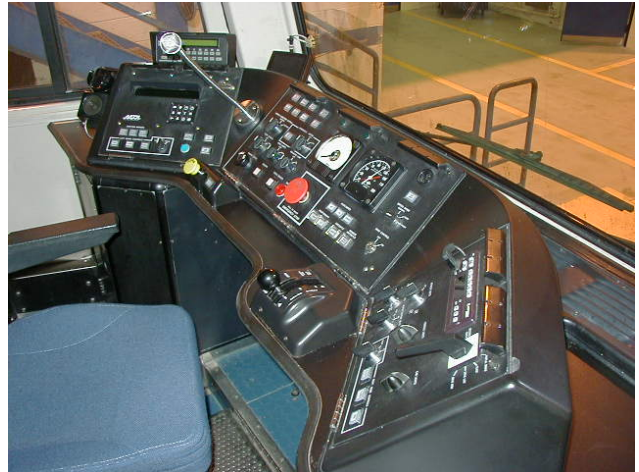
Normal LRV movement is controlled by a Master Controller handle that is connected to a computerized control unit known as TRACS which communicates the Operator's requests to the TRACS units throughout the consist. The TRACS unit coordinates local Propulsion and Friction Brake control commands based on the Operator's request(s), movement interlocks, and status indications for its specific LRV. TRACS provides automatic conventional wheel slip-slide correction control during full service braking.

There is an independent trainlined control circuit for emergency braking (friction brake + track brake + sanding). Conventional wheel slip-slide correction control is disabled during an emergency brake application.

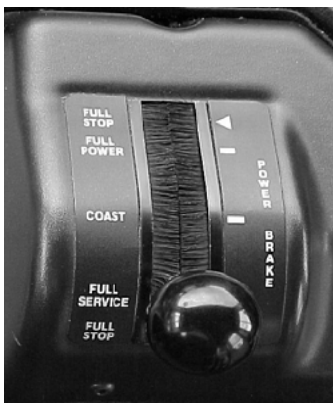
The Deadman feature consists of an electric switch and a spring-loaded telescoping extension of the Master Controller handle. The telescoping extension causes the electric switch to “make” and “break” its electrical contacts based on the extension's position when depressed or released. The handle must be in its “depressed” state in order for the vehicle to follow control requests signaled by the Master Controller. If the handle is in its “released” position for a period exceeding five (5) seconds, a Full Service brake application (Service Brake with Wheel Slip-Slide Correction) is automatically requested until the train comes to a stop.

The problem is that the spring load requires significant force to keep the handle depressed-- tiring the Operator's hand and arm. As a result, nuisance stops and complaints were encountered due to the fatigue of the Operators.

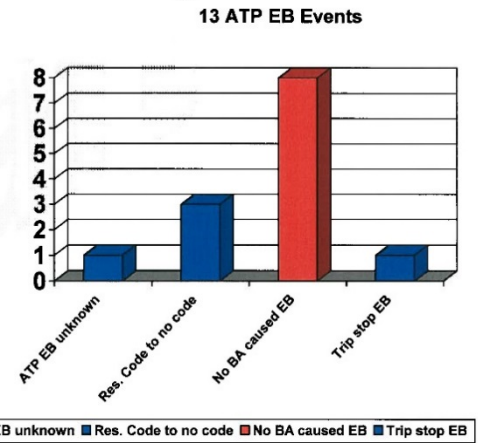
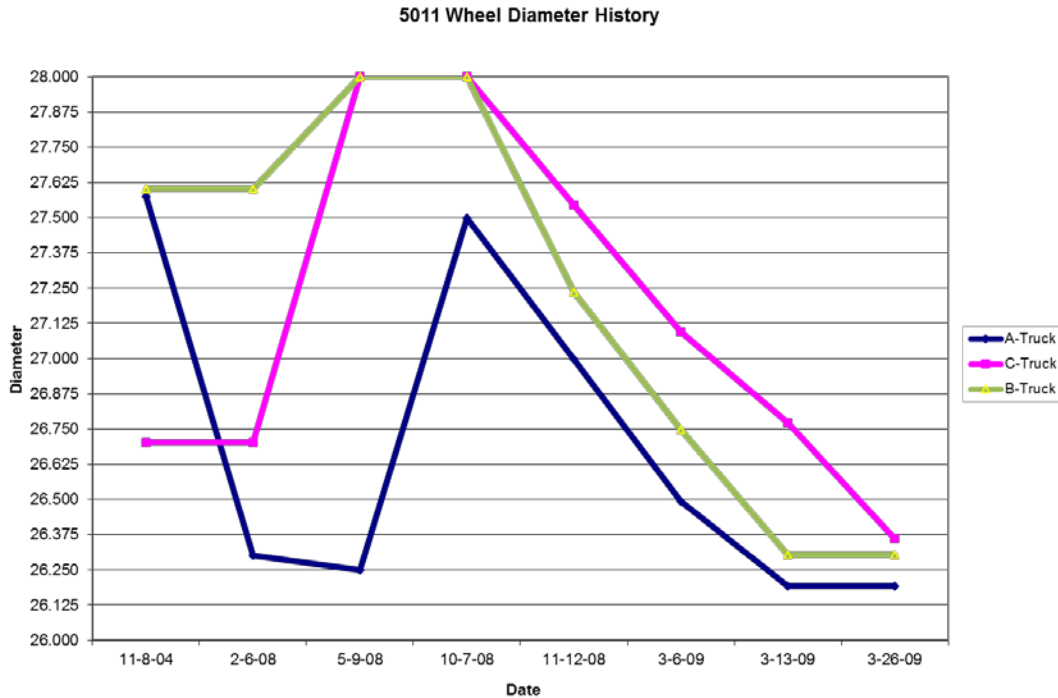
The graph below illustrates how often LRV tires had to be trued due to flats. From October 2008 thru March 2009, LRV 5011 powered trucks (A and B trucks) where trued three times and the non-powered (center C-truck) had been trued four times. This means the twelve LRV tires only lasted five months. With the requirement of extensive wheel truing, and to maintain fleet availability, Light Rail transported truck assemblies to the Metro Rail Car shop to be trued. This issue was fleet wide and had to be addressed.

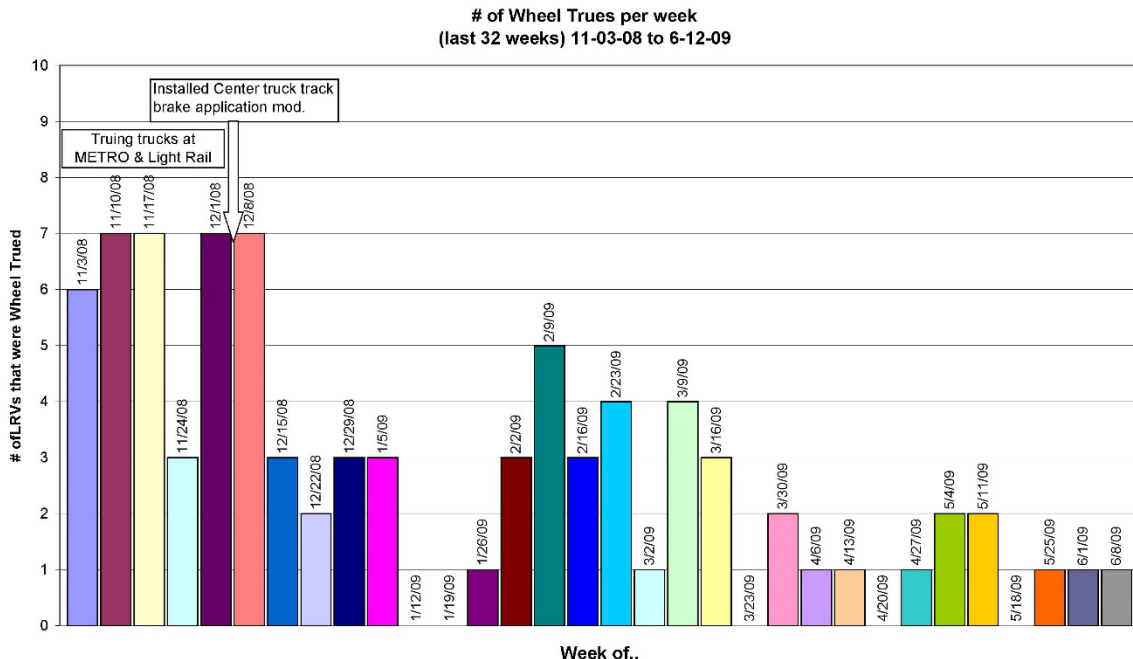
The effect of the control circuit change was significant as depicted in the histogram below. The number of vehicles developing wheel flats decreased by more than 50% from 7 vehicles per week to 3 vehicles per week and ultimately to one (1) vehicle per week approaching summertime.

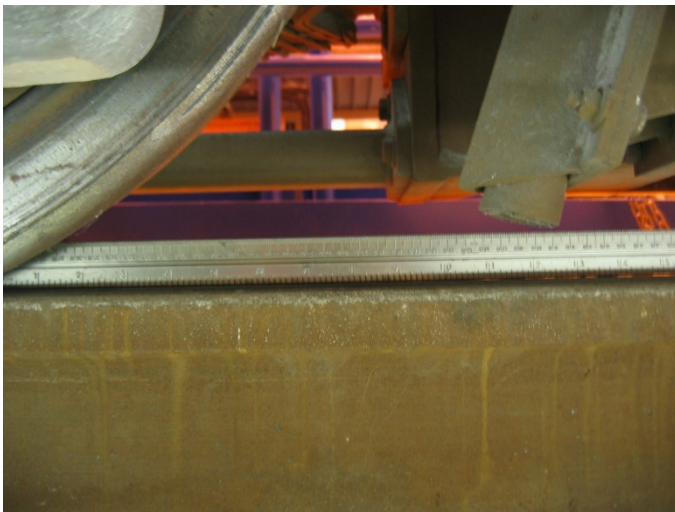
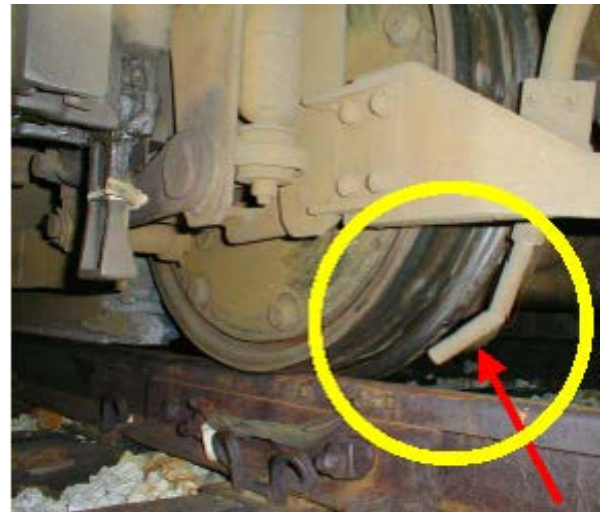
Also addressed were other identified causes for wheel flats which were attributed to the location of the sand tubes on the trucks and to wayside/track issues involving the greasing of curves/etc. and speed code equipment. In the case of the location of the sanding tubes on the trucks, efforts were made to reduce the original distance of the tube from the wheel-to-rail interface of 12 inches.

The goal is to improve the reliability of sand availability and flow while also improving the performance of the sand deposit by dropping it closer to the wheel-to-rail interface as discussed in Section 3.6.

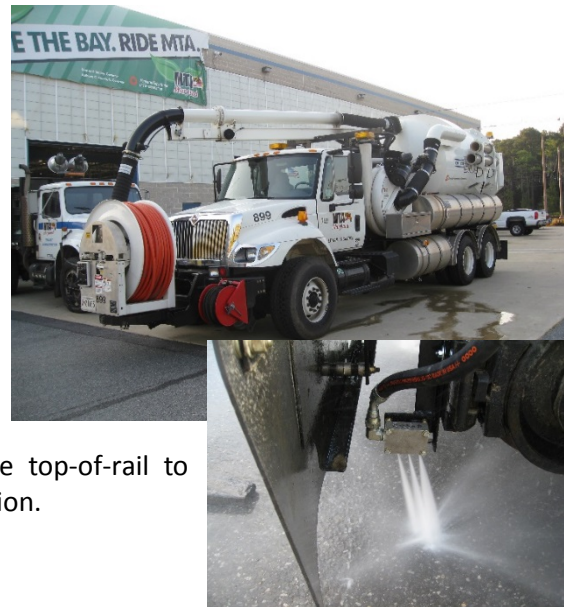
In addition to LRV ATP control circuits, training, sanding and wayside lubrication, Light Rail also modified their MOW VAC Truck to clean the top-of-rail with high pressure water.

During the “leaf season” MOW personnel would clean the top-of-rail to remove leaf residue. This effort enhanced wheel-to-rail adhesion.

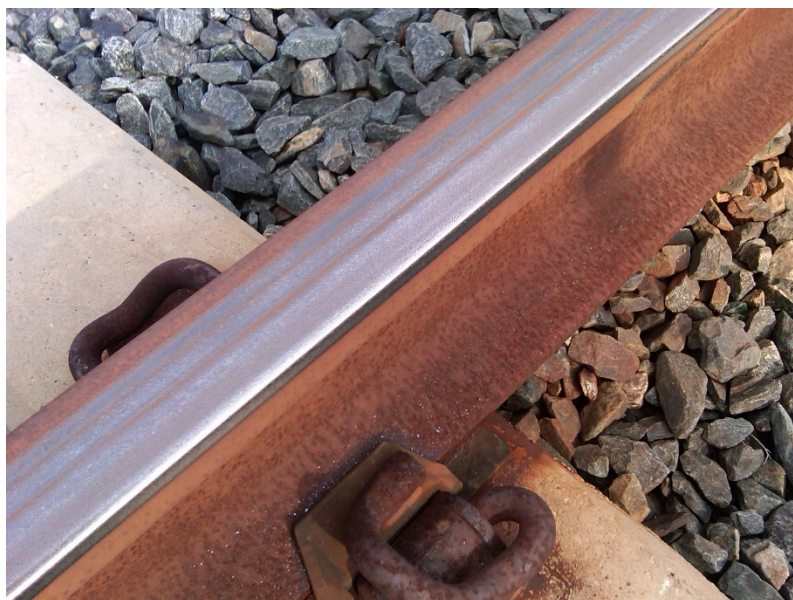
The photo below shows the top-of-rail and gauge face of the high rail after 30 runs of the test LRV. The top of rail has several bands of friction modifier transferred from the wheel tread, and the gauge face shows a dark coloration of LCF material transferred from the wheel flange.

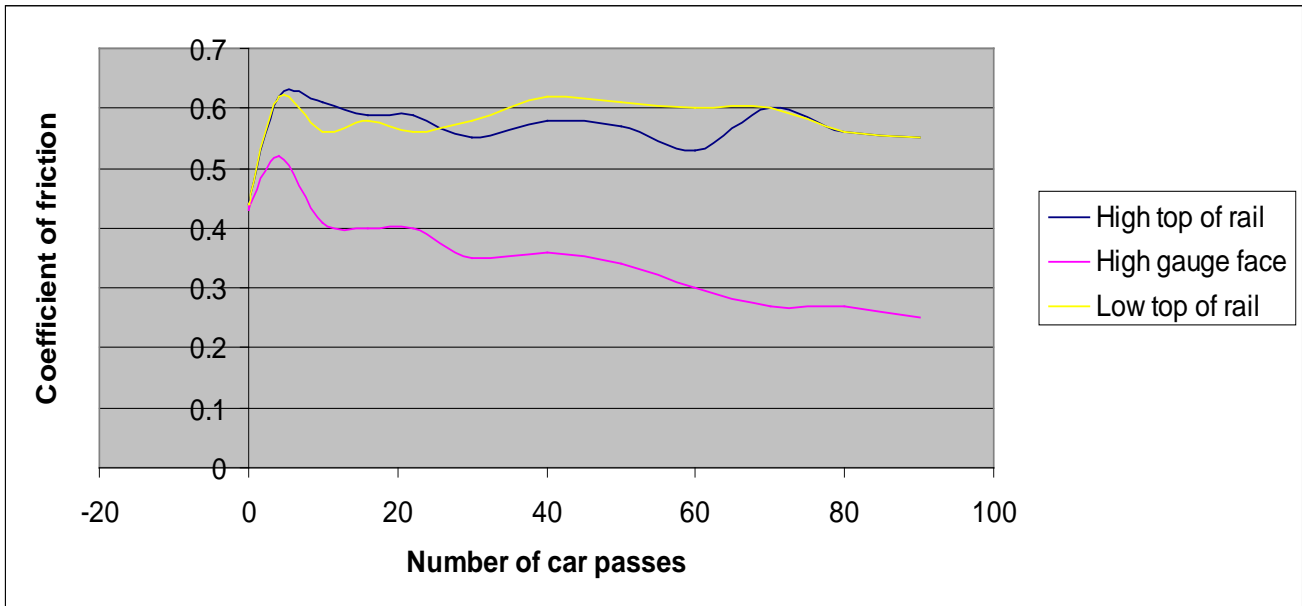
From the graph of test runs versus coefficient of Friction the following was determined:

1. The initial dry rail coefficient of friction for both the top-of-rail as well as the gauge face was measured and found to be 0.44 percent. (There may have been a residual amount of degreaser still on the rail which would have brought the coefficient of friction to this lower level).
2. The final top-of-rail coefficient of friction for both the high and low rails tended to be higher at 0.55 percent.
3. The graph indicates that the top-of-rail coefficient of friction was reached and tended to level off after 20 runs of the test LRV.
4. The high rail gauge face coefficient of friction shows a leveling off at between 0.25 – 0.27 percent.
5. The final gauge face coefficient of friction took much longer and many more runs before it stabilized. As indicated by the graph, the gauge face coefficient of friction didn't become less than 0.3 percent until after the 60th test run.

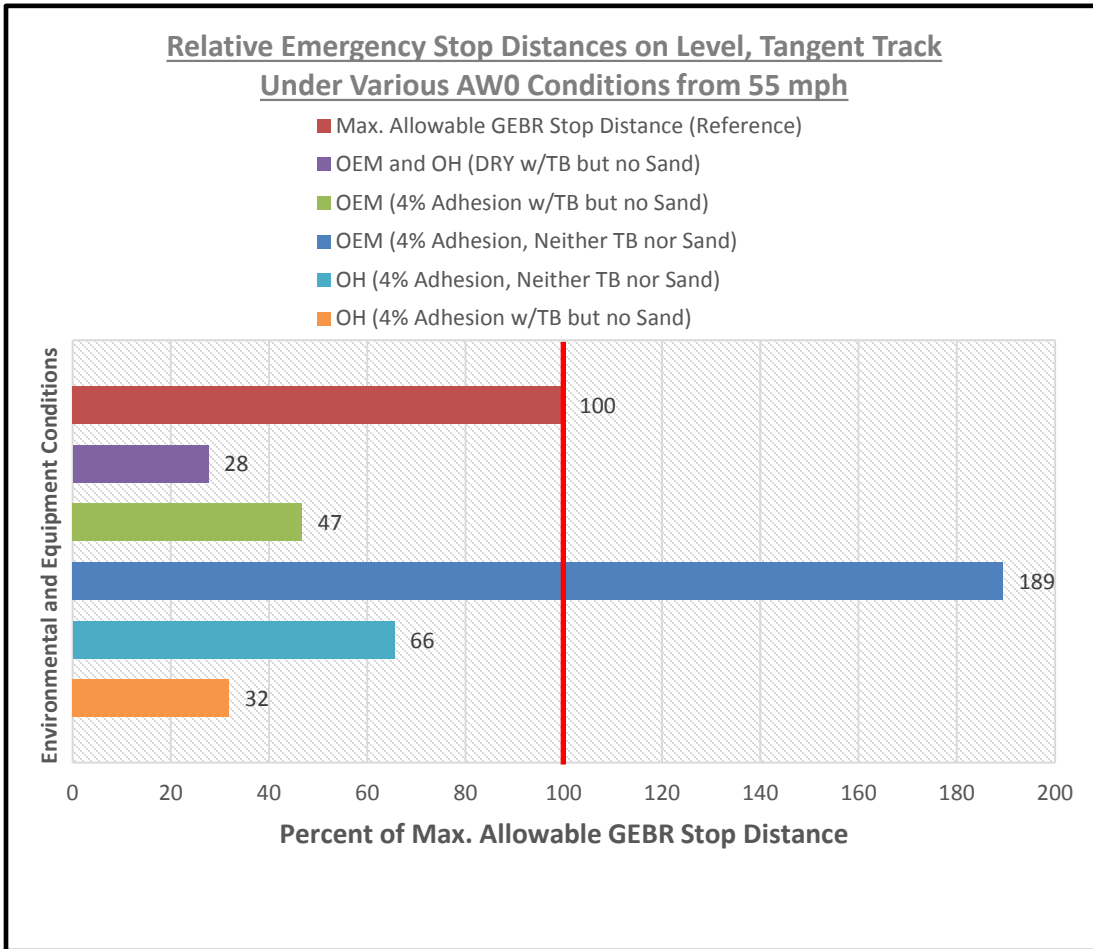
The following graph is offered to provide a visual perspective of the preliminary test results and comparisons in the stop distances during various modes of braking operation. The significant comparison is between the BLUE colored bar (4th down on graph) and the TIEL (or LIGHT BLUE) colored bar (5th down on graph). These bars show the “key” difference in stop distance between “conventional” wheel slip-slide correction control and “aggressive” wheel slip-slide correction control.

- 1) Even though the OEM vehicle is able to stop within the maximum allowable GEBR stop distance as long as Track Brakes **are functioning**, the OEM vehicle is unable to stop in the distance needed should the Track Brakes malfunction / fail.
- 2) The Overhauled Vehicle is able to stop within the maximum allowable GEBR stop distance **without** the Track Brake and Sanding functioning and to have significant stop distance margin to spare. Hence, operational safety is enhanced.

Perhaps the more significant consideration of the 4th and 5th bars on the graph is the fact that they also represent the performance of normal FULL SERVICE braking when there is a light dew / misty rain on the rails in the early morning hours of the day or when there are wet leaves on the rail. Due to the readily apparent improvement in stop distance of the Overhaul Vehicle which translates into a higher brake rate (mphps), this fact should serve to mitigate the ATP Overspeed correction issues discussed in Section 3.3 without ultimately resulting in an Emergency Brake application. Only revenue service throughout the entire system will ultimately provide an indication as to how successful the upgrade efforts are to the ATP Overspeed correction function under all situations.
