Safety and Security of the Patrons

Govind R. Sulibhavi

Maryland Transit Administration

Metro Interlocking Projects & Service Shutdown

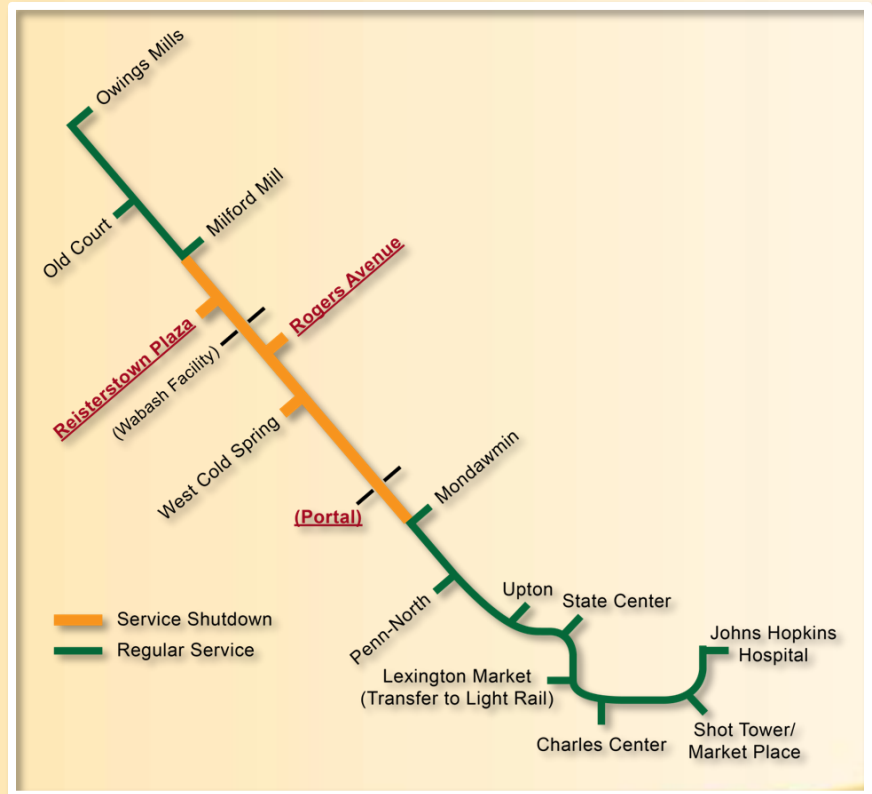
Project Shutdown Layout

- Replacement of three interlockings at Portal, Rogers Avenue (RA), and Reisterstown Plaza (RP-West) in order to bring the track, the track bed, and associated signaling and traction power to a State of Good Repair.
- A 21-day service shutdown of metro operations from Milford Mill to Mondawmin Station was utilized.
- A bus bridge was required during the service shutdown.

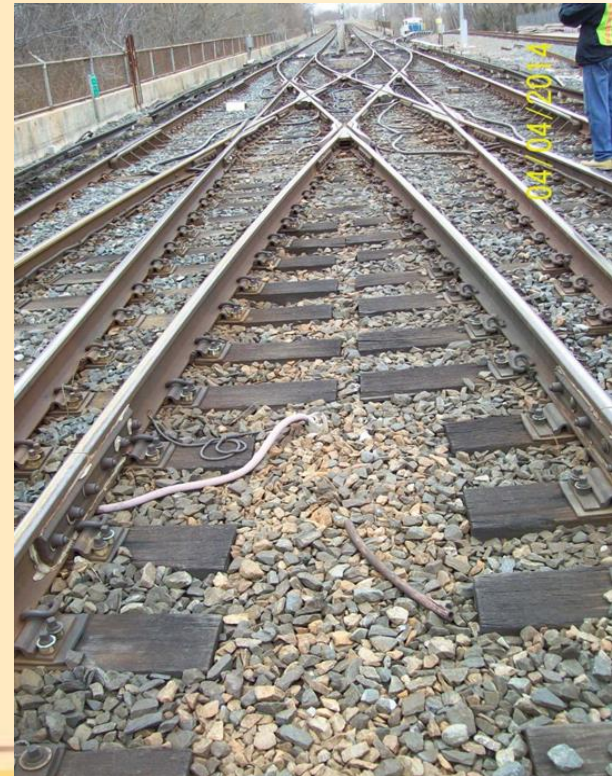
- Interlockings allow trains to cross over from one track to another.
- The RP-West, Portal, and RA interlockings consist of a double crossover with diamond on timber ties. The Portal interlocking also includes two single crossovers to connect the storage track.

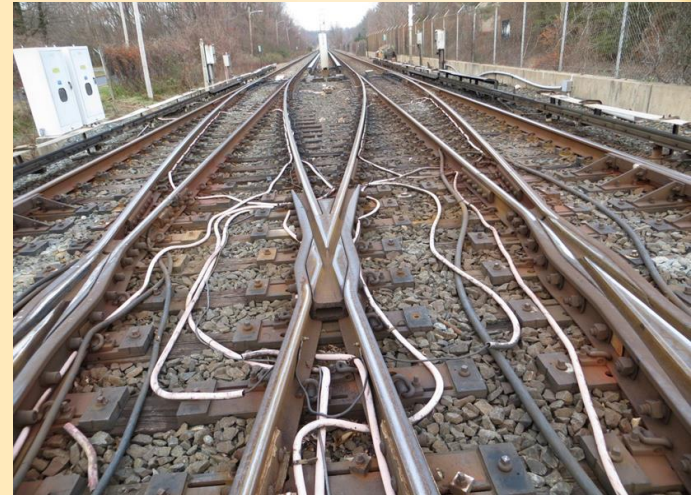
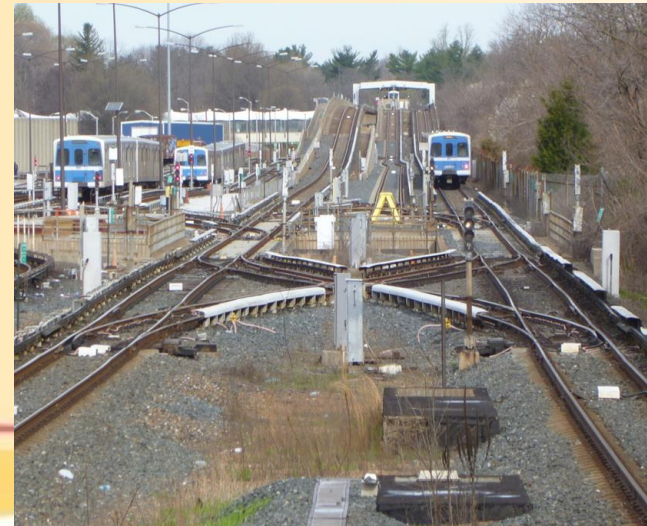
- The Federal Transit Administration (FTA) had expressed safety concerns for the track and tie conditions in December 2014.
- All three interlockings were under a slow order with serious pumping problems at some locations, as well as drainage issues (Portal & RP West).

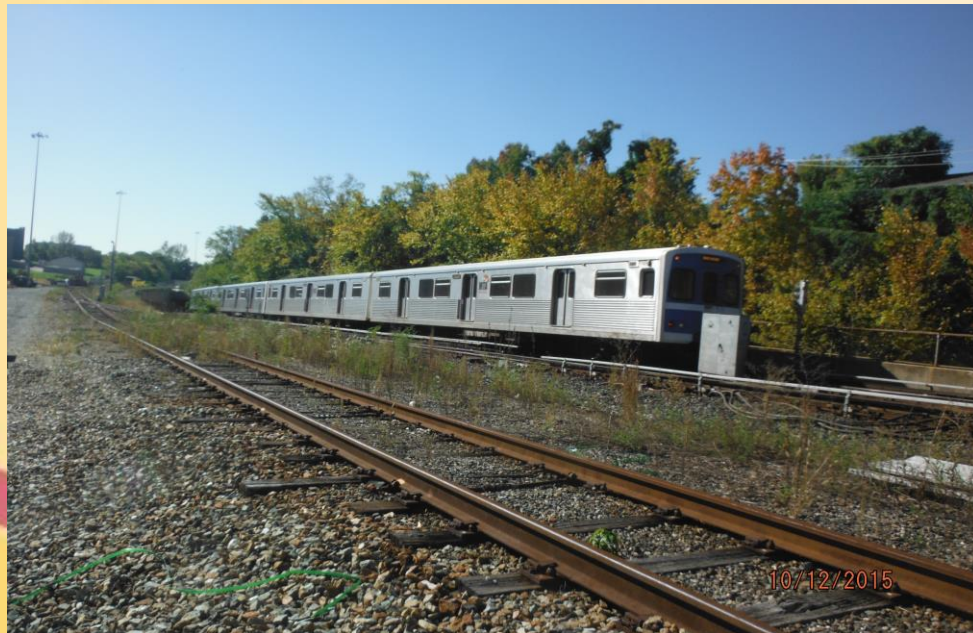
Train Control Safety Criteria

- Safety criteria designed into the existing train control system block design
- Limitations placed on train movements and train storage during the 21-day outage period that were location specific.

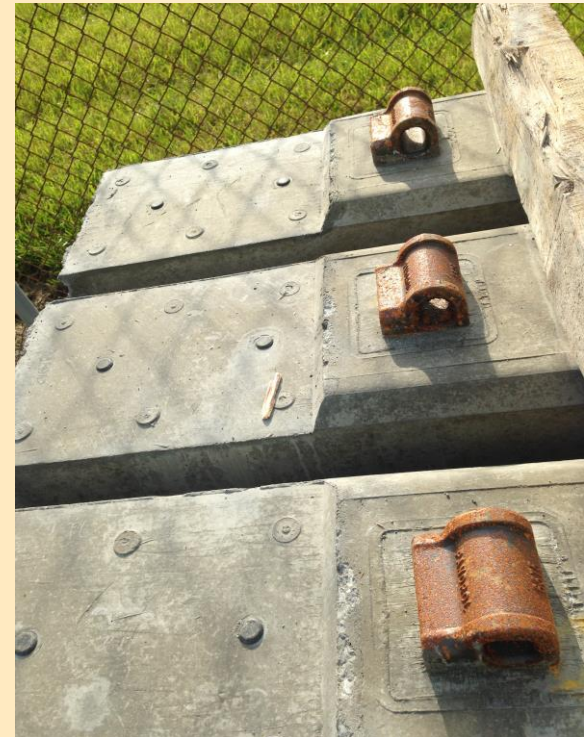
- Inspections revealed standard concrete ties had protrusions where contact rail support plates were to be anchored
- The concrete surface was required to be flat and smooth to provide an even and stable surface to securely anchor the support plate

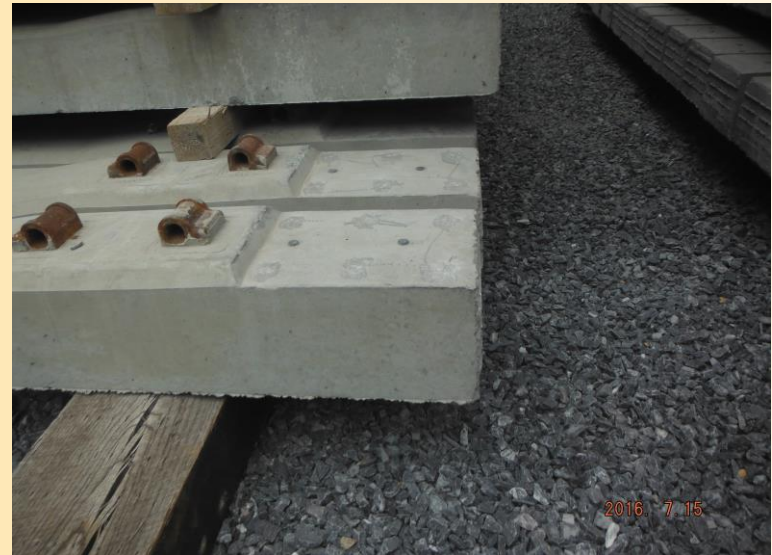
- Supplier agreed to repair these defects by grinding down the raised bumps
- Repair provided the required smooth concrete surface to safely and securely anchor the support plates
