Curve Noise and Friction Modifiers: A Case Study

2018 Rail Conference

Case Study Overview

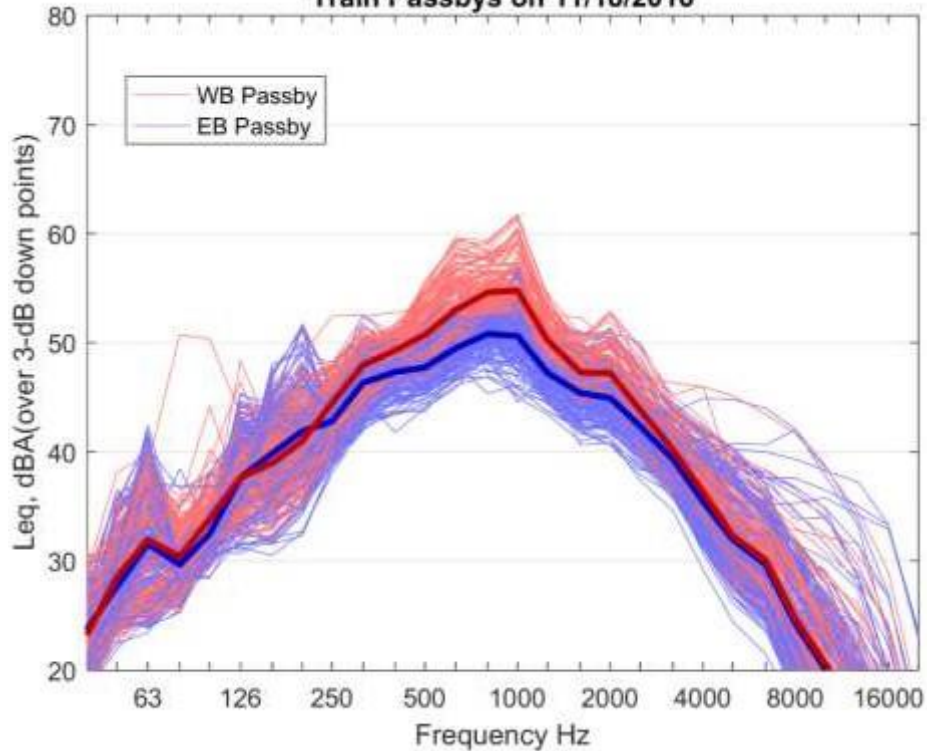
Train Passbys on 11/18/2016

No evidence of flange noise over 24 hrs.

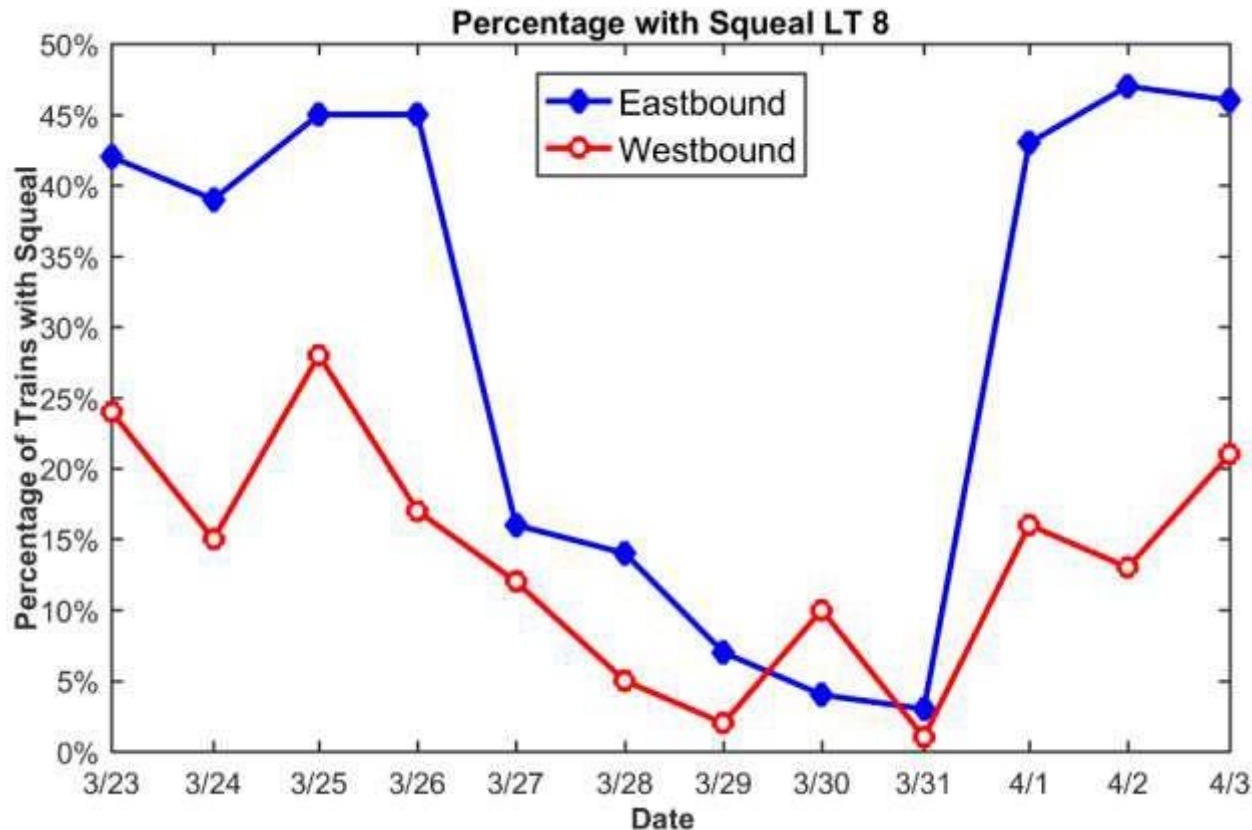
Noise Measurements: Mar 2017

- 45% of EB trains exhibit high-frequency noise events.
- 20% of WB trains exhibit high-frequency noise events.
- Explanation for period of low noise unclear.

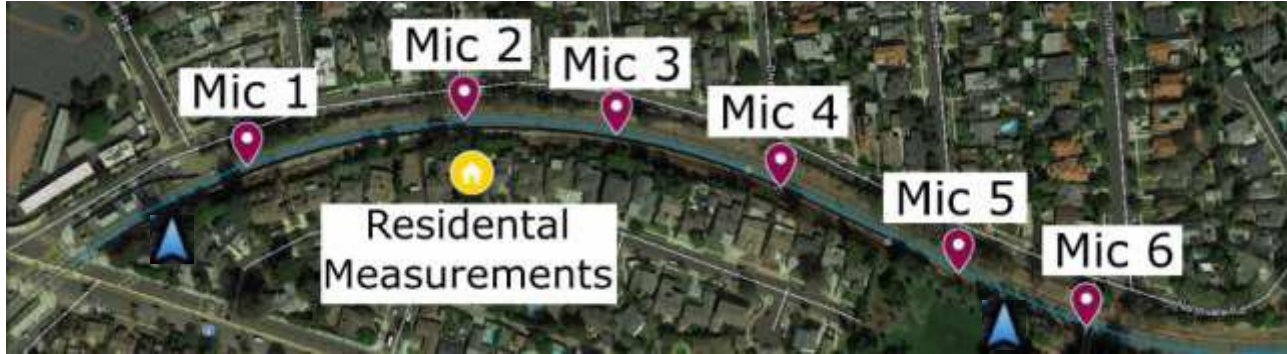
Noise Measurements: Mar 2017

- Existing EB
- FM Applicator

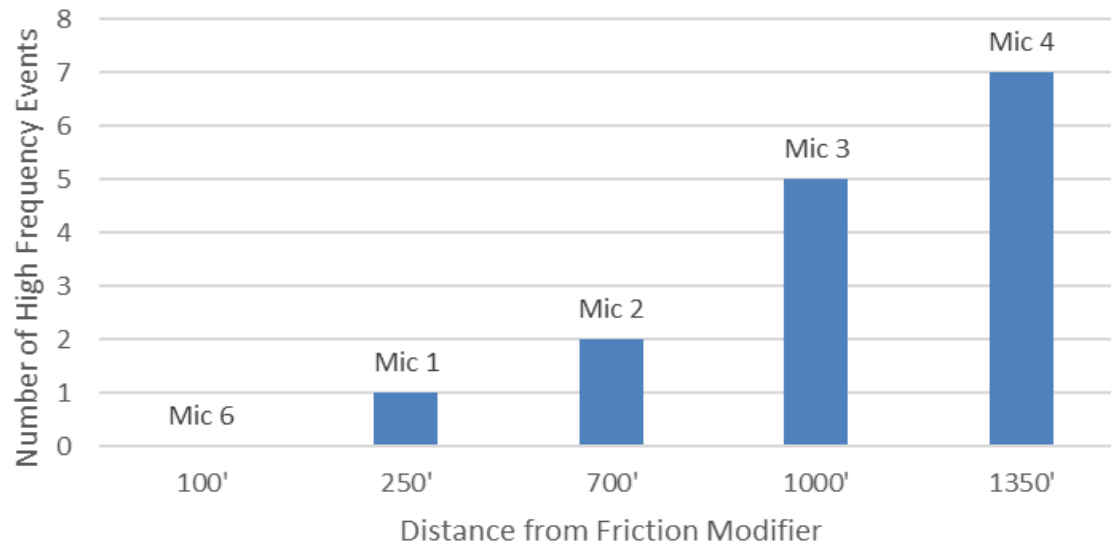
EB High-Frequency Events

High-frequency noise events appear to be related to distance from the Friction Modifier applicator.

- Install additional Friction Modifier applicators spaced 500 feet apart to help the product carry through the curve
 - Lubrication not considered due to safety concerns.
 - Gauge face grinding not considered due to equipment constraints.
 - August 2017 – Additional Friction Modifier applicators installed.

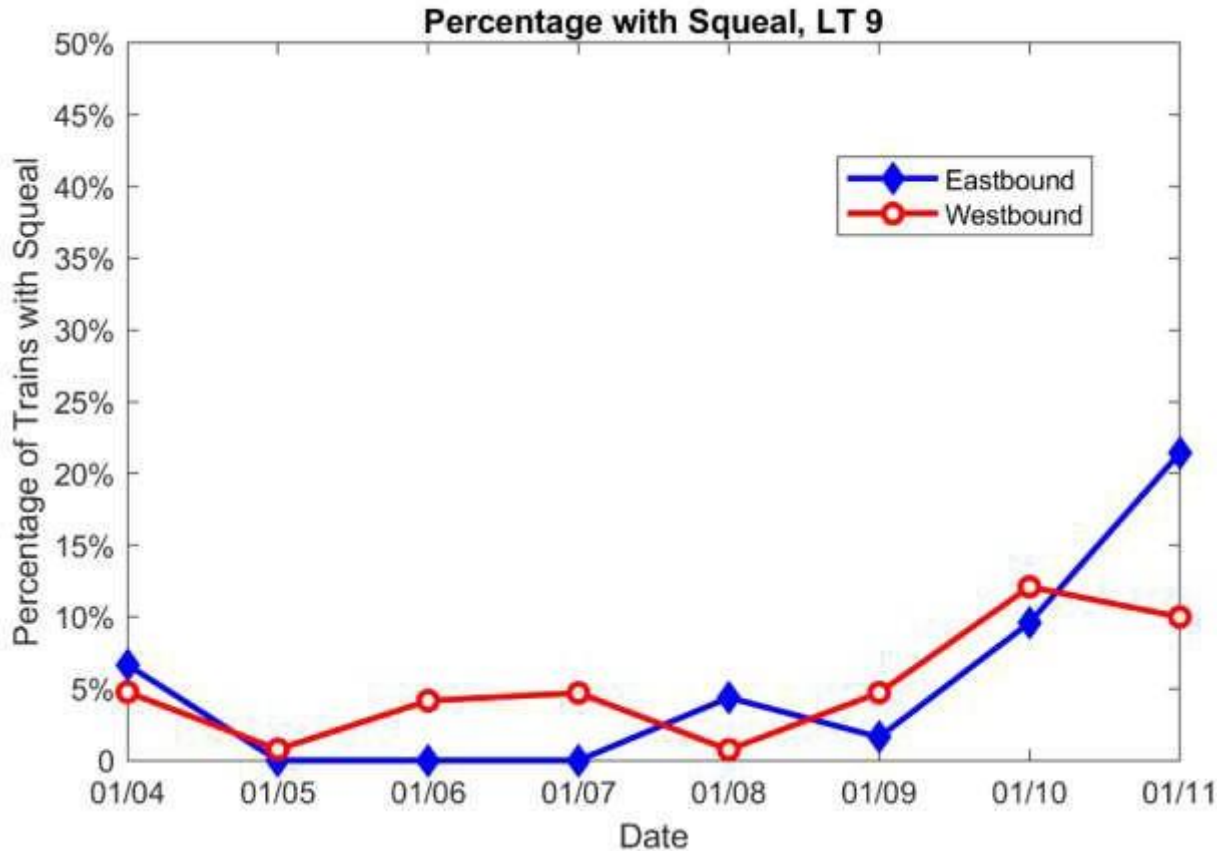
Noise Measurements: Jan 2018

- 5% of trains exhibit high-frequency noise events.
- Noise still not completely eliminated at locations furthest from the Friction Modifier applicators.

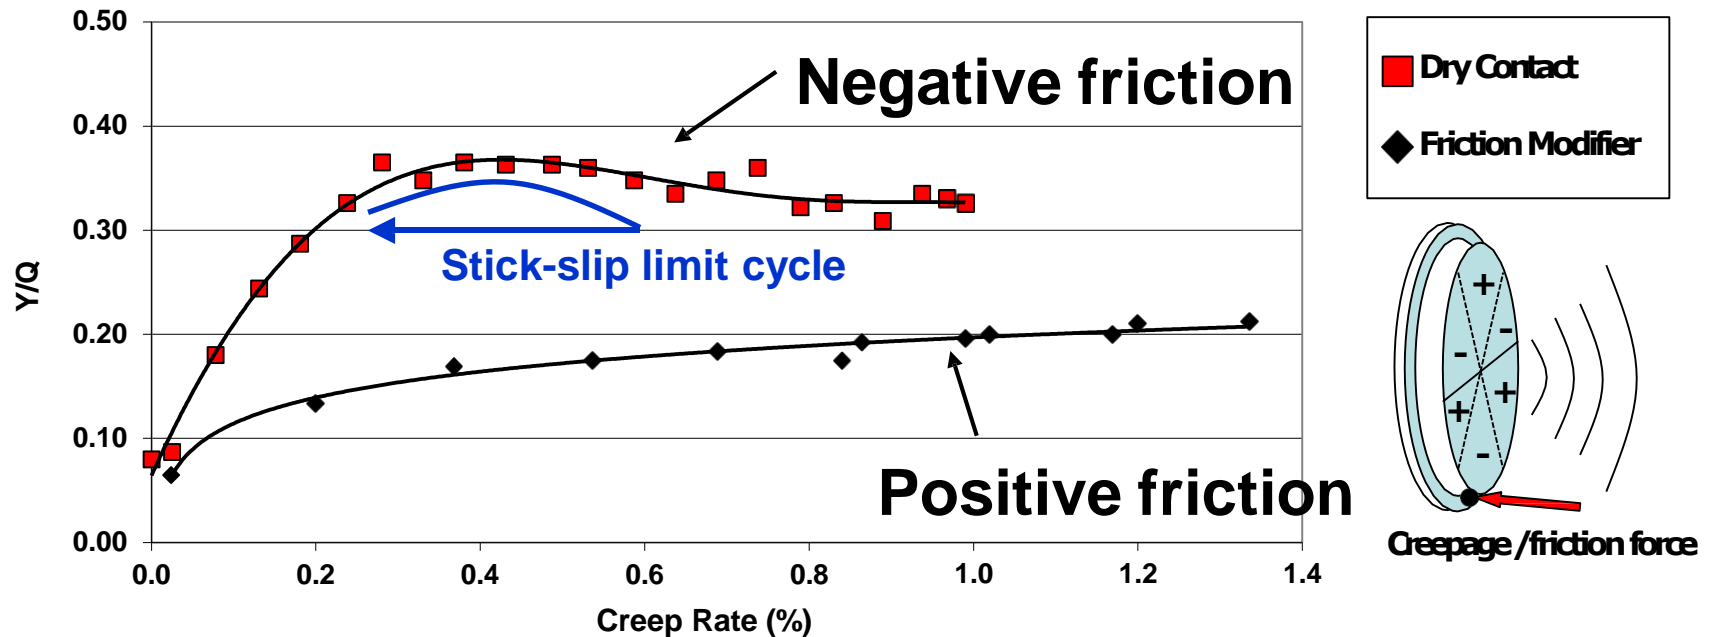
Addressing Root Cause of Wheel/Rail Noise

1. Top-of-Rail (TOR) Squeal – Use a Friction Modifier to:

1. Reduce coefficient of friction (COF) on the TOR to 0.3 – 0.4¹
2. Create positive friction conditions to eliminate stick-slip oscillations.

* Replotted from: “Matsumoto a, Sato Y, Ono H, Wang Y, Yamamoto Y, Tanimoto M & Oka Y, Creep force characteristics between rail and wheel on scaled model, *Wear*, Vol 253, Issues 1-2, July 2002, pp 199-203
