Transit Bus Air Disc Brake Wheels-Off Inspection and Reline

Abstract: This *Recommended Practice* provides guidelines for performing complete brake maintenance on a bus with disc brakes. It includes disassembly, cleaning, inspection and assembly. This document is to be used in conjunction with the manufacturer's service manual. It is recommended that all components be replaced equally on both wheel ends of the axle. Failure to do so may affect braking performance.

Summary: This document establishes a recommended practice for transit bus front/rear axle disc brake inspection and reline. Individual operating agencies should modify these guidelines to accommodate their specific equipment and mode of operation. The recommended practices and guidelines in this document assume that the end users have sufficient skills and knowledge to repair and maintain the related systems at a journeyman level. This must include a fluent understanding of safe shop working practices, not only for the agency but also OSHA/CCOHS/provincial/federal/state and local safety standards. A familiarity with applicable industries, component/system suppliers and vehicle manufacturers is also assumed.

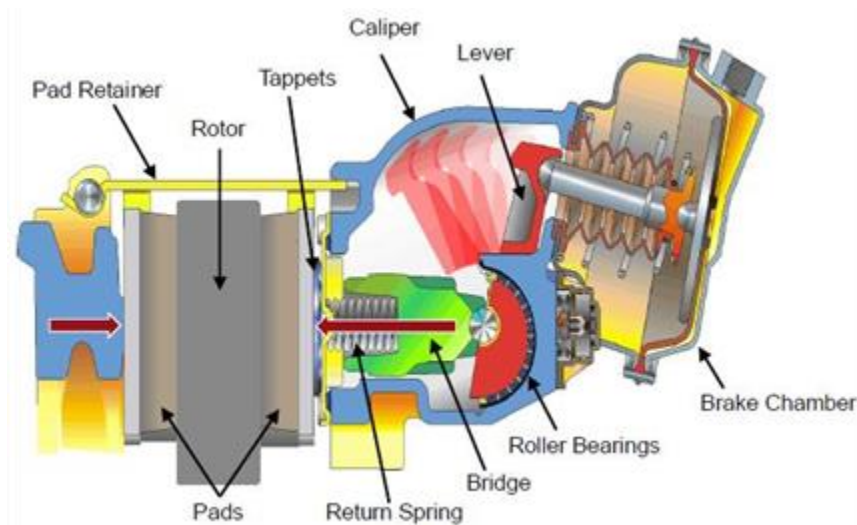
FIGURE 2

Cross-Section of Knorr-Bremse Caliper Assembly

When the brake chamber is pressurized, the chamber push rod moves forward and acts against a cup in the internal lever. The lever, which has an abutment in the caliper housing, then acts against a pair of tappets, which apply the force onto the inner brake pad. The distances from cup to abutment to tappets are designed to provide a high leverage ratio to apply the required actuation force to the inner brake pad. The inner brake pad moves into contact with the brake rotor. The brake caliper, which is free to slide laterally relative to the brake rotor, then slides on two guide pins, and the reaction force applies an equal and opposite force to the outer brake pad and against the rotor. The rotor now is clamped between the inner and outer pad, and friction is created as the rotor moves across the clamped pads. This results in the creation of a brake torque acting through the wheel and tire, and this torque creates a stopping force acting on the vehicle through the tire contact patch. The higher the clamping force (which is proportional to the brake chamber air pressure), the higher the resulting brake torque.

Air disk foundation brakes operate as all foundation brakes. It takes a force, multiplying and applying it to a rotating member (disc or rotor) attached to the wheels such that a friction is created that converts energy of motion into heat and slows the vehicle. In the case of air disc brakes, air pressure is applied to a diaphragm, and the pressure on the diaphragm creates a large linear force, which is applied to a lever (internal to the brake caliper), which further increases the actuating force. See **Figure 2**.

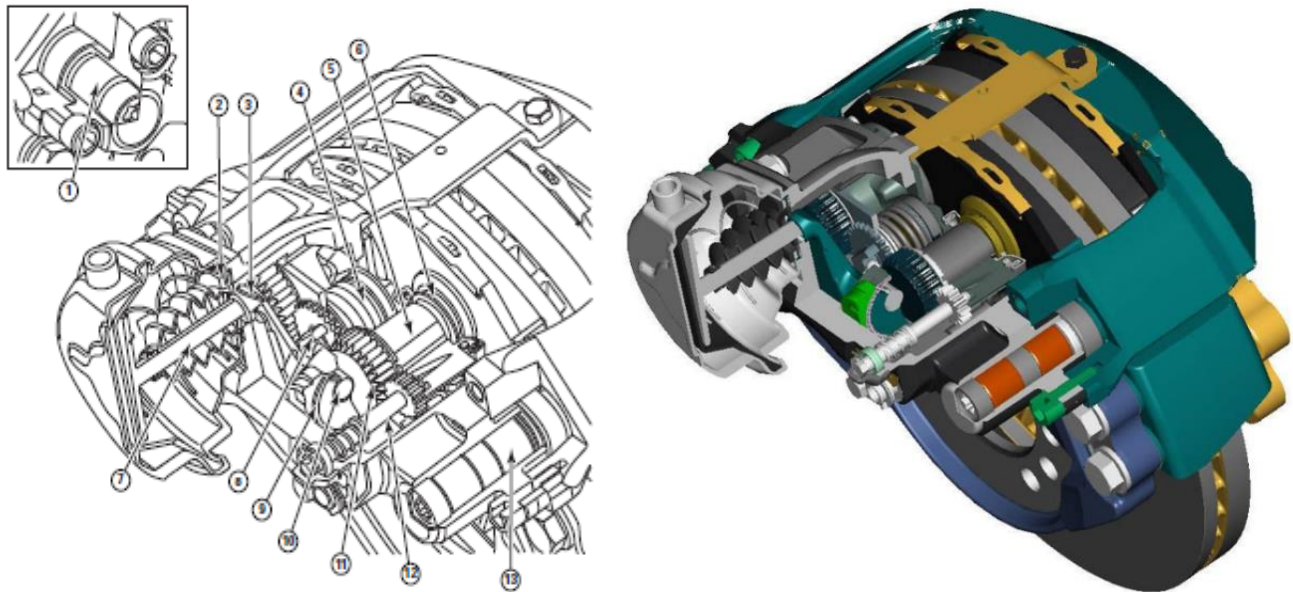
Meritor EX225 Caliper Gear-Driven Adjustment Mechanism (Not Serviceable)

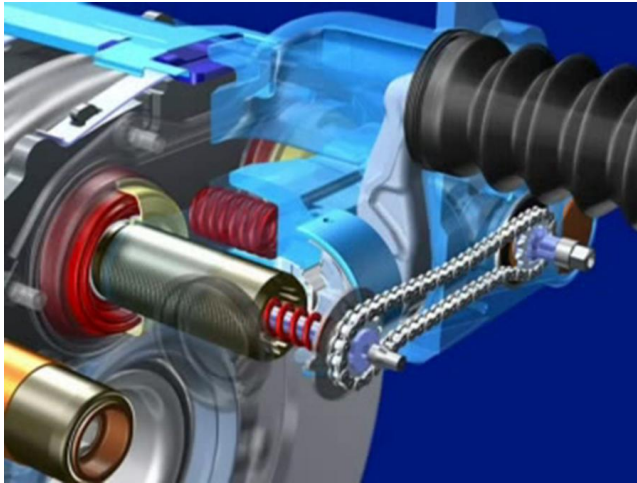
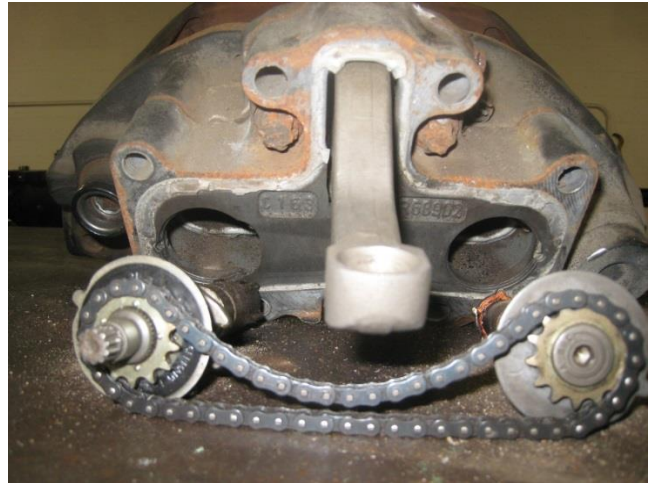
Knorr-Bremse Timing Chain Mechanism (Not Serviceable)

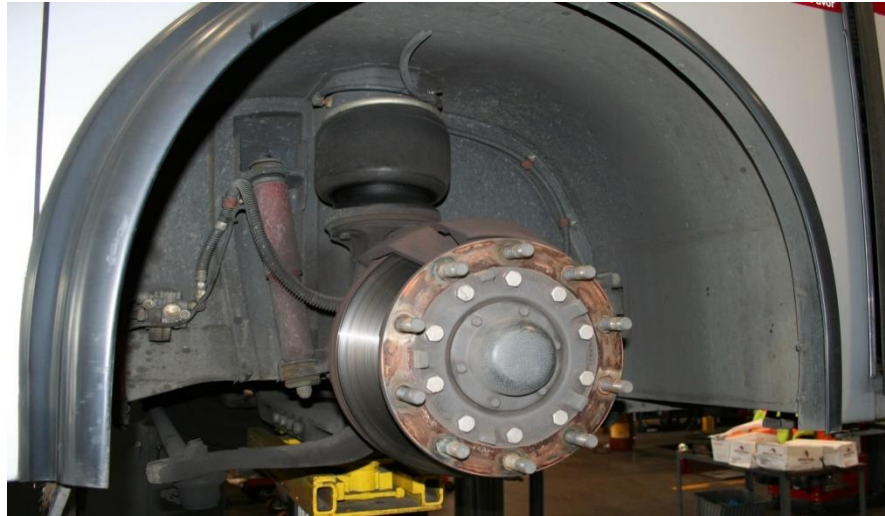
FIGURE 5

Safely raise and support the bus by the axles at an appropriate working height and remove the wheels (see [Figure 5](#)).

Wheels-Off Inspection

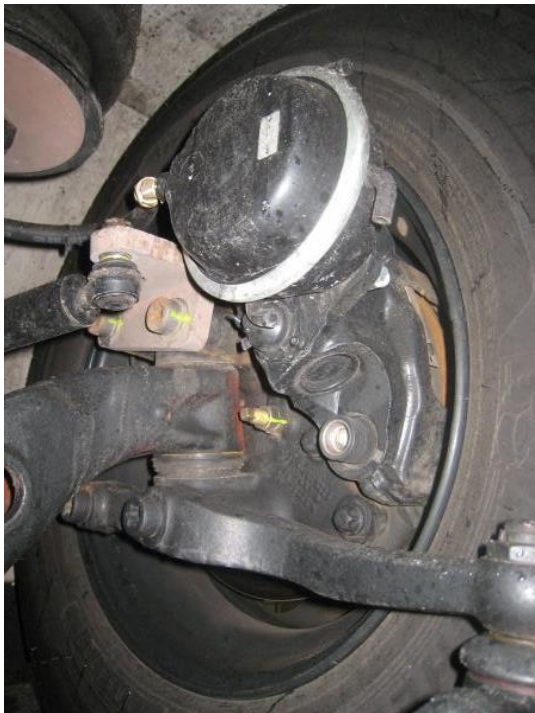
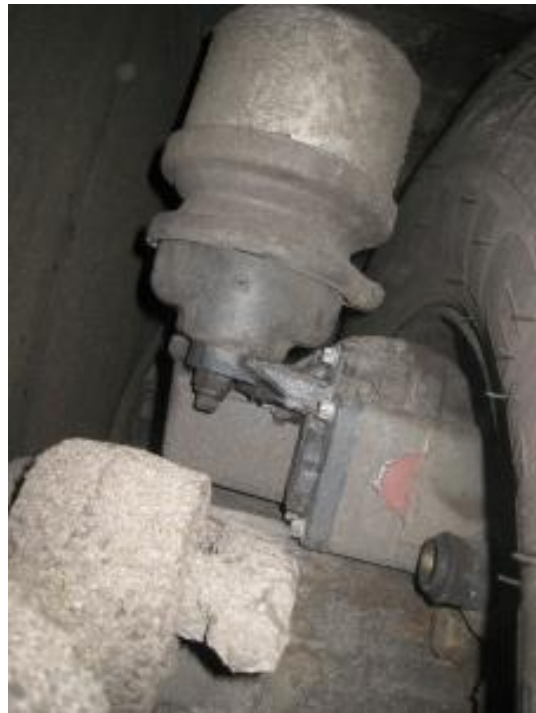
Axial and Radial Positions

Axial

Radial

Brake chambers can be mounted in two positions, either axial, which is horizontal, or radial, which is vertical. See **Figure 6**.

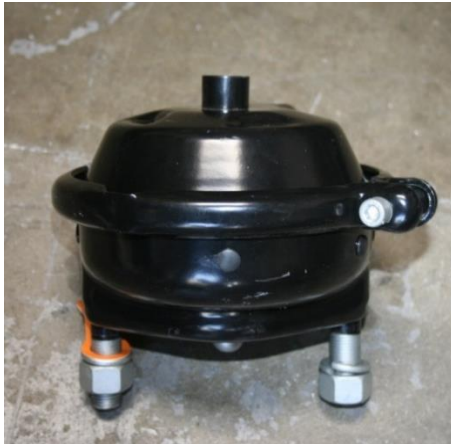
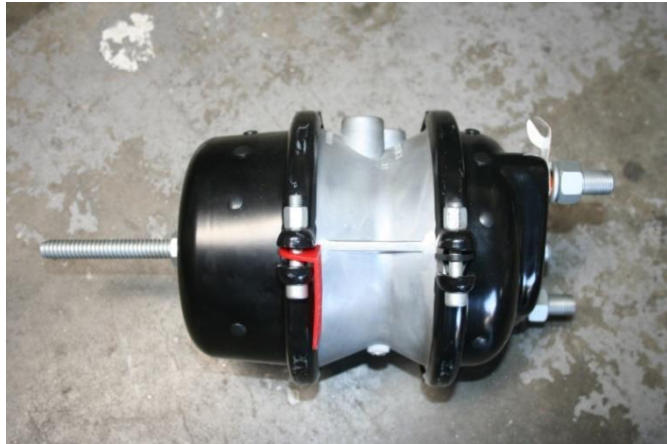
FIGURE 7
Brake Chamber Types

Service brake chamber

Spring brake chamber

Brake chambers will be either a service brake chamber used on the front axle or a spring brake chamber, comprised of a non-serviceable parking brake housing and a non-pressure housing found on the middle and rear axles. See **Figure 7**.

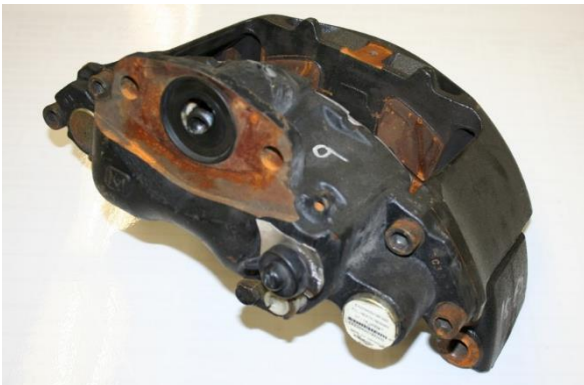
FIGURE 8
Caliper Types

Meritor EX225 caliper

Before beginning the caliper inspection, remove dirt from the brake assembly with a vacuum and brush or a damp cloth. The nomenclature varies among manufacturers. **Figure 8** contains examples for reference comparison.

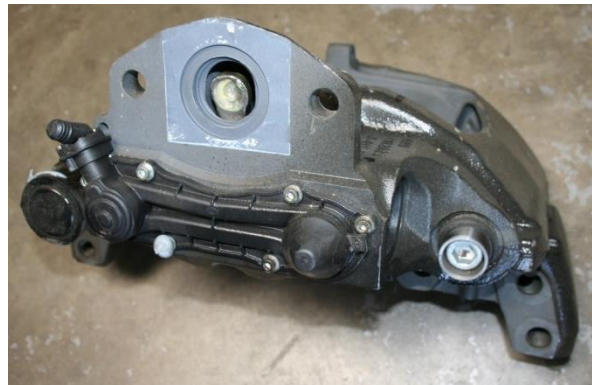
FIGURE 8
Caliper Types

Knorr-Bremse SN7 caliper

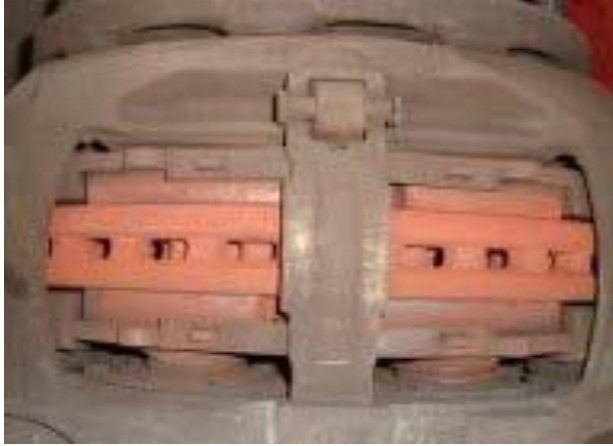
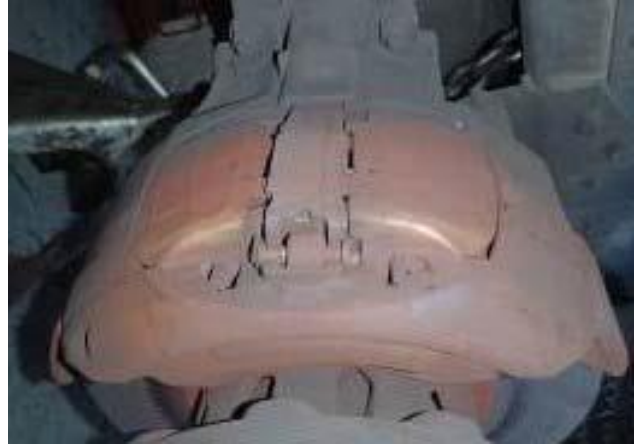
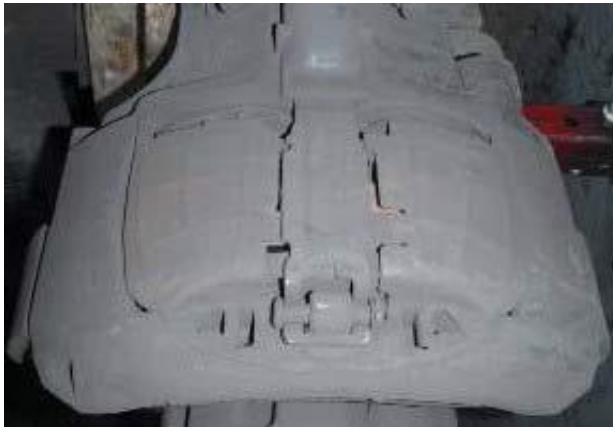
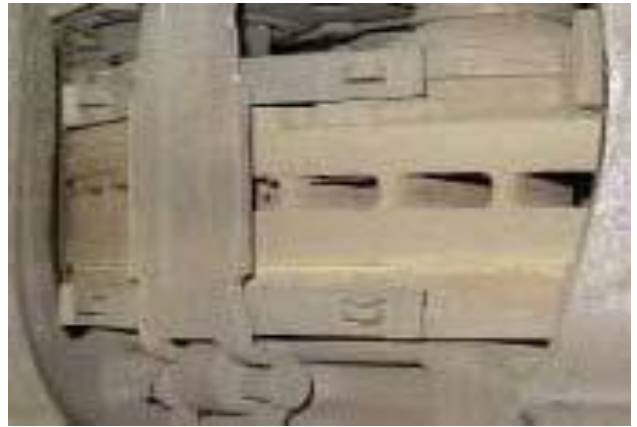
FIGURE 9
Brake Assemblies With and Without Thermal Overload

Examples of brake assemblies exhibiting thermal overload

Examples of brake assemblies exhibiting normal operating conditions

For example, a thermal overload (**Figure 9**) is an indication of excessive heat frequently caused by dragging brakes. The cause of the thermal overload must be identified and repaired.

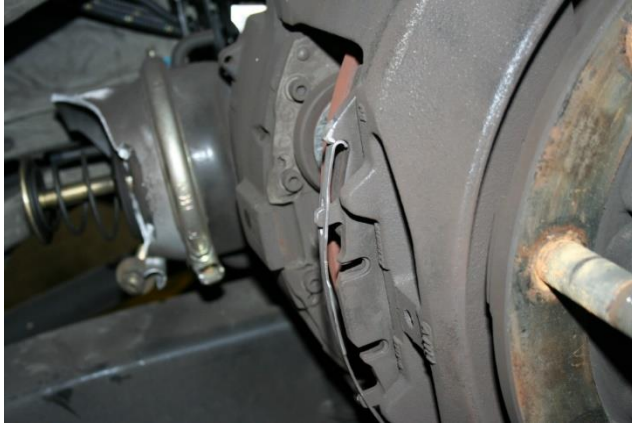
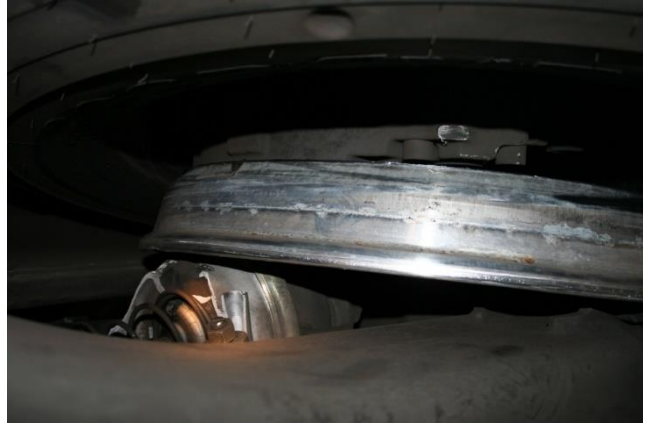
Other Types of Brake Assembly Damage

Damage caused by a missing pad retainer strap

Damaged rim and brake chamber caused by missing pad retainer strap

A missing pad retainer strap can allow pads to climb out of the caliper and wear on the rim, resulting in rim and brake failure (see **Figure 10**).

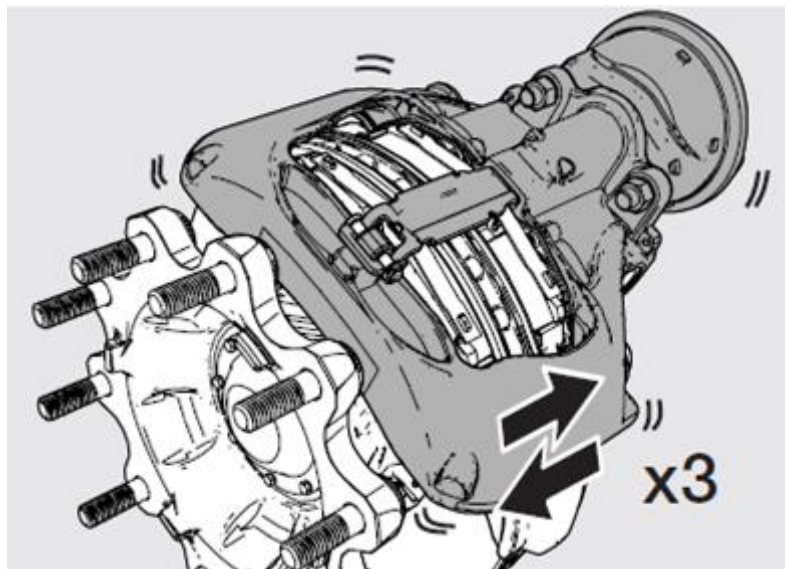
Knorr-Bremse Caliper Movement Test

Push and pull caliper by hand three times in an axial direction.

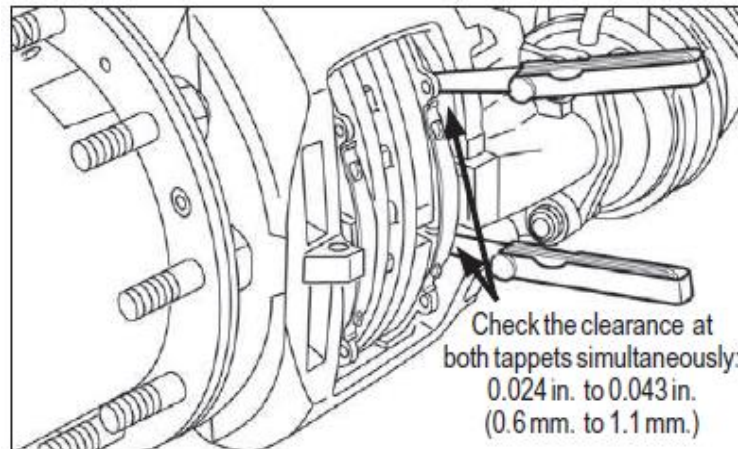
FIGURE 12
Knorr-Bremse Tappets-to-Pad Clearance

Check that there is no dirt in the gap, and clean if necessary. Use two long feeler gauges to measure over the whole tappet surface, and check the gap between the tappet and the inboard pad backplate. Knorr-Bremse requires the gap to be between 0.024 in. (0.6 mm) and 0.043 in. (1.1 mm). If the gap is within this range, then

the test is complete. If the clearance is too wide, then there is a danger of brake failure. If the distance is too small, or if there is no gap at all, then there is a danger of the brake overheating. These conditions must be corrected before returning the vehicle to service. Knorr-Bremse does allow a difference of 0.010 in. (0.25 mm) between the upper and lower tappet and pad measurements (**Figure 12**). If the tappets-to-pad clearance exceeds 0.010 in. (0.25 mm), then the caliper bearing must be checked.

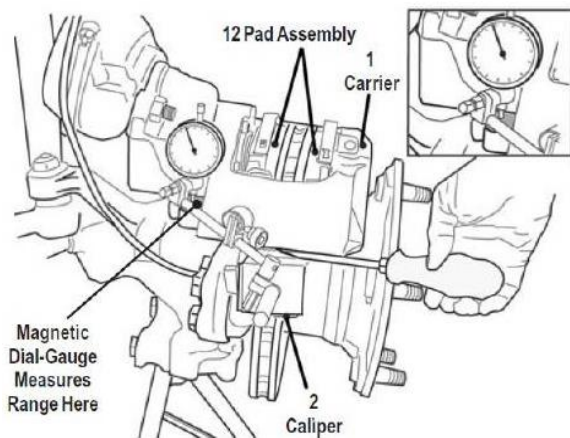
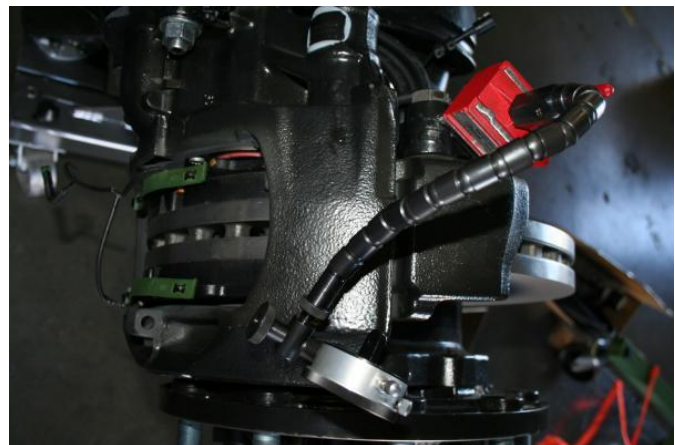
FIGURE 13
Measuring Knorr-Bremse Caliper Guide Pin Wear

Place a flat-blade screwdriver between carrier and caliper, forcing them in opposite directions; then read the maximum value on the dial-gauge.

Guide pins and bushings keep the brake caliper perpendicular to the brake rotor and therefore must be maintained to ensure proper brake performance. The guide pin inspection will be conducted in two parts (**Figure 13**). The first part will be done before the brake pads are removed. The second part will be done after the other caliper tests are done and the pads are removed. The first test will need to be done with a new set of brake pads installed to ensure an accurate measurement. If the original pads are to be reused, then the current position of the assembled pads must be noted, so that they can be reassembled in the same position.

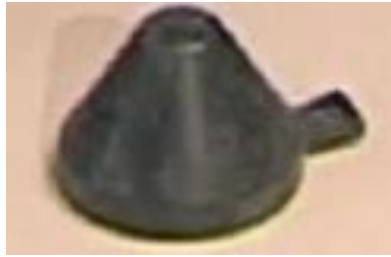
FIGURE 15

Adjuster screw cap

Check that the adjusting screw cap is properly installed and is not torn or loose. Remove the cap and visually inspect the adjusting screw seal for damage (see **Figure 15**).

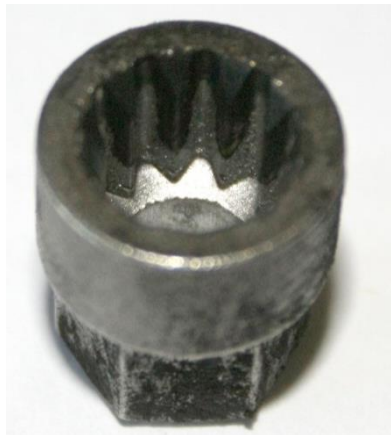
Shear adapter

Make sure the bus has at least 95 psi air pressure and, if applicable, make sure the spring brake is released. Using the shear adapter, turn the adjuster three clicks counterclockwise, increasing the running clearance. Make sure the shear adapter is used with a box wrench or socket (**Figure 16**). Using the wrong wrench or continuing to torque after the tappets are fully retracted will cause the shear adapter to fail.

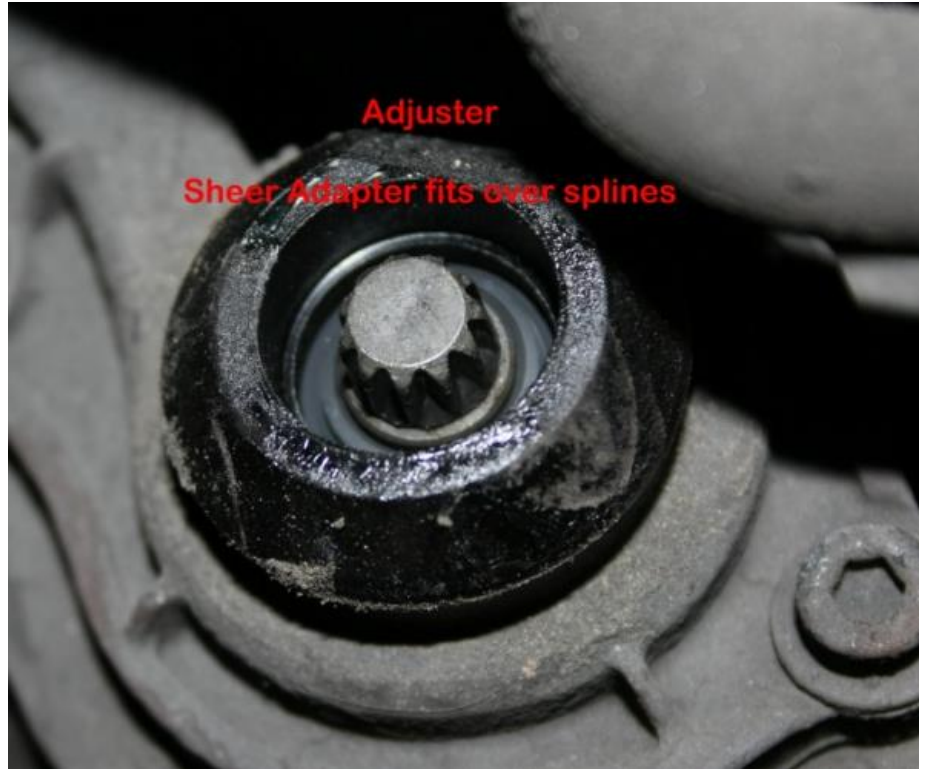
Adjuster with seal visible

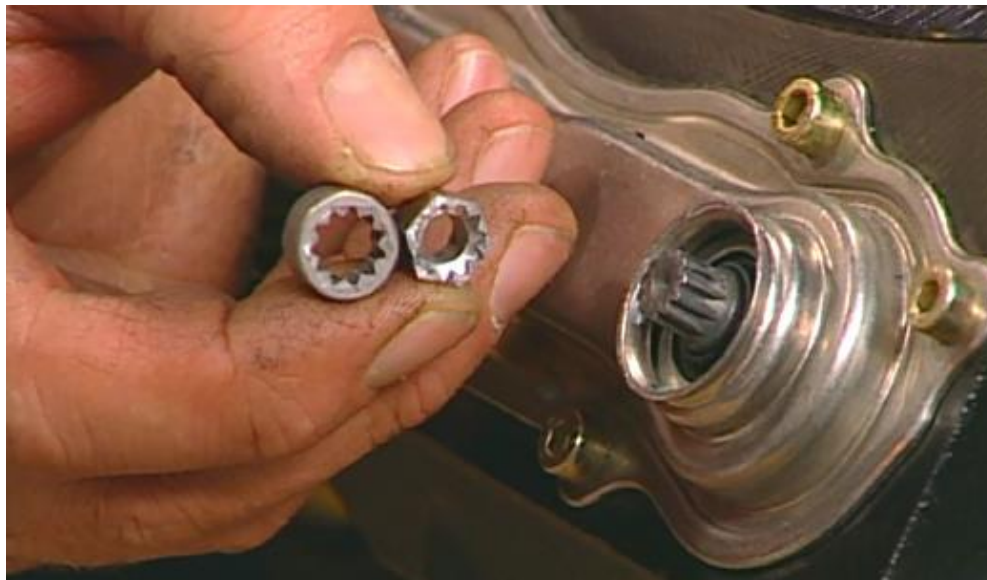
FIGURE 17

Broken Shear Adapter

If the shear adapter fails, check for free movement of the pads and caliper slide pins before attempting a second time. Replace the shear adapter and make a second attempt. If the adapter fails on the second attempt, and the caliper slide pins or brake pads are not stuck, then the shear adjuster mechanism is seized and the caliper must be replaced. The shear adapter is designed to shear if excessive torque is required to turn the adjuster. See **Figure 17**.

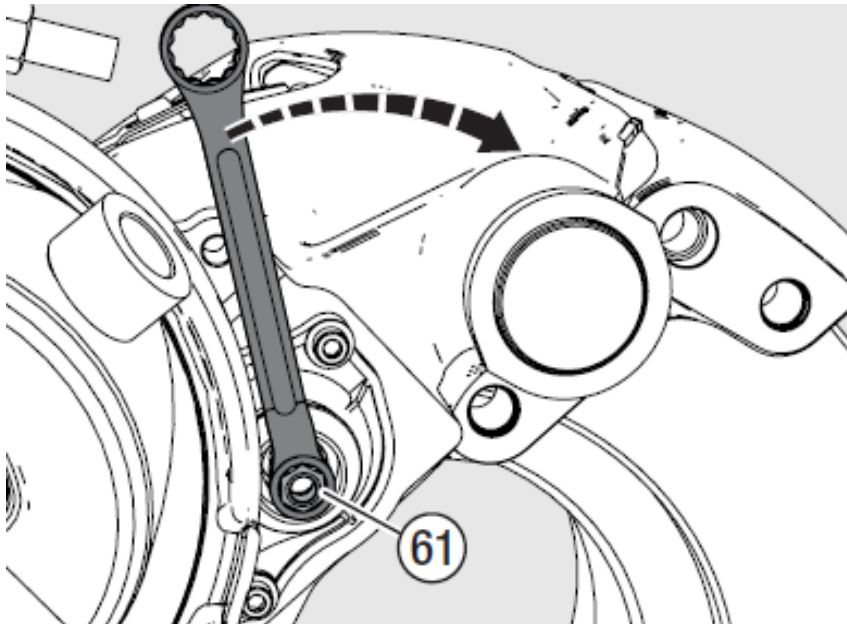
FIGURE 18

Knorr-Bremse Caliper Adjuster Test

Number 61 is the shear adapter.

Leave the box wrench on the shear adapter and make sure it can move in the clockwise direction without obstruction. Apply the brakes with about 30 psi (2 bar) pressure five to 10 times. The wrench should turn clockwise as seen from the actuator side. If the wrench does not turn, turns only on the first application or turns forward and backward with every application, then the automatic adjuster has failed and the caliper must be replaced.

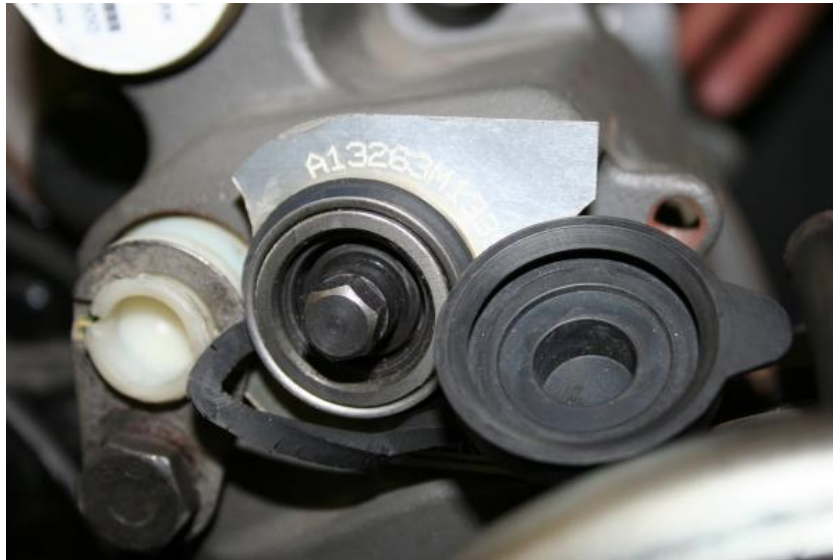
Meritor EX225 Dust Cap with Adjuster and Seal Visible

Check that the adjusting screw cap is properly installed and is not torn or loose. Remove the cap and visually inspect the adjusting screw seal for damage (**Figure 20**).

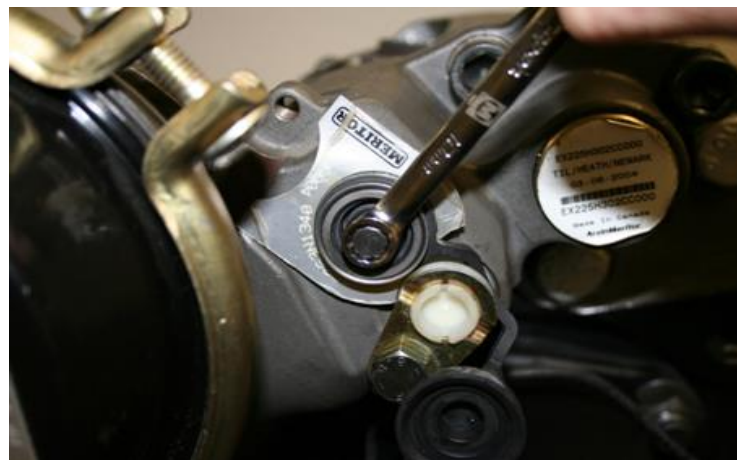
FIGURE 21

Meritor EX225 Caliper

Make sure the bus has at least 95 psi air pressure and, if applicable, make sure the spring brake is released. Using a 10 mm box wrench, de-adjust the brakes one quarter turn. Do not exceed 30 ft-lbs (40 Nm) of torque. Leave the box wrench on the adjuster, and make sure it can move in the clockwise direction without obstruction. Apply the brakes with about 30 psi (2 bar) pressure. The wrench should turn clockwise as seen from the actuator side (**Figure 21**). If the wrench does not turn or turns forward and backward with each application, then the automatic adjuster has failed, and the caliper must be replaced.

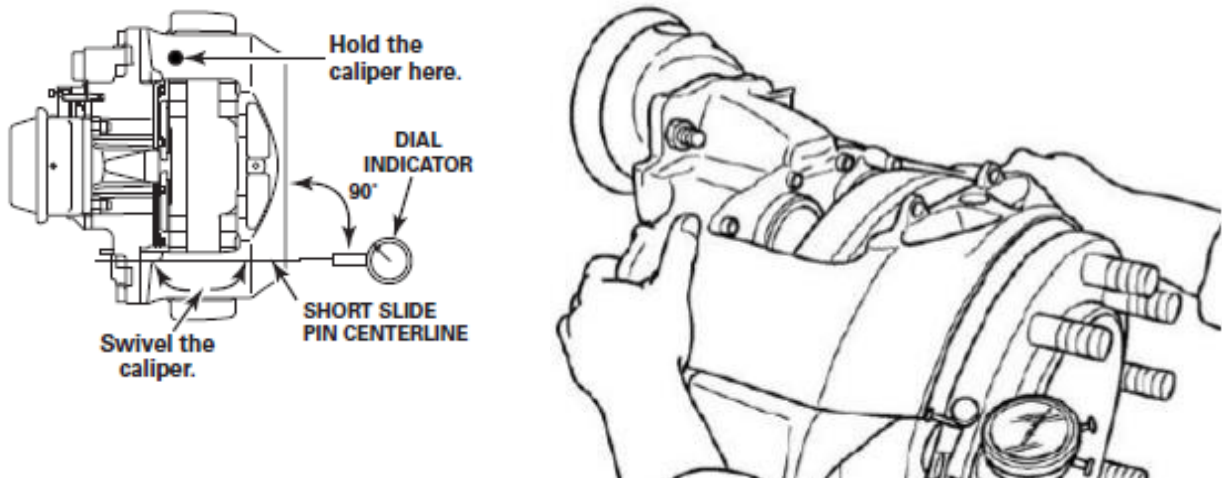
Checking Meritor EX225 Slide Pin Bushing Clearance

With the pads removed, pull the caliper housing assembly *outward* toward the wheel flange to the center position, as it would be when brake pads are installed. Attach a dial indicator so that it is in line with the centerline of the short slide pin. Attach the indicator to the hub. Hold the caliper so that it cannot move. Swivel the caliper until it stops in one direction. Set the gauge to zero. Move the housing in the opposite direction until it stops. The maximum acceptable reading is 0.118 in. (3 mm). If the reading is more than 0.118 in. (3 mm), then replace the bushings, slide pins or caliper assembly. See [Figure 22](#).

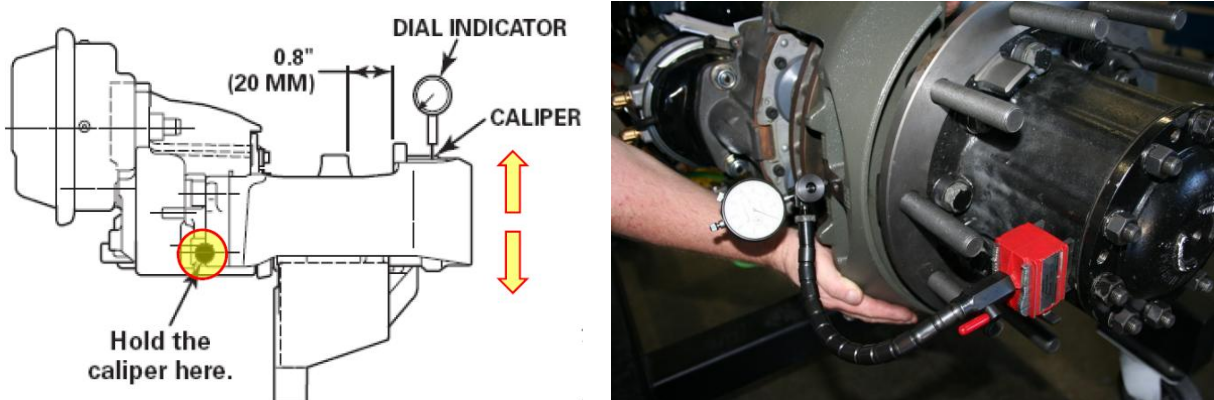
Checking Meritor EX225 Slide Pin Bushing Clearance

Attach a dial indicator onto the vehicle hub and set it against the caliper. Position the brake caliper in the center position as it would be when the brake pads are installed. This is set when a gap of approximately 0.8 in. (20 mm) exists between the rotor and the bridge ([Figure 23](#)). Hold the caliper at the outboard pad edge and by the air chamber. Push the brake caliper down by hand as far as possible and set the gauge to zero. Pull the caliper up as far as possible without allowing the caliper to slide. The maximum acceptable reading is 0.078 in. (2 mm). If the reading is more than 0.078 in. (2 mm), then replace the bushings, slide pins or caliper assembly.

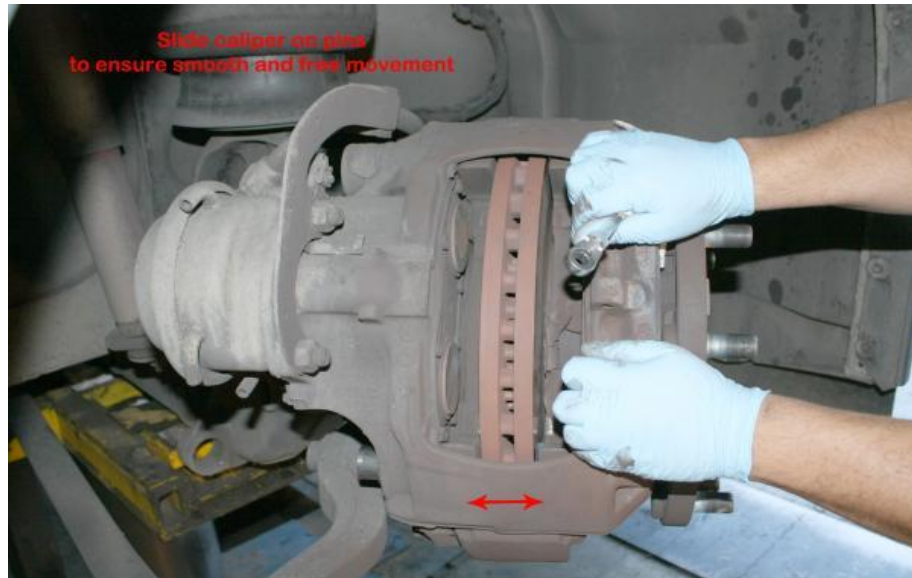
Checking for Smooth Caliper Movement on the Guide Pins

This test is used for both the Meritor EX225 and Knorr-Bremse calipers. Using hand pressure only, with the brake pads removed, make sure the caliper slides freely along the whole length of the guide pins (**Figure 24**). Replace the guide pins and bushings if the caliper does not slide freely.

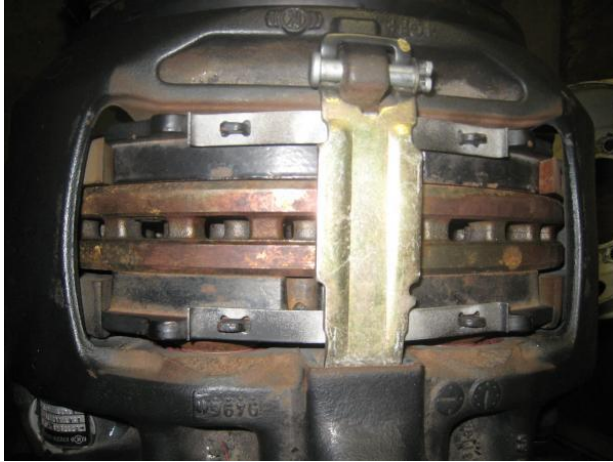
FIGURE 25
Brake Pad Removal

Knorr-Bremse pad retainer with clevis pin

Disconnect and remove wear sensors where applicable. Visually inspect the brake pad retainer for bending or wear. Replace if wear or damage is evident and when brake pads are replaced. Remove the brake pad springs. See **Figure 25**.

NOTE: Some pad springs are permanently affixed to the pads and cannot be removed. Slide the caliper outboard and remove the outer pad. Slide the caliper inboard and remove the inner pad.

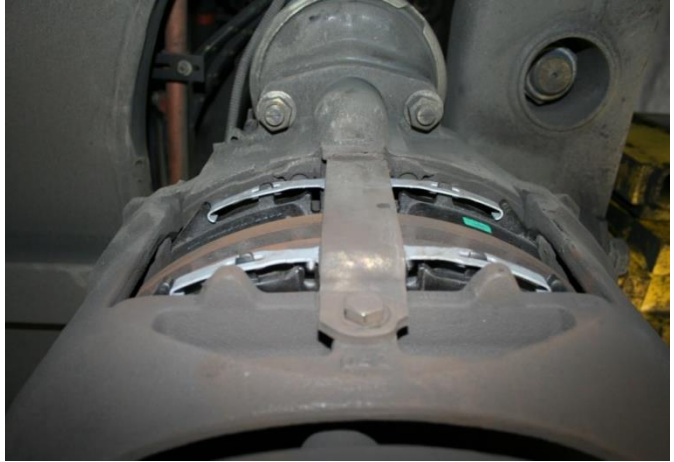
Meritor EX225 caliper pad retainer secured with a bolt

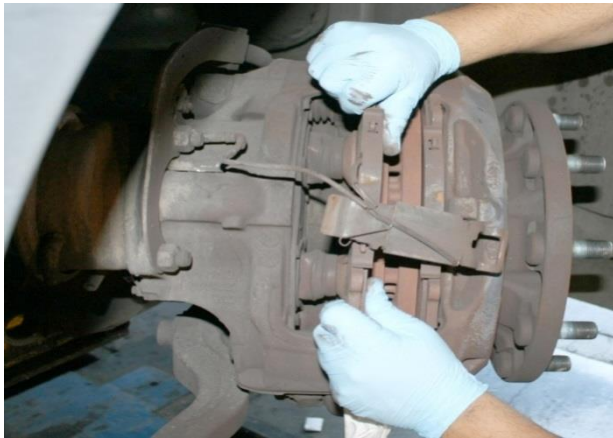
Knorr-Bremse

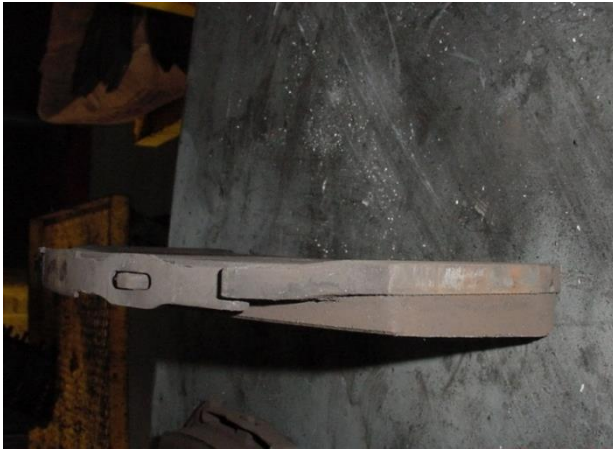
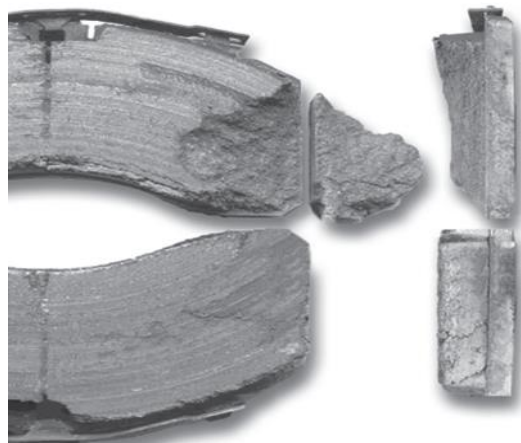
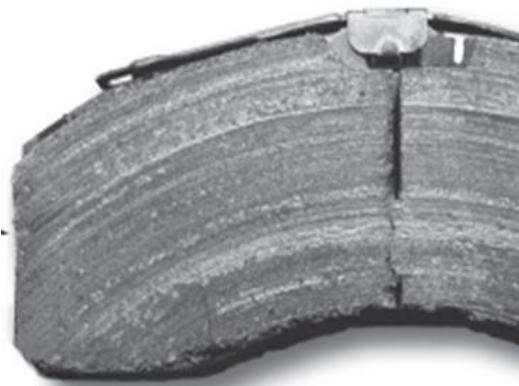
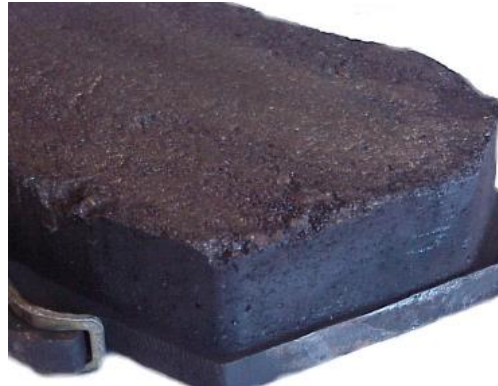
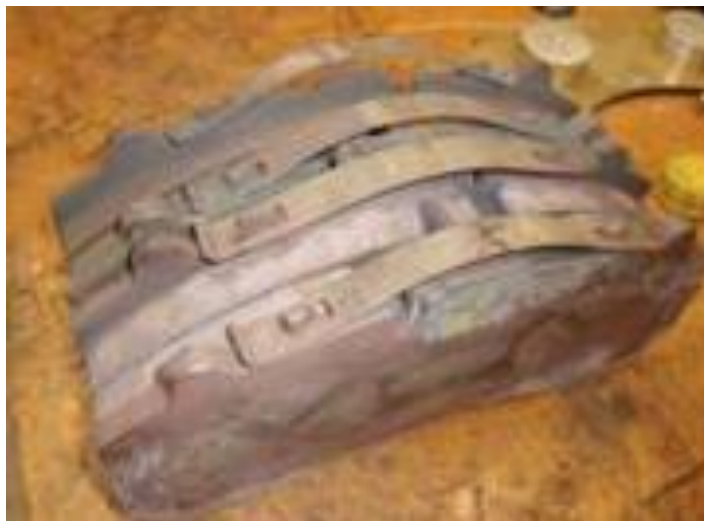
FIGURE 26
Brake Pad Inspection

The cause of tapered brake pad wear must be identified and corrected. Possible causes include uneven tappet height and a loose caliper.

Reuse of brake pads with major damage is not permitted.

Minor wear patterns and edge wear are acceptable.

Thermal overload indicated by white discoloration. The cause of the thermal overload must be identified and corrected.

Inspect the brake pads for uneven wear, thickness and damage. Measure the pad friction material thickness with a suitable measuring device. If pad thickness is within acceptable measurement, then inspect the pad surface. Minor damage at the edges is permitted. Replacement is required if major damage on the surface is found. Brake pad reuse is permitted if the pads pass inspection and are reinstalled in their original positions. When performing a replacement, you must replace all pads on the same axle (left and right side). See **Figure 26**.

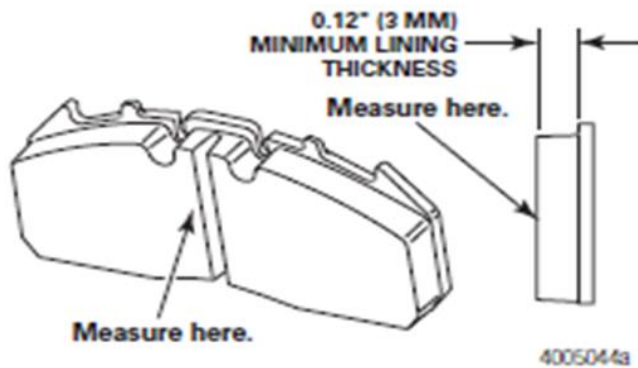
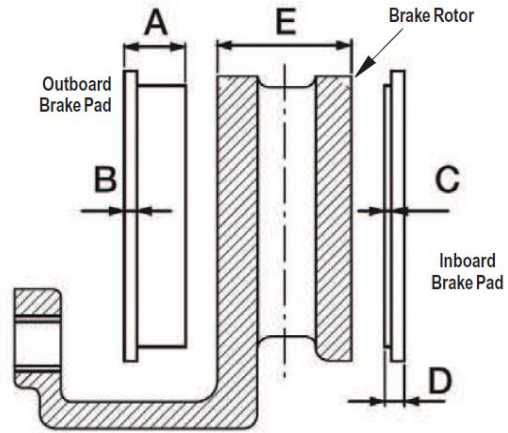
FIGURE 26
Brake Pad Inspection

Meritor EX225 brake pad dimension

Knorr-Bremse brake pad dimension

- A Thickness of a new pad (1.18 in. [30 mm])
- B Backing plate thickness (0.36 in. [9 mm])
- C Minimum thickness of friction material (0.08 in. [2 mm])
- D Minimum thickness of a worn pad (0.43 in. [11 mm]); replace pads
- E Thickness of a new rotor (1.77 in. [45 mm])
Minimum rotor thickness (1.46 in. [37 mm])

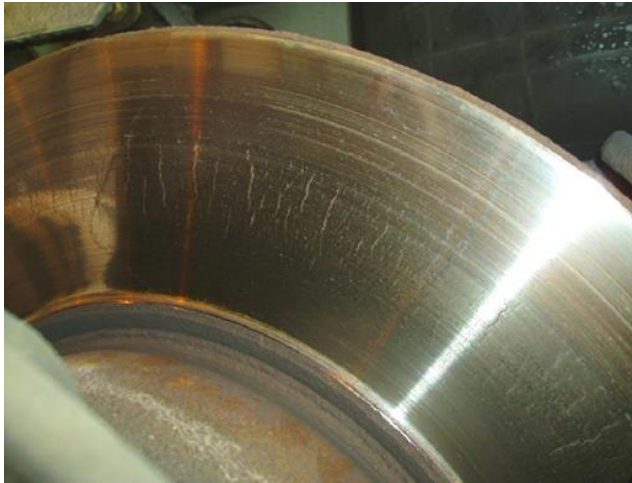
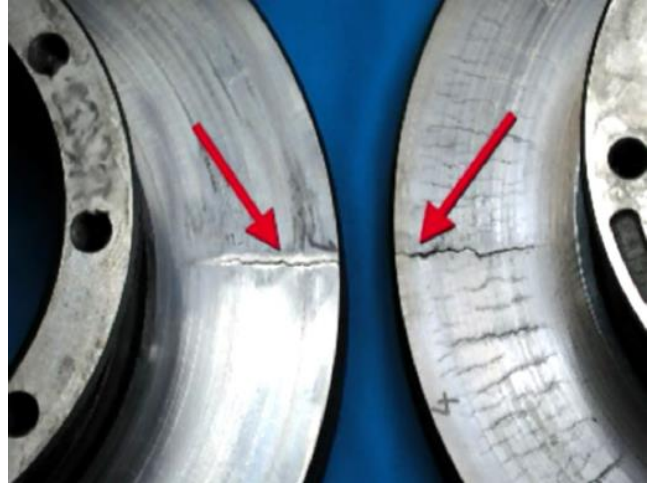
FIGURE 27
Heat Checking

Small heat checks (as shown) are allowable. Cracks on the surface of the rotor that result from light heat checking are small and fine and do not require rotor replacement.

Large cracks creating a split in the rotor are not acceptable and require rotor replacement. Heavy heat checks have width and depth. Cracks going through to the cooling fins or into the inner or outer edge of the friction surface are not allowed, and the rotor must be replaced.

Heat checks are short, thin, sometimes numerous radial interruptions of the rotor braking surfaces. They are the result of disc brake operation. They are caused by the heating and cooling that occurs as the brakes are applied time after time. Heat checks will frequently wear away and reform, or they may become braking surface cracks, depending on such factors as the lining and rotor wear rate, brake balance and how hard the brakes are used. There are two common types of heat checks: light heat checking and heavy heat checking. See [Figure 27](#).

Meritor requirements are to replace the rotor if the heat checks have a width greater than 0.02 in. (0.5 mm), a depth greater than 0.04 in. (1 mm) and extend across the surface more than 75 percent in the radial direction.

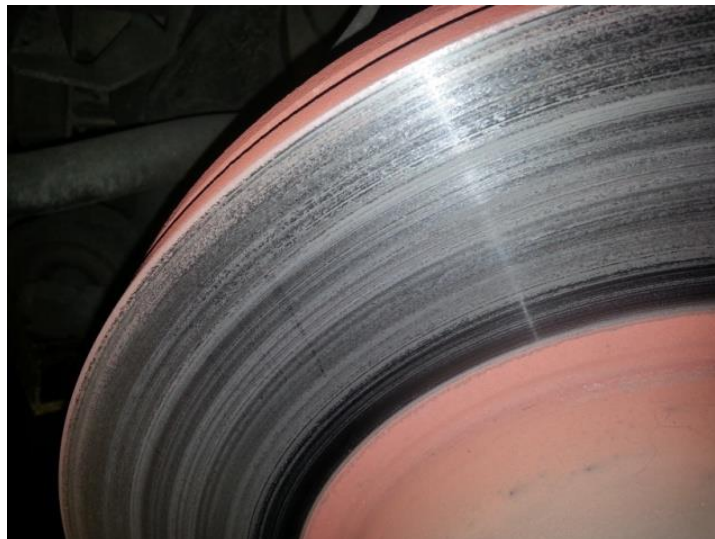
FIGURE 28
Radial Grooves

Knorr-Bremse allows radial cracks (**Figure 28**) less than 0.06 in. (1.5 mm) deep or wide if their length is less than 75 percent of the radial measurement of the friction surface and the cracks do not extend to either end of the friction surface.

Blue bands and discoloration indicate that the rotor was very hot.

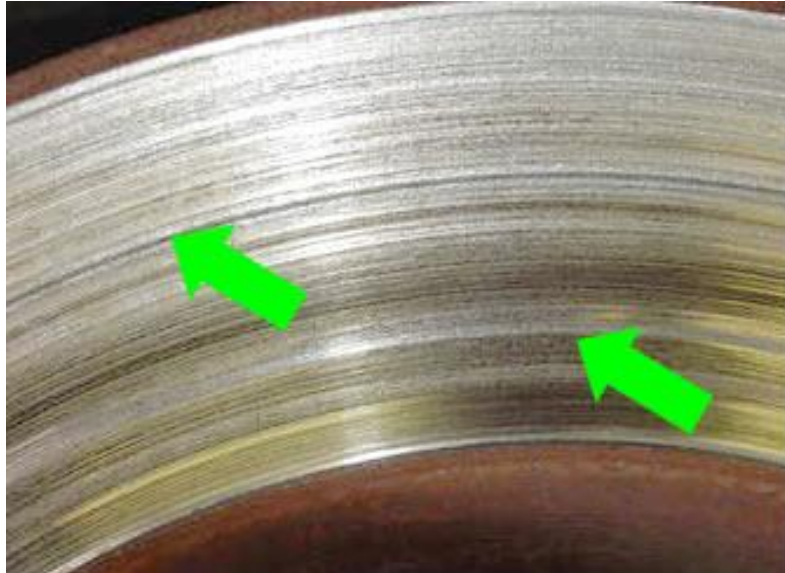
FIGURE 29
Axial Grooves

Knorr-Bremse allows axial grooves (**Figure 29**) less than 0.06 in. (1.5 mm) deep or wide. Meritor permits axial grooves less than 0.02 in. (0.5 mm) deep or wide. Grooves that exceed manufacturer's specifications will require rotor resurfacing or replacement. See **Figure 30**.

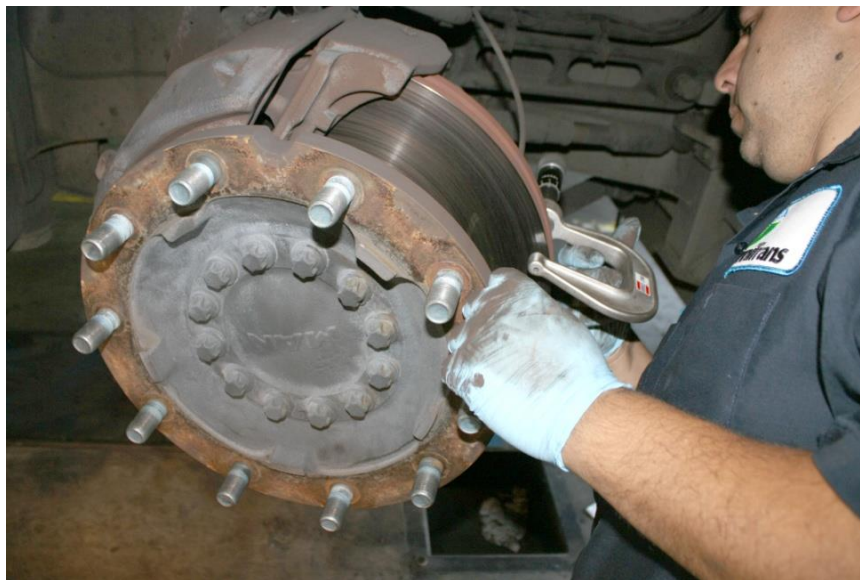
FIGURE 30
Measuring Brake Rotor Thickness with a Brake Rotor Micrometer

Use a brake rotor micrometer to measure thickness at 90-degree intervals at the thinnest portion of the rotor. Avoid measuring near the edge of the rotor, as minor burrs may result in inaccurate measurement. If unsure of

the thinnest point, measure at three points. Point one is about 10 mm below the outer friction diameter. Point two is at the friction surface center. Point three is about 10 mm above the inner friction diameter. The brake rotor micrometer must be square to the rotor friction surface for accurate measurement. Typical new rotor thickness is 45 mm. Rotors must be discarded when a minimum thickness of 37 mm or the minimum discard thickness found on the rotor casting is reached. The discard thickness is frequently cast into the rotor hat flange and is the minimum thickness the rotor can be worn to before the rotor is no longer considered safe for operation. Minimum thickness is not the minimum brake pad change thickness. New brake pads can be installed with a used rotor, providing that the rotor passes the visual inspection and no portion of the rotor friction surface measures less than 39 mm in thickness.

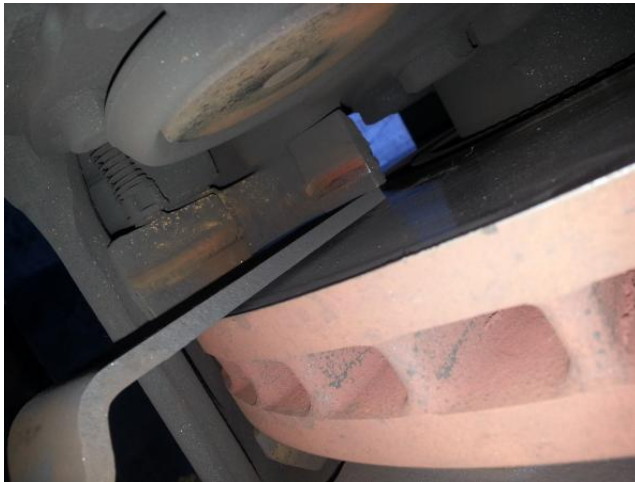
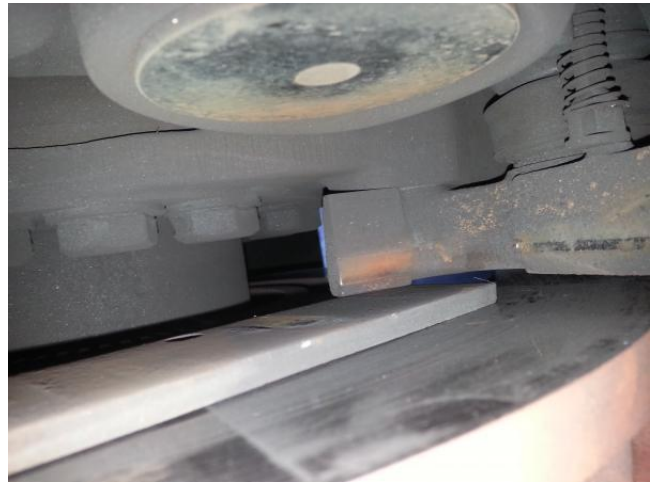
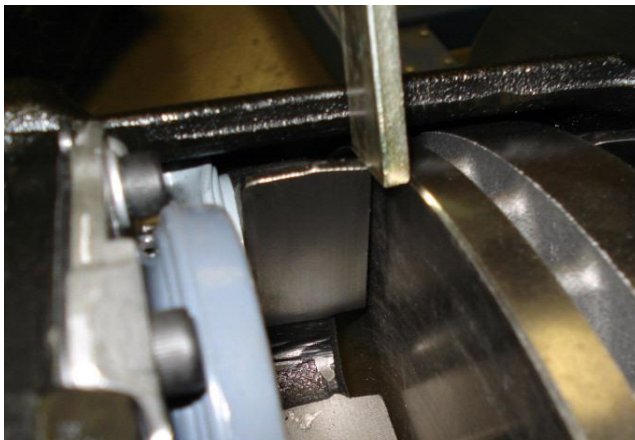
FIGURE 31
Rotor Wear

Uneven Meritor EX225 rotor wear indicated by angular gap between pad retainer and carrier. The rotor will need to be replaced.

Worn Meritor EX225 rotor indicated by gap between the pad retainer and the carrier. The rotor will need to be replaced.

Acceptable Meritor EX225 rotor thickness indicated, as the pad retainer will not fit between the rotor and the carrier.

Meritor EX225 pad retainers can be used as a gauge to help identify uneven wear or worn rotors. To check wear, place the retainer between the rotor surface and the carrier pad abutment. Make sure that wear is checked on both the inboard and outboard sides of the rotor.

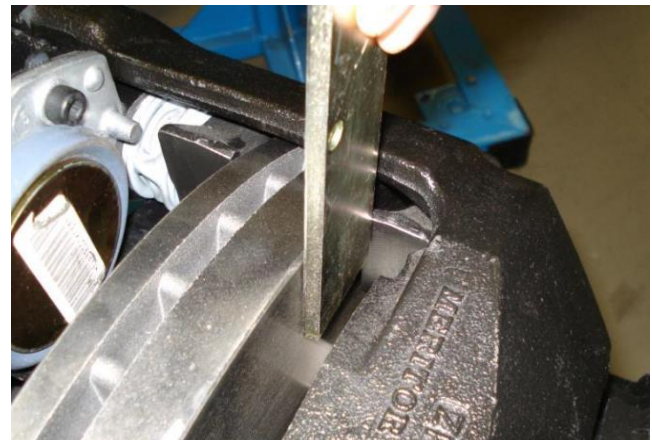
Some Meritor rotors have different inboard and outboard swept area thickness. The flange and hub add to brake mass and increase heat transfer.

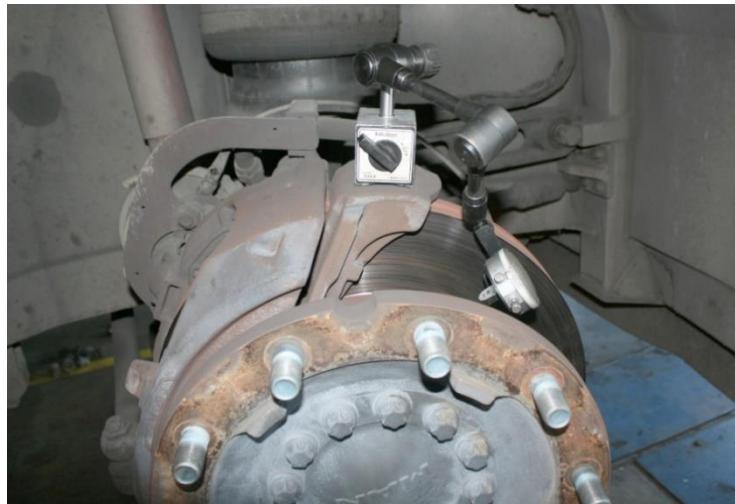
FIGURE 32
Checking the Rotor

Measuring rotor run-out

If need be, check rotor thickness in several areas, as rotors can experience different wear rates in different areas. Thickness can vary, creating the false illusion of run-out. These variances in thickness can cause wheel vibration during braking. If these differences in thickness occur at different locations, they can appear as minor run-out, but when compared with both sides, they can appear as exaggerated run-out. See [Figure 32](#).

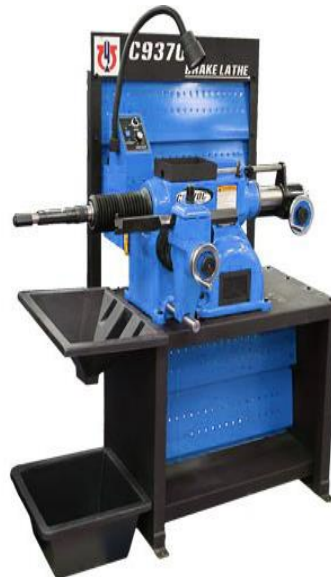
Options exist to turn rotors both on and off the vehicle.
