Transit Bus Air Disc Brake Wheels-Off Inspection and Reline

Abstract: This *Recommended Practice* provides guidelines for performing complete brake maintenance on a bus with disc brakes. It includes disassembly, cleaning, inspection and assembly. This document is to be used in conjunction with the manufacturer's service manual. It is recommended that all components be replaced equally on both wheel ends of the axle. Failure to do so may affect braking performance.

Summary: This document establishes a recommended practice for transit bus front/rear axle disc brake inspection and reline. Individual operating agencies should modify these guidelines to accommodate their specific equipment and mode of operation. The recommended practices and guidelines in this document assume that the end users have sufficient skills and knowledge to repair and maintain the related systems at a journeyman level. This must include a fluent understanding of safe shop working practices, not only for the agency but also OSHA/CCOHS/provincial/federal/state and local safety standards. A familiarity with applicable industries, component/system suppliers and vehicle manufacturers is also assumed.

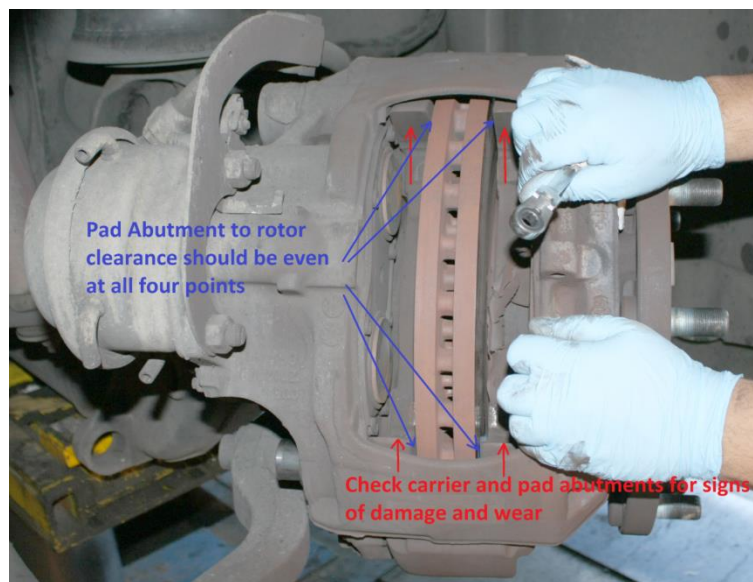
Pad Abutment Inspection

Checking pad abutment to rotor clearance and pad abutment wear

Pad abutment to rotor clearance should be approximately equal at all four points. Large variances from side to side can indicate hub and rotor position off center caused by uneven rotor wear, incorrectly installed spindle wear ring, or incorrect or out-of-adjustment wheel bearings. Minor abutment wear is normal. Wear that will cause the pads to hang up will require carrier replacement.

Carrier and pad abutments should be inspected for signs of wear and damage. See **Figure 33**.

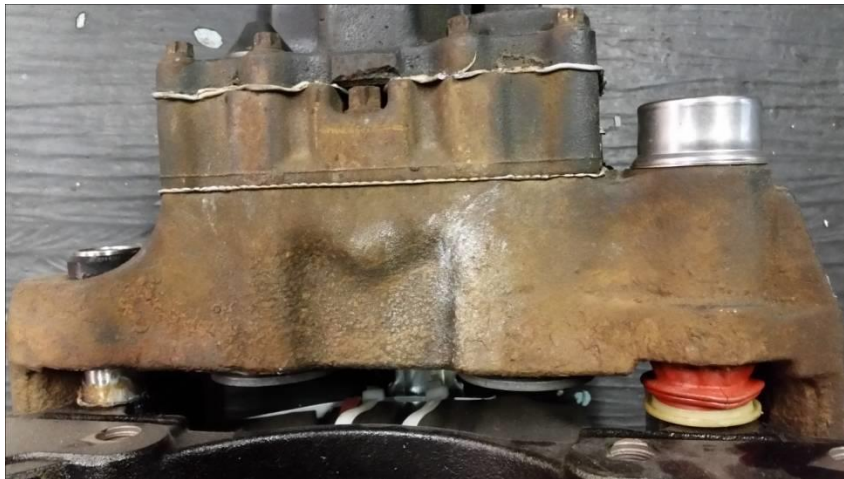
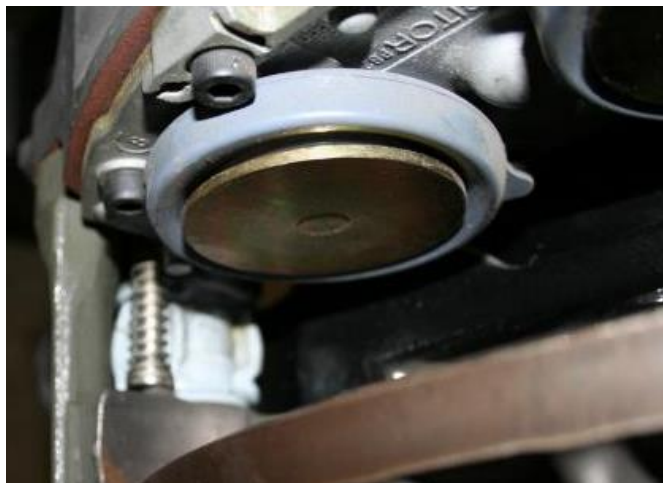
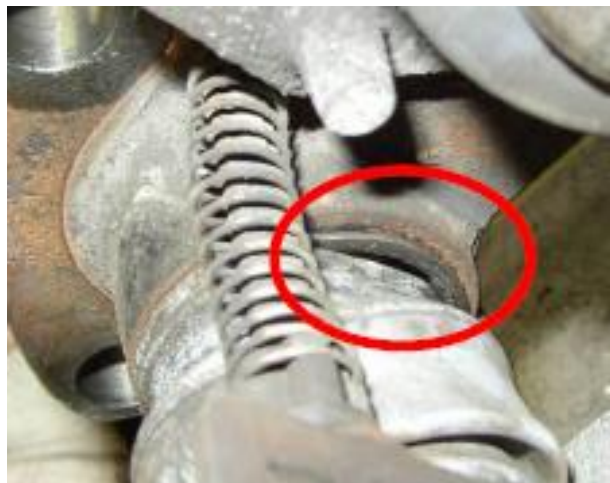
FIGURE 35

Knorr-Bremse guide pin boot

Meritor EX225 slide pin boot and tappet boot

Improperly installed slide pin boot

All slide/guide pin boots should be free from damage and should be correctly seated. When a damaged or leaking slide pin seal is identified, the caliper should be removed for replacement of the bushings and seals. See **Figure 35**.

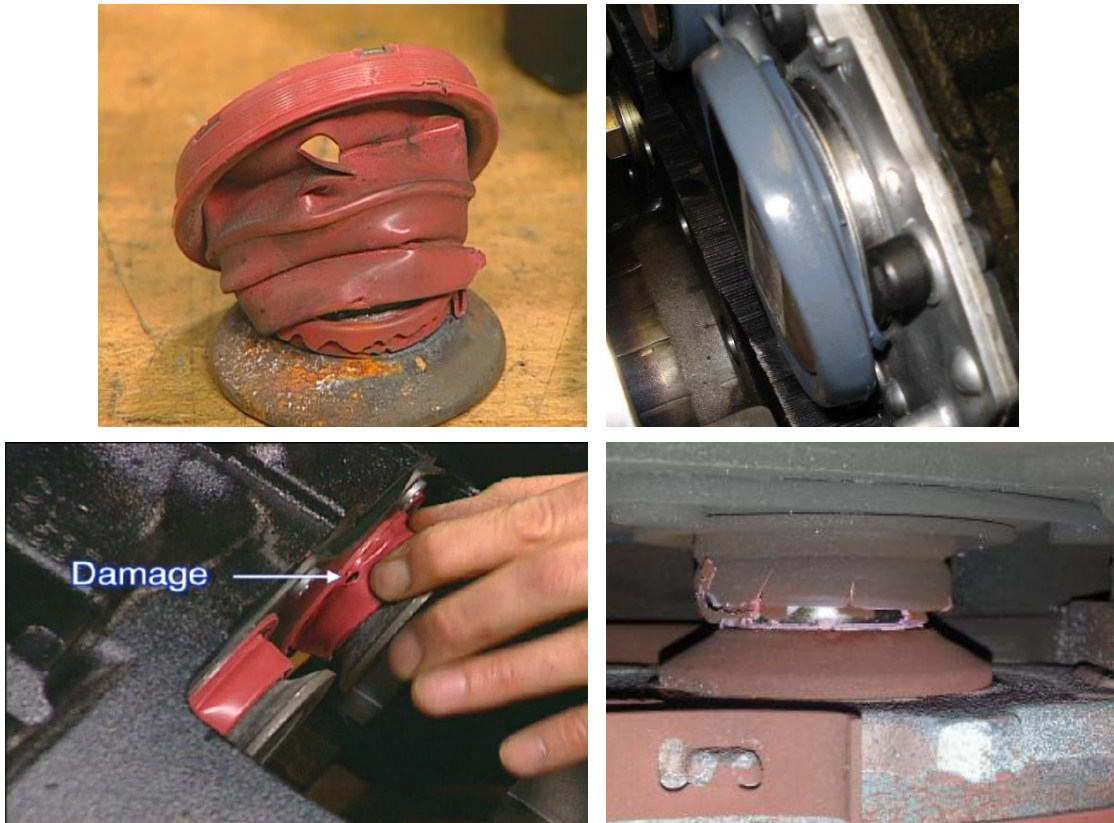
Examples of Damaged or Improperly Installed Tappet Boots

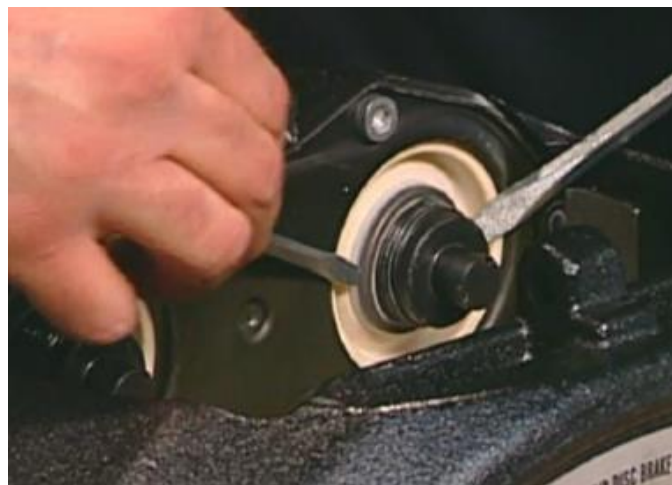
FIGURE 37

Knorr-Bremse Inner Tappet Seal Replacement

be replaced as a set. Replace inner tappet seals on Knorr-Bremse calipers whenever tappets and outer seal assemblies are replaced.

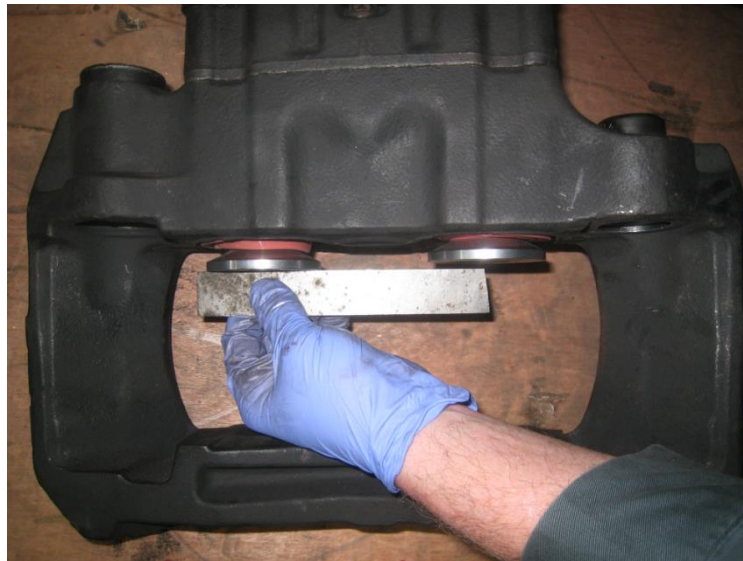
FIGURE 38
Straight Edge Showing Uneven Tappet Height

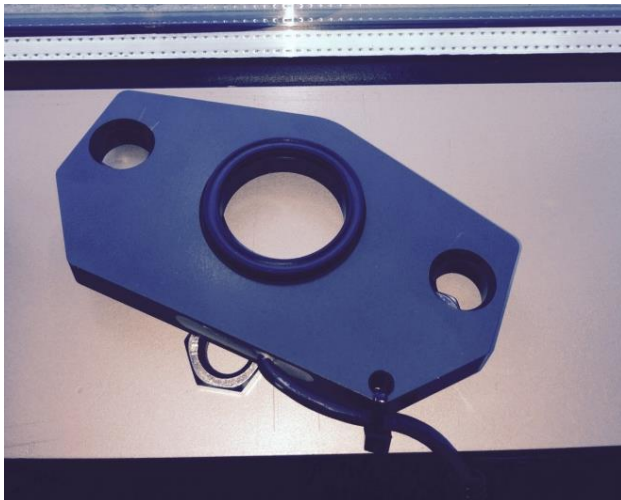
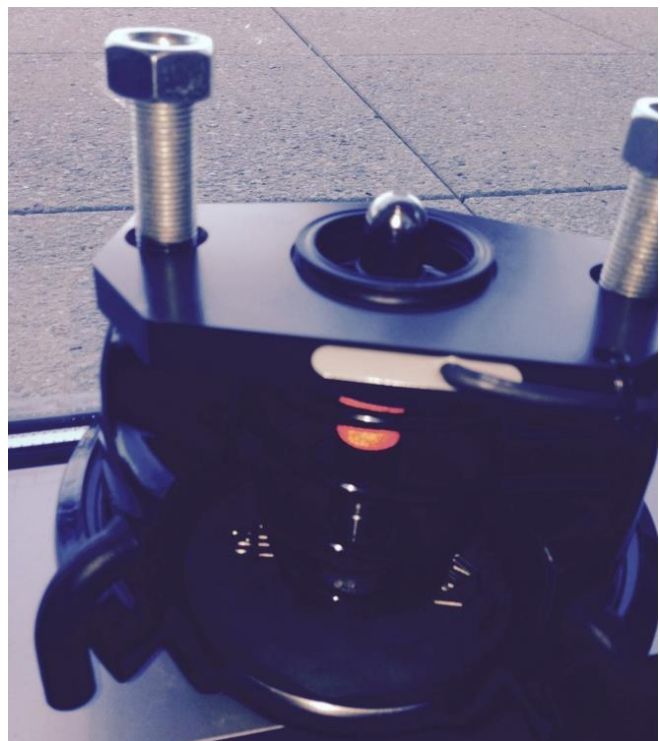
FIGURE 40

MGM E-Stroke sensor pack

MGM E-Stroke sensor fitted to a brake chamber

MGM E-Stroke brake chambers (**Figure 40**) use a seal on the sensor pack with the same 3 mm minimum protrusion. If equipped, this seal must be inspected and replaced if worn or damaged.

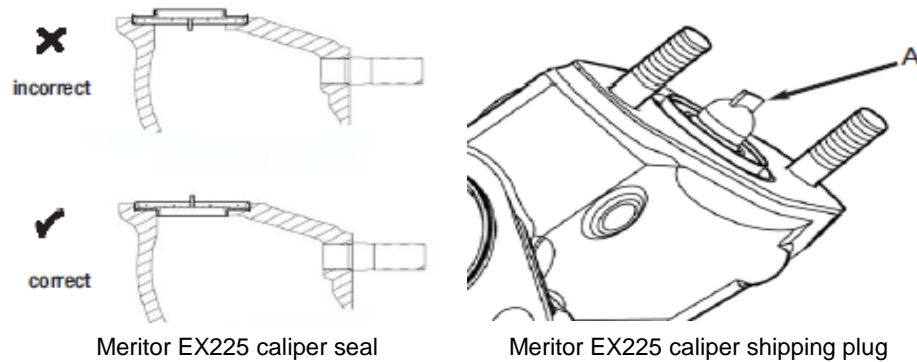
FIGURE 43

Meritor EX225 Caliper Seal and Shipping Plug

NOTE: The Meritor EX225 caliper has a seal on the caliper that rests against the brake chamber seal (see **Figure 43**). New calipers are shipped with a transit plug and should not be confused with the caliper seal. The transit plug must be removed before the chamber is installed.

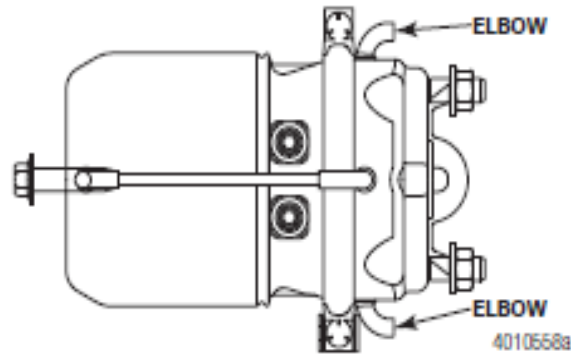
FIGURE 45
Brake Chamber Elbow Orientation

For brake chambers equipped with elbows, the brake chamber must be oriented in such a way that the two elbows will easily allow water and contaminants to drain from the brake chamber. Ensure that the vent tubes have no internal restrictions, which could cause poor venting and dragging brakes. See [Figure 45](#).

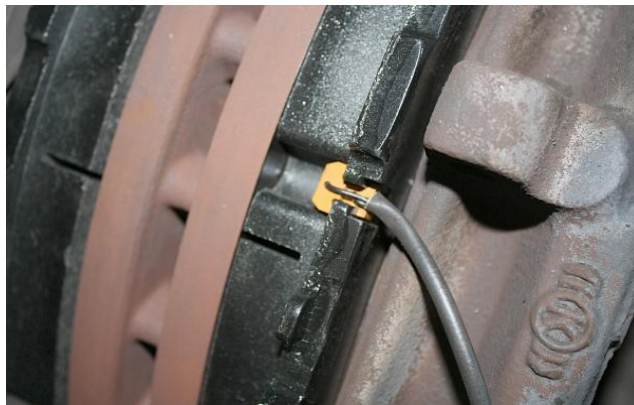
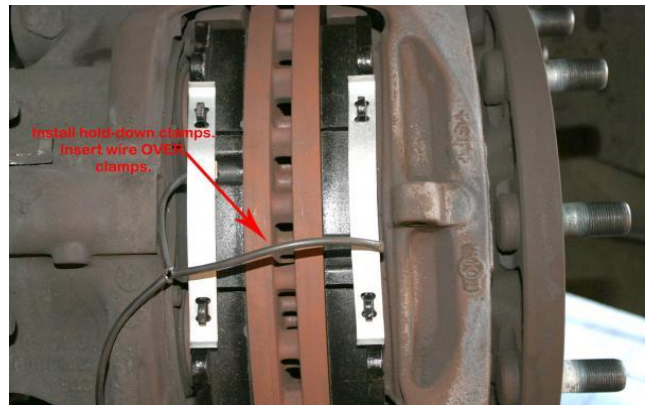
FIGURE 46
Brake Pad Installation and Adjustment

Install sensors as required

Knorr-Bremse wear sensor harness routing

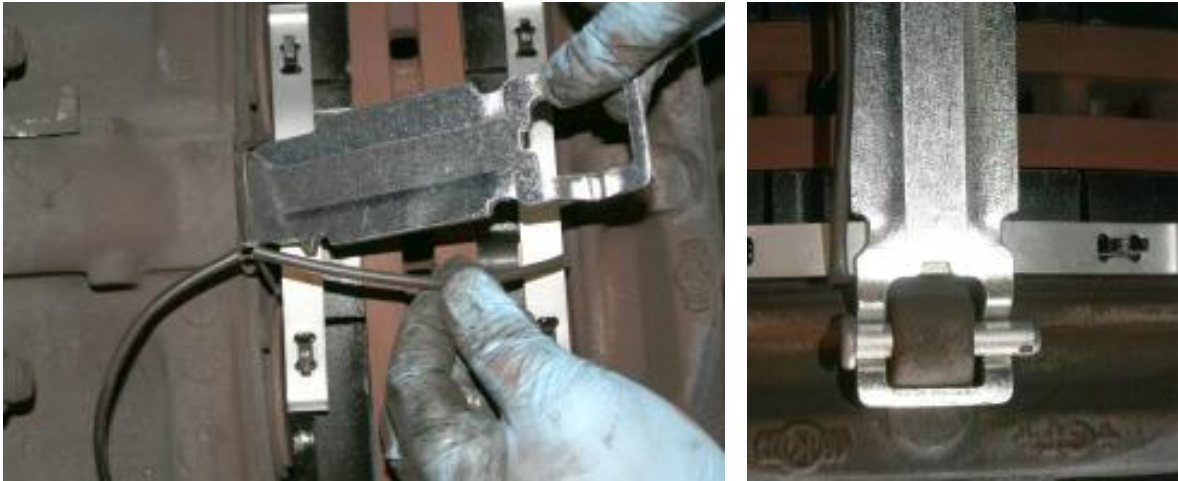
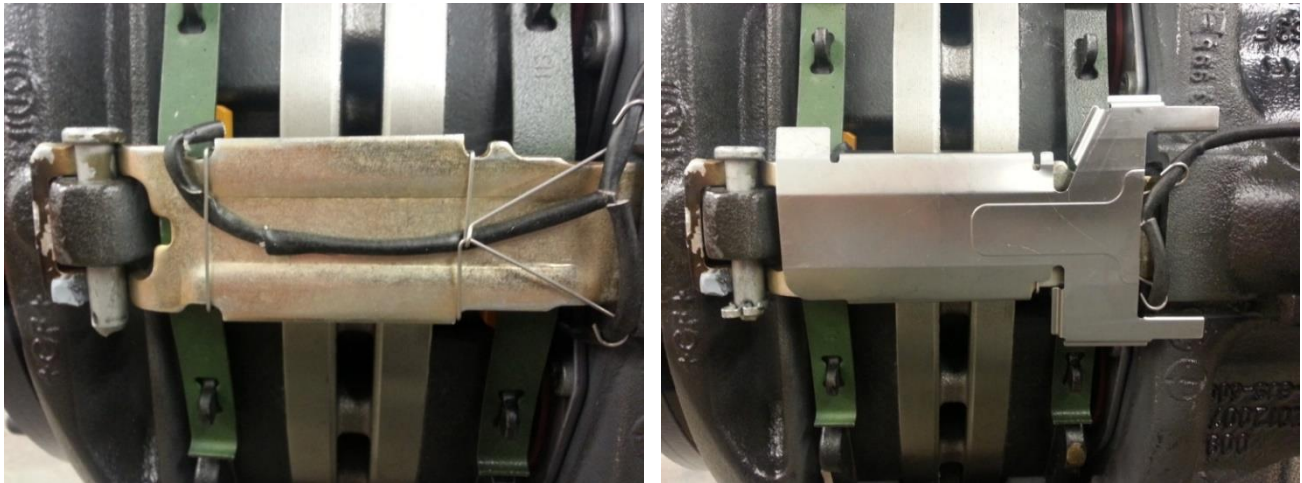
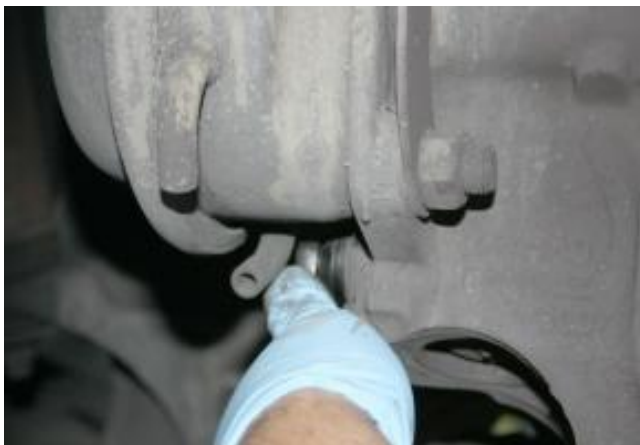
Knorr-Bremse pad retainer installation

If equipped, properly secure Knorr-Bremse wear sensor harness.

Adjusting the brakes to set the initial clearance
