Rail Clip Failure Investigation at Sound Transit

Clip Failures – As of April 11, 2017

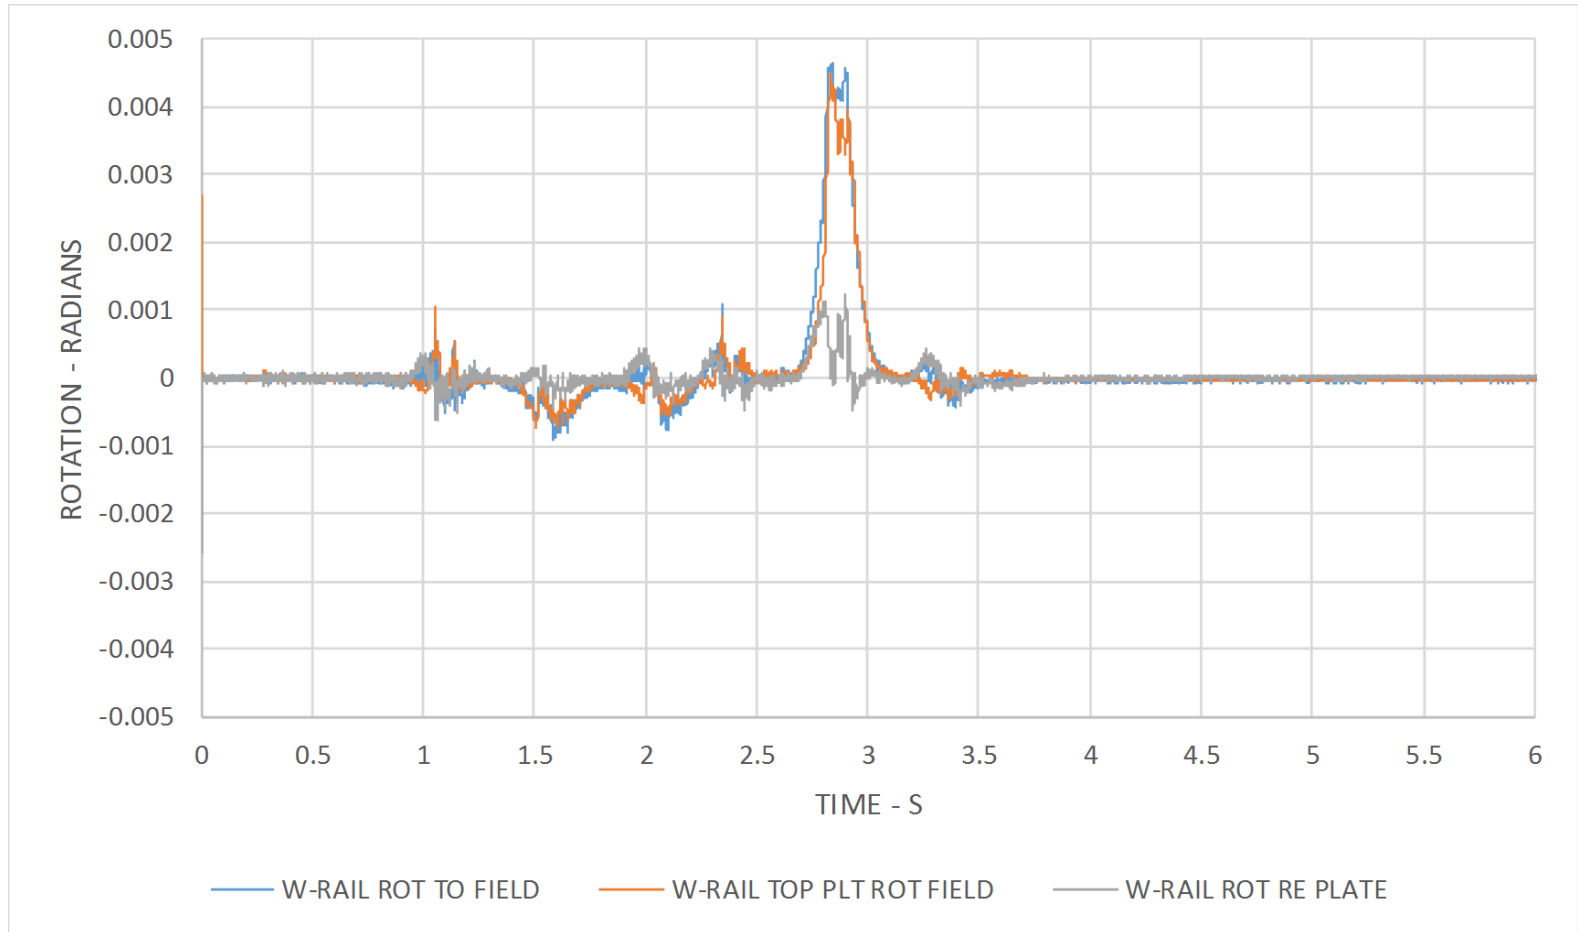
Southbound West Rail and Fastener Top Plate Rotation

- Center truck produces largest rail rotation and lateral displacement
- No evidence of clip toe load being overcome
- No clear evidence of fatigue due to relative deflection of rail and fastener
- Acceleration spectrum contains strong peaks above 800Hz
- Laboratory tests indicate system resonance at about 800 to 900Hz
- Amplification of rail vibration acceleration at nominally 800 to 900Hz

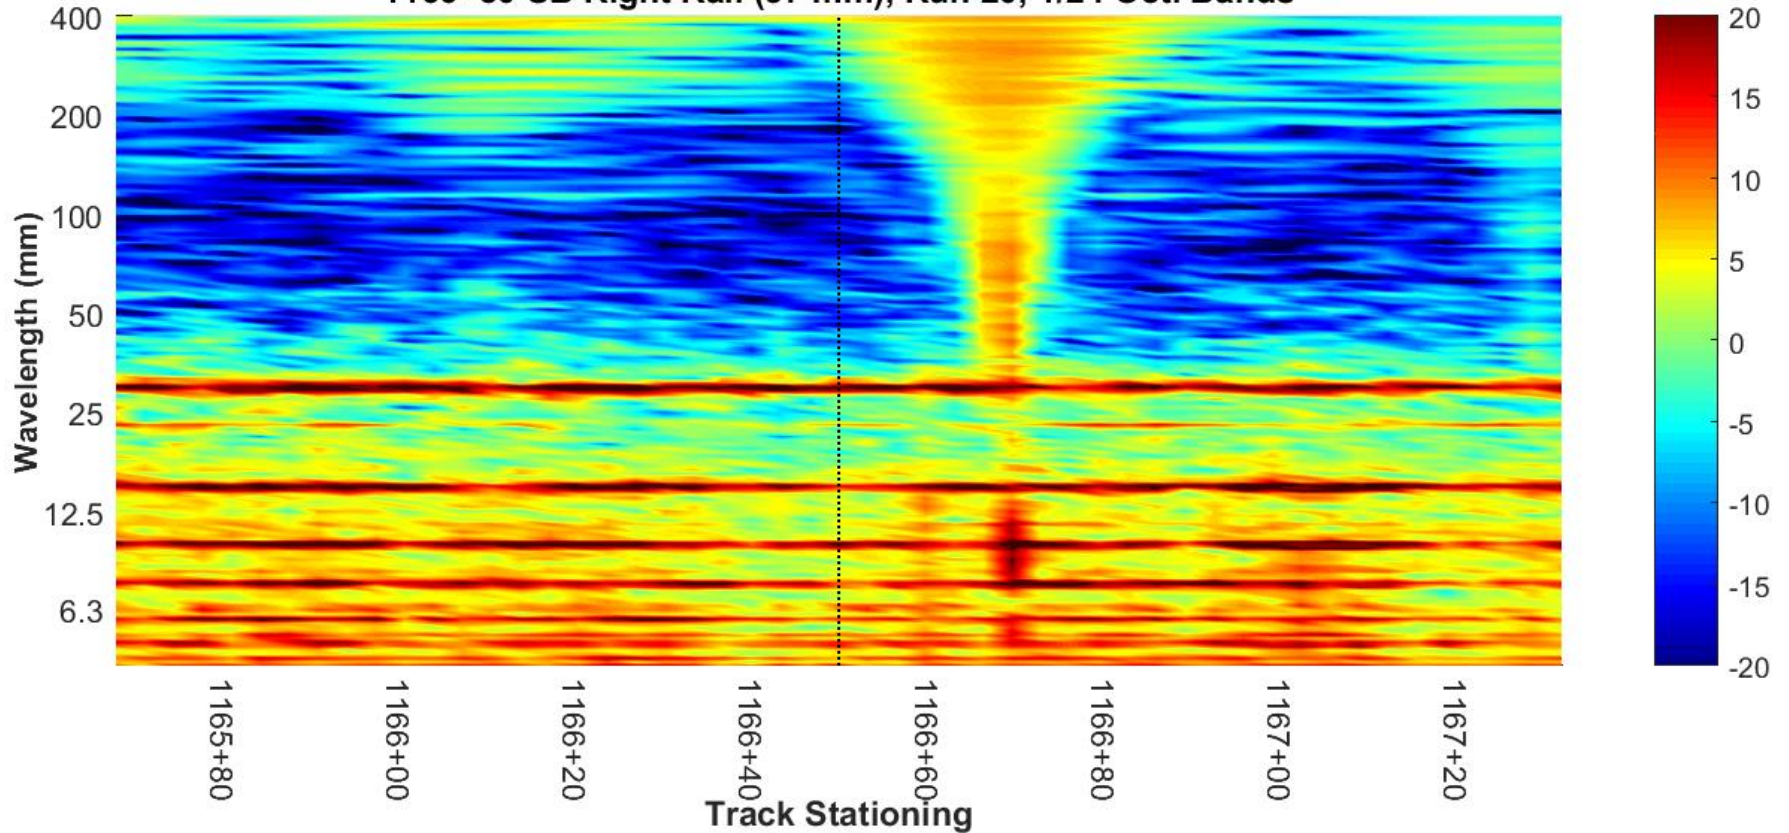
1166+50 SB Right Rail (37 mm), Run 20, 1/24 Oct. Bands

- Rail grinding left $\sim 1.1''$ wavelength.
- At 55 mph, $1.1''$ wavelength causes vibration at 848 Hz.
- There are short segments where this wavelength disappears.
- Resonance of rail clips is 800 to 900 Hz.
- Rail clip failures appear to be greater where 800 to 900 Hz peak is stronger.
- Reducing or increasing the grinder speed would change the wavelength and could help resolve problem.
