Tackling obsolescence issues for power electronics

Wim Platschorre

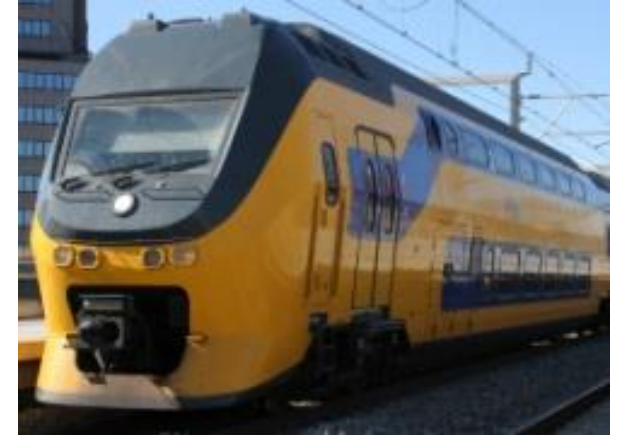
Example GTO inverter 90's

- Only partial modular, shared components
- Critical fibre optic control

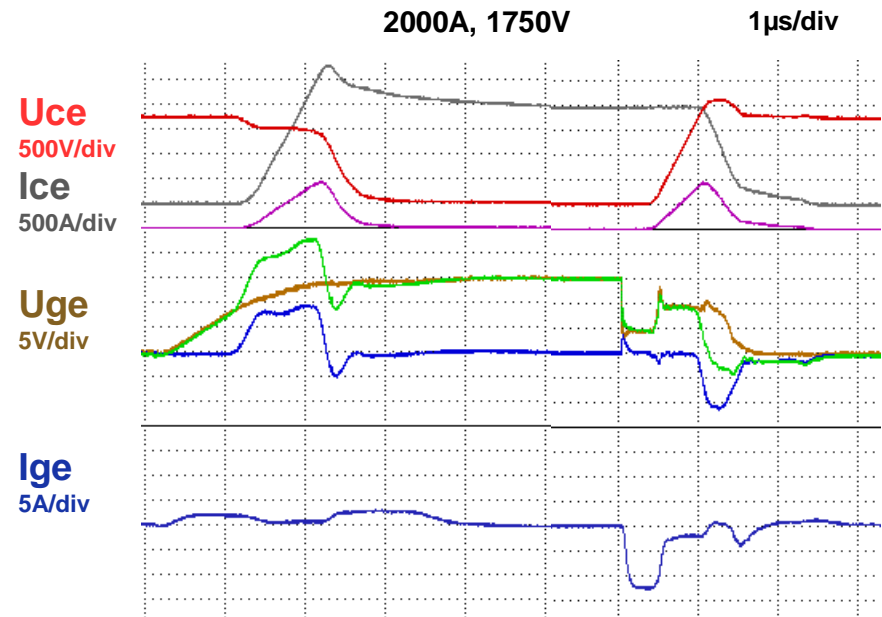
- di / dt and dV / dt control => optimized switching behaviour
- Zero dead band: turn-off and turn-on within one phaseleg simultaneously
- Fast short circuit detection

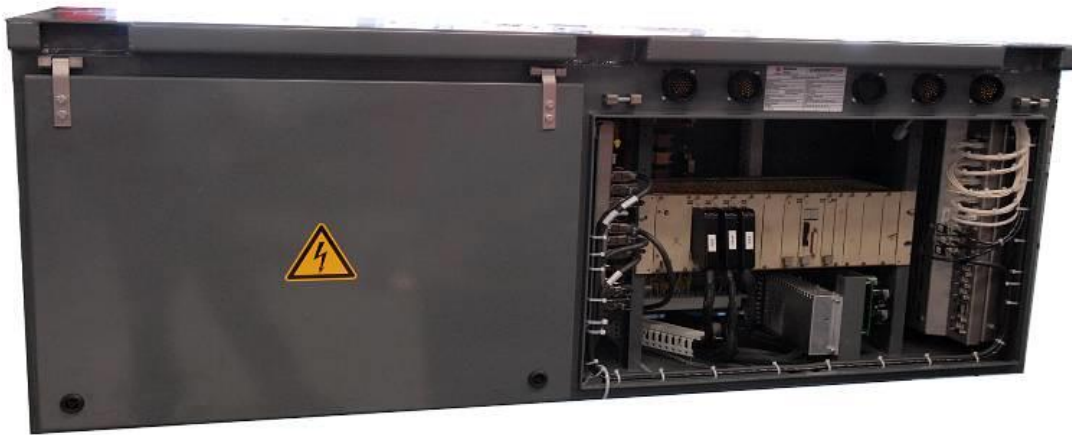
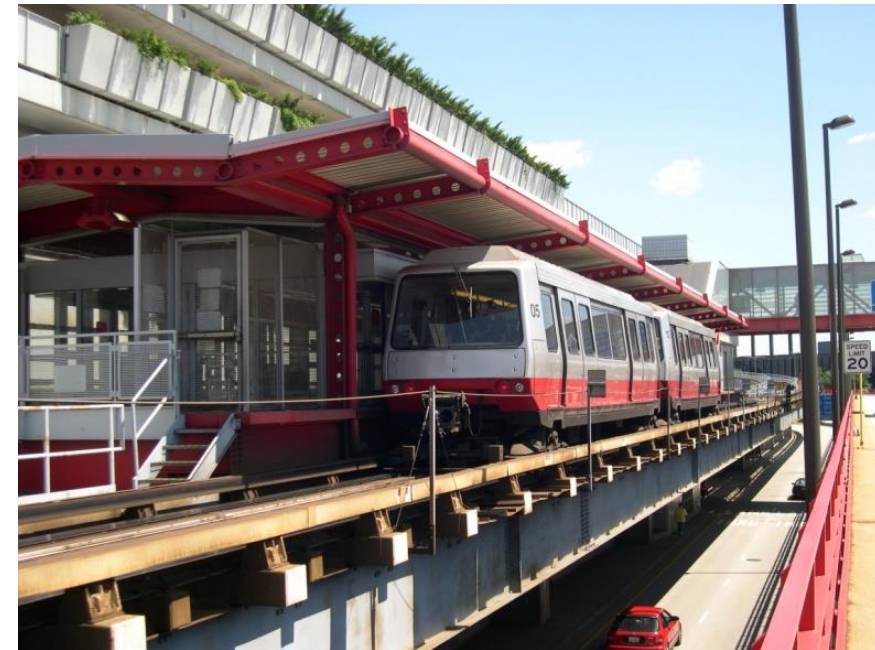
Chicago O'Hare airport shuttle

- DC motors not replaced
- New control electronics
- IGBT based DC Chopper
- Integrate existing brake control in new drive box

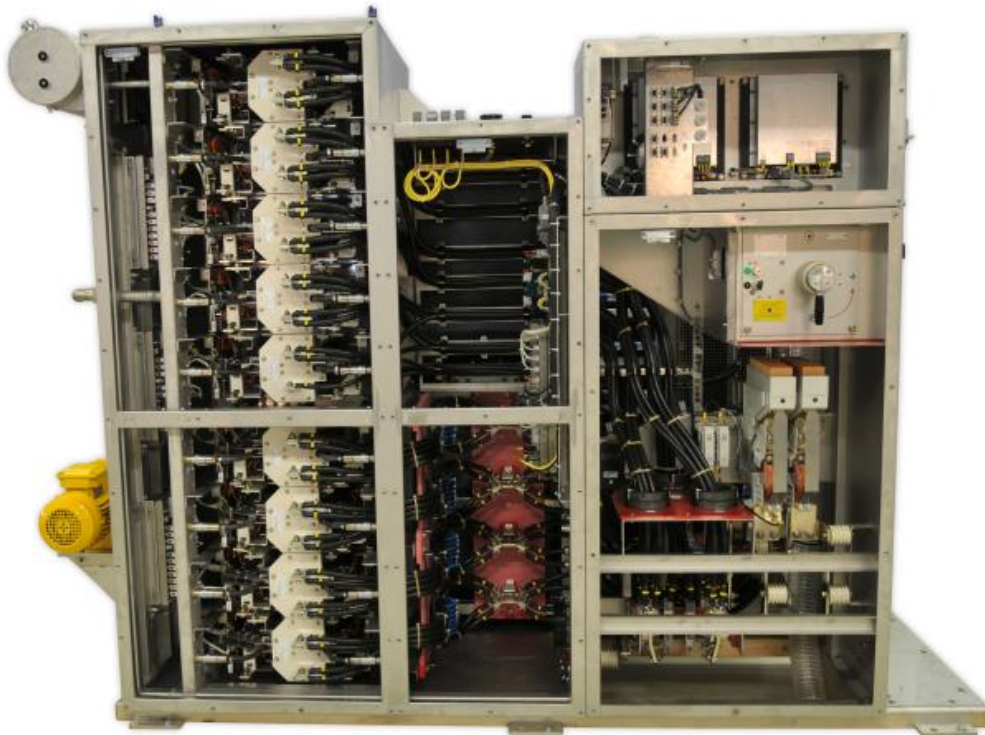
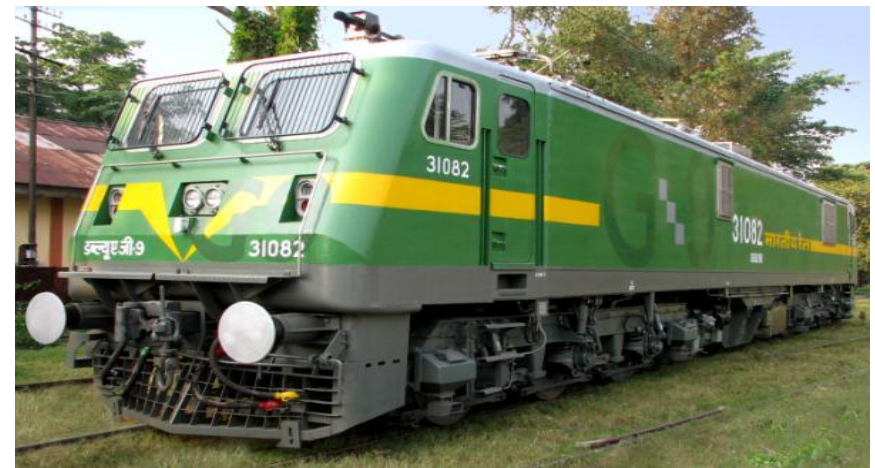
India, 6000 HP locomotive

- New build locomotives, but existing design, originally with GTOs.
- 4.5kV IGBTs
- Watercooled

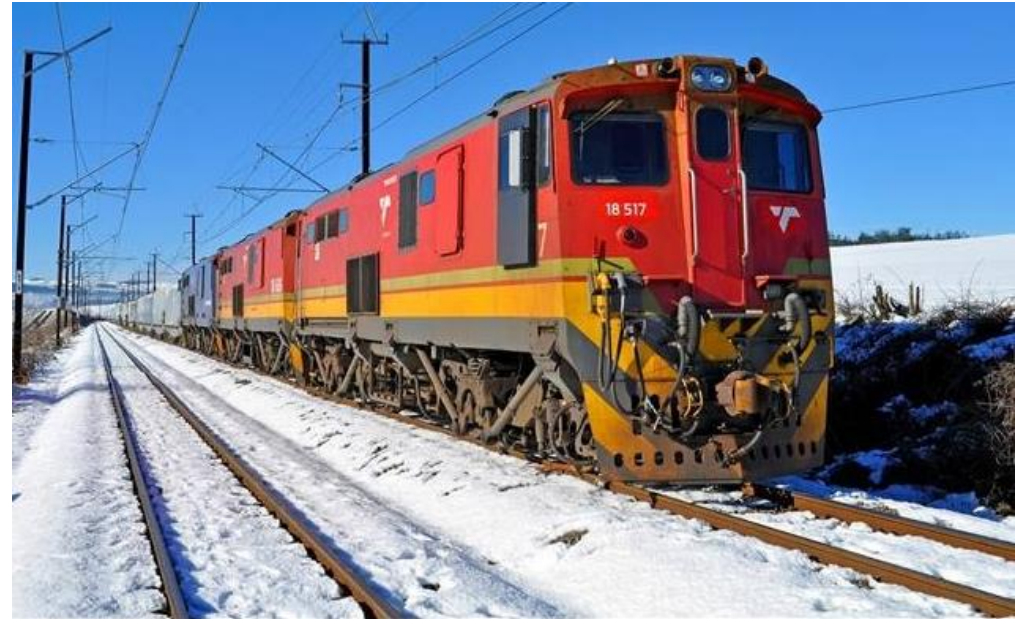
- Replacement rotating converter for a static converter
- Power: 150kW
- Line voltage 3kV
