SEPTA's Broad Street Subway Propulsion Control Box Retrofit – Post Installation, Realized, & Hidden Benefits

SEPTA's BROAD STREET SUBWAY (BSS) CAR PROPULSION SYSTEM RETROFIT

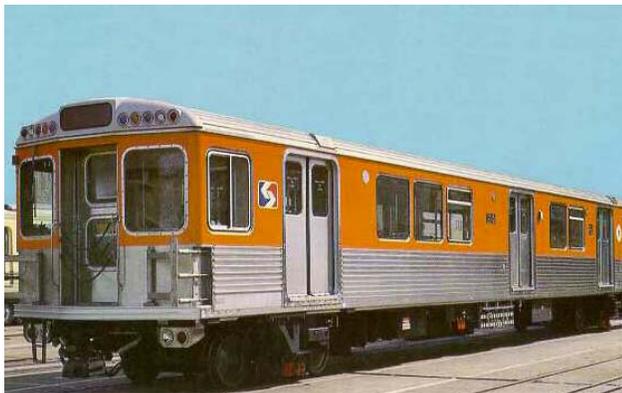
Figure 2- BSS B-IV Vehicle

Builder	Length	Year Built	Quantity	Mode of Power (present)	Seating	Fleet No
Kawasaki Heavy Industries	67' 6"	1981-1983	76 Single	IGBT Chopper Controlled DC Motor	65 Single	501-576
			49 Double		62 Double	651-699

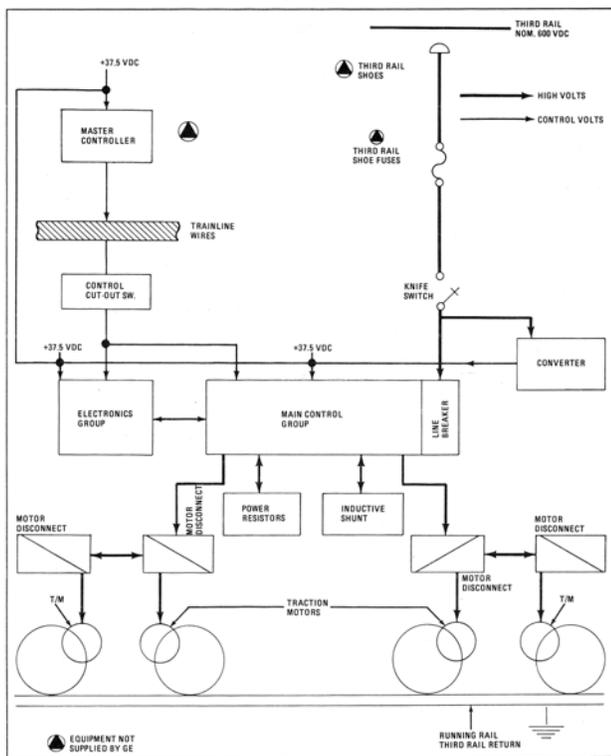
Figure 3- Original B-IV GE Propulsion System Overview

The scope of work detailed that the equipment would replace the present KM 48 cam control system, the 17KG412 Electronics Group, and the 17F1219 Rate Setting Card originally supplied by GE. Also, all items under this contract would be supplied by the contractor, in kit form, for installation by SEPTA.

FIG. 1. GE PROPULSION SYSTEM. E-23235

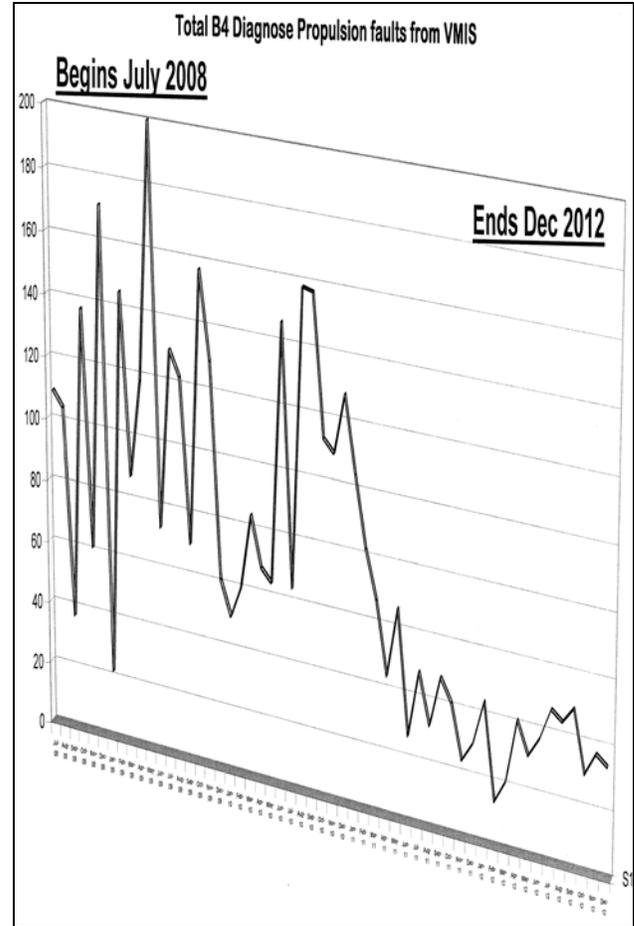
Figure 4- B-IV Propulsion Fault Chart

Another realized benefit was an increase in system MDBF or reduced “blue lights” as seen on figure #4 which displays propulsion faults recorded in SEPTA’s Vehicle Maintenance Information System (VMIS) before, during, and after installation. Eleven months of fault data from before installation of the new controller shows an average of 95 propulsion related faults per month and eleven months of recorded data running with the new controller shows an average of only 35 faults per month.

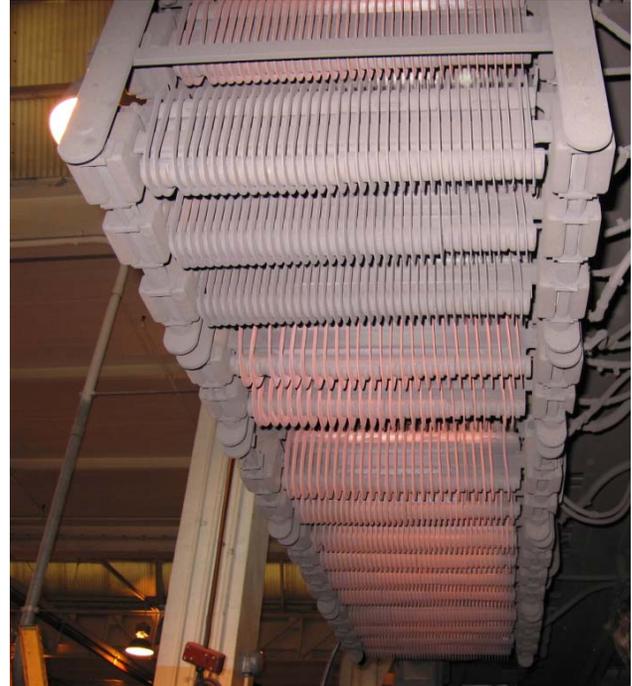
Figure 5 - Grid Resistors

An unexpected consequence of reusing the brake resistors was that the 1250 HZ pulse frequency of the IGBT chopper that flows through the resistors created a nuisance noise that sounds like “squealing brakes”. While many operators and passengers alike thought that we were having brake troubles, it was actually just our resistors squealing. When we enabled regenerative braking, the “squealing brake” noise stopped because the energy was sent back into the 3rd rail and not dropped across the brake resistors. Therefore, enabling the regenerative braking functionality led to an additional power savings (\$40K per year, 4-month sample), and it also took away SEPTA’s squealing brake resistor problem.
