**APTA BTS-BC-RP-010-20**

# Troubleshooting Transit Bus Air Systems

**Abstract:** This recommended practice provides guidelines for troubleshooting transit bus air systems, including basic design criteria, preventive maintenance and common problems.

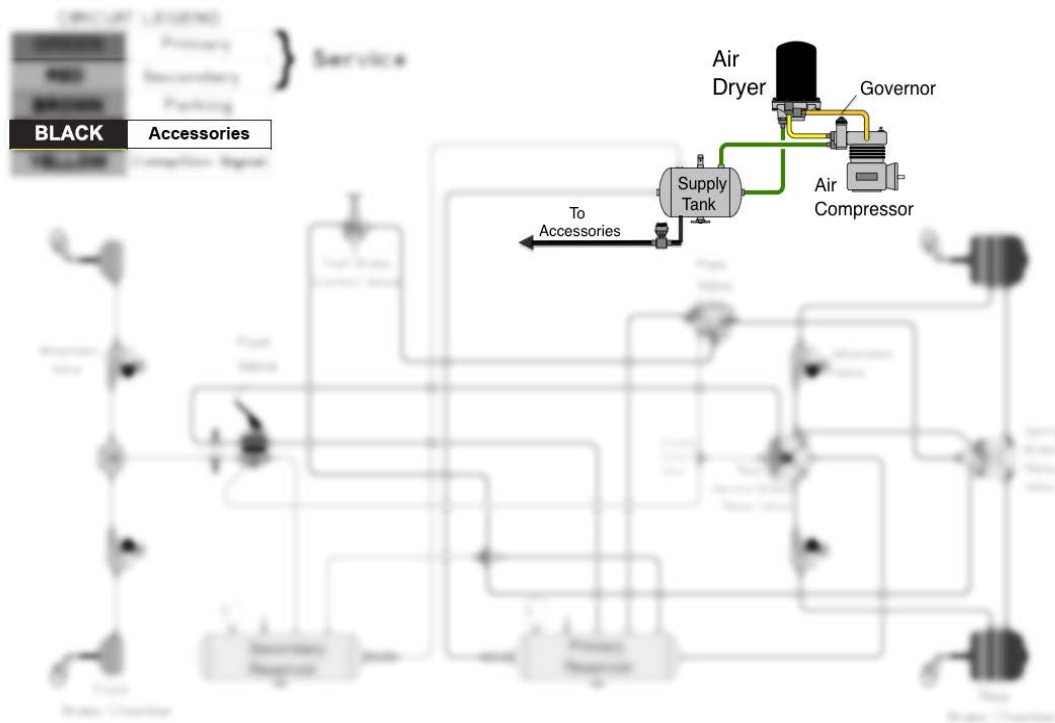
**FIGURE 2**  
Supply System Components

The supply system (**Figure 2**) is designed to provide an adequate supply of clean, dry air to meet the needs of the following air subsystems:

The filtered air is compressed and delivered to the supply reservoir through an air dryer. Air pressure is controlled by the governor. The air dryer removes moisture/oil and other contaminants. The supply reservoir air is protected by a one-way check valve (typically located in the air dryer). The supply system is typically protected by multiple pressure relief/safety valves. Usually a 250 psi safety valve is located on or in the air compressor, a 175 to 200 psi safety valve is located at the air dryer, and a 150 psi safety valve is installed in the supply reservoir.

If the supply reservoir pressure is controlled by a mechanical air governor, then the reservoir port on the governor receives a pressure signal from the supply reservoir. When air pressure falls below the governor cut-in setting (commonly between 100 and 120 psi), the air compression begins. When the reservoir pressure reaches the governor cut-out setting (typically 120 to 135 psi), air compression ceases and the air dryer purges.

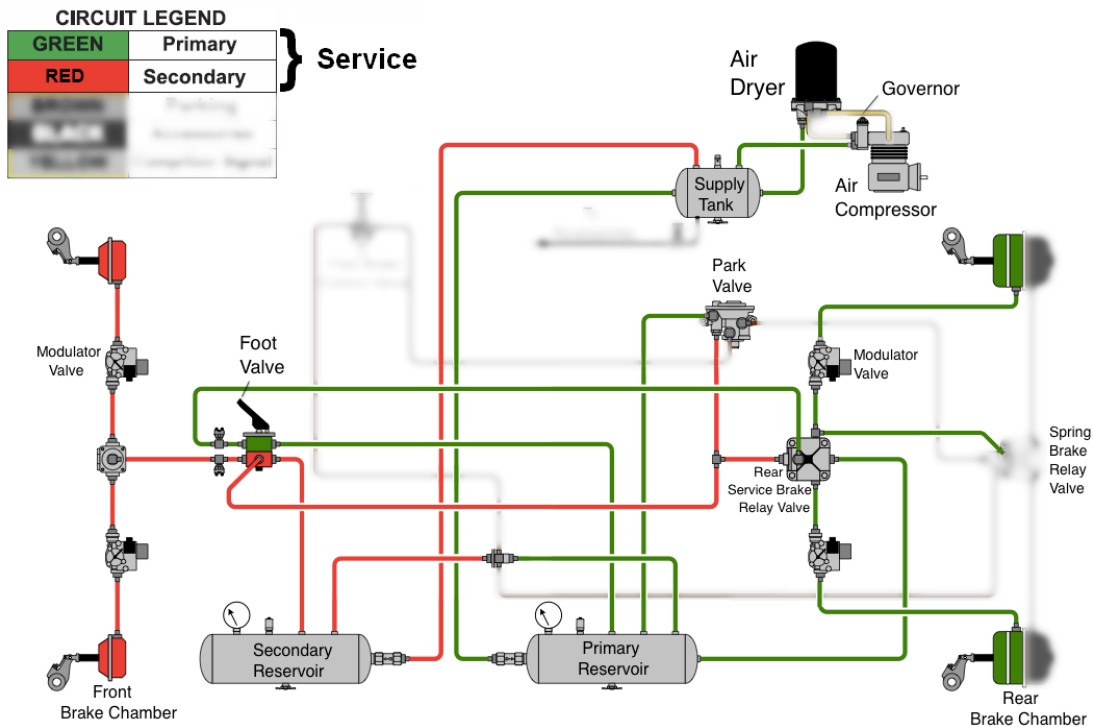
**FIGURE 3**  
 Service (Control) Brake System Components

In an air brake system, service brakes are pneumatically powered. The brake pedal, when pressed, mechanically operates the brake (treadle) valve, which in turn delivers air pressure to brake chambers (actuators) that convert air pressure into linear mechanical force. When the pedal is released, air pressure from the chambers is released to the atmosphere, thereby releasing the mechanical force from the foundation brake components.

In addition to the brake (treadle) valve and chambers, stop light switches, relay valves and quick-release valves are employed in the service brake system. During a service brake application, air pressure is delivered to the stop light switch, which completes an electrical circuit to apply the brake lights. A quick-release valve is typically used to distribute delivery air pressure to each front brake chamber and quickly release air, without it having to travel back to the treadle valve. The relay valve located near the rear axle speeds up the application and release of the rear brakes. It has a dedicated supply of air from the primary reservoir, requiring only an air control signal from the treadle valve. Quick-release valves can also be used in the control circuit to speed application and release of relay valve control signals.

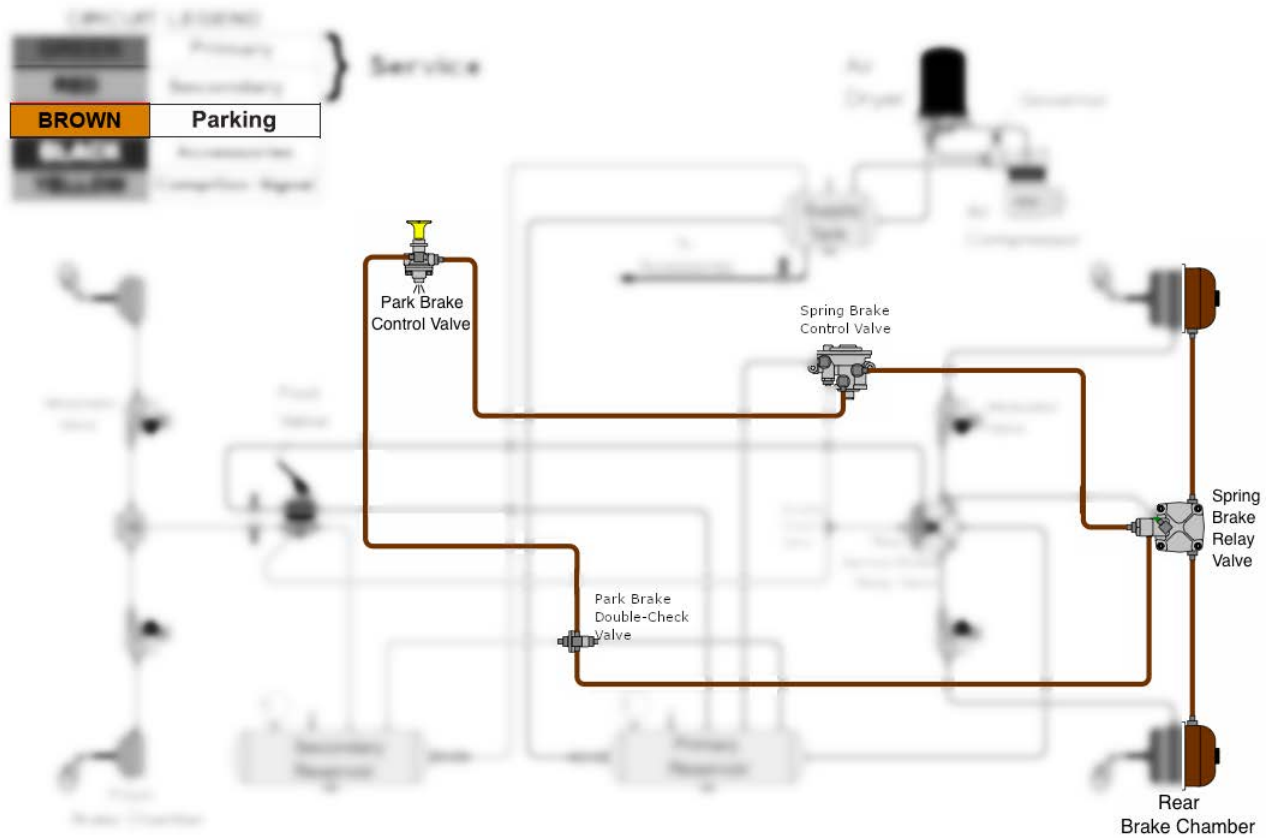
**FIGURE 4**  
 Parking and Emergency Brake System Components

All buses must be equipped with an emergency brake system and parking brakes (**Figure 4**). The parking brake's function is to hold the bus stationary on a specified grade at GVWR. The parking brakes are held on by mechanical force to ensure that they remain activated while the bus is stationary, even if air pressure leaks away. The emergency system's function is to provide braking force at the primary brakes, to assist the intact secondary brake system in the event of a primary brake system failure.

The parking brake system uses a spring brake chamber that contains a powerful spring that mechanically applies the foundation brakes. To allow normal vehicle operation, the spring force is held back by air pressure (referred to as "hold-off air"), which releases the foundation brake. A parking brake control valve in the operator's compartment allows the operator to either apply this air to release the springs and drive the vehicle or to exhaust this air to apply the springs to hold the vehicle stationary. Park control valves are typically pressure-sensitive, normally closed, on/off valves that automatically move to the exhaust position (applying the parking brake) when supply pressure falls below the required minimum for the particular valve installed. A leak in the parking brake system, which causes both primary and secondary service air to be lost, will exhaust hold-off air and cause the springs to apply, and slow a moving vehicle to a parked position or keep a parked vehicle stationary.

The emergency brake system uses the spring brake chambers and parking brake air distribution components to provide modulated braking on the rear axle(s) in the event of rear (primary) air reservoir pressure loss. When primary pressure is lost, the application of the intact front (secondary) brake system causes the hold-off air to be partially released (in proportion to the amount of front brake application, via treadle application). The result is controlled partial application (and release) of the primary brakes via the spring brake chambers. This provides increased stopping performance when a rear (primary) system failure occurs.

- air reservoirs
- spring brake control valve
- double check valve
- dash control valve (park push-pull valve)
- spring brake chambers
- foundation brake components
