APTA BTS-SS-RP-005-10, Rev. 1

Troubleshooting Common Transit Bus S-cam and Air Brake Complaints

Abstract: This document establishes a *Recommended Practice* for troubleshooting common braking-related complaints on transit buses equipped with S-cam brakes. Individual operating agencies may modify these guidelines to accommodate their specific equipment and mode of operation. Test results must meet or exceed federal, state or other local regulatory agency requirements if different from the recommendations outlined in this document.

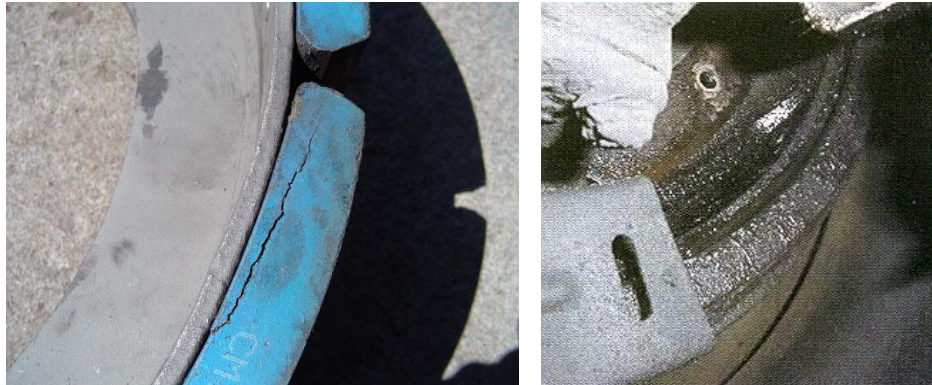
FIGURE 2

- Lining/shoe (**Figure 2**)
 - Check that the block is not worn to the wear line or less than 1/4 inch as measured at the center of the shoe. At no time should rivets or bolts touch the drum.
 - Check that there is no movement between the brake block and the shoe.
 - Check for missing segments of brake block.
 - Check for the brake blocks for cracks, hardness and glazing.
 - Inspect for signs of block contamination i.e. oil or grease.
 - Check shoes for damage, broken welds, worn roller pockets, and/or broken shoes.
 - Make sure all components are appropriate for the application (proper length pushrod, proper brake chamber size, etc.).

Brake Lining Problems

Cracked lining

Contaminated lining

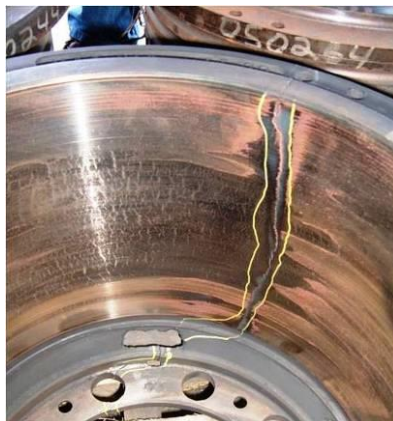
FIGURE 3

- Brake actuator (chamber):
 - During pushrod travel measurements, listen for air leaks in the brake chambers or other foundation brake components.
 - Inspect for dents, bends, alignment, leaks, pushrod return, corrosion, and missing caps.
- Air hoses:
 - Inspect for cracks, kinks, routing, leaking, chafing and deterioration.
 - Check for proper size and material.
 - Different configurations side to side (different fittings, hose size and routing, etc.).
- Hardware:
 - Check the condition of the clevis, pin and yoke.
 - Check for broken or missing return springs.
 - Check brake return spring for proper installation.
 - Check drums for excessive wear or cracks (**Figure 3**).
 - Check S-cams, rollers (wear, flat spots, lift).

Brake Drum Problems

Cracked brake drum

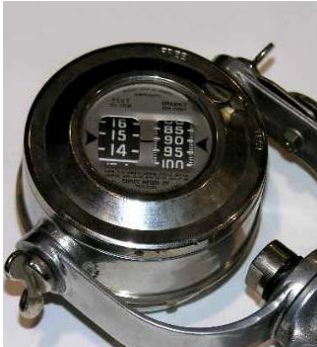
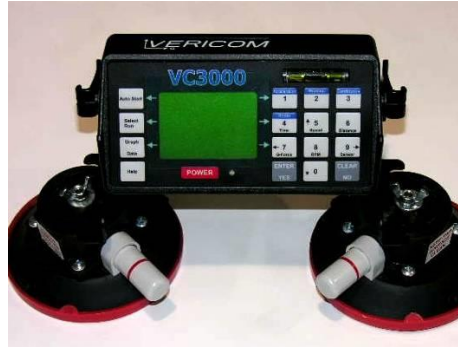
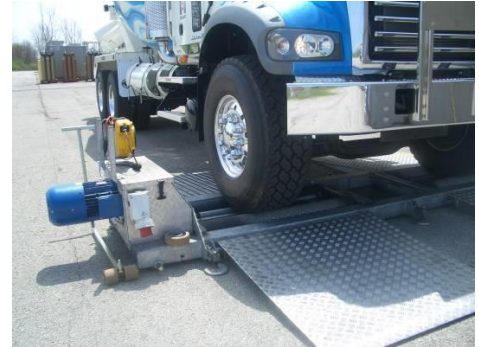
FIGURE 4
Brake System Testers

If the deceleration capability of the service brake system is tested with an electronic deceleration measurement device (**Figure 4**), an *average* in-stop deceleration rate of at least 0.528 g should be achieved from a speed of 20 mph to a complete stop.

Typical mechanical tester

Typical electronic tester

Performance-based brake tester

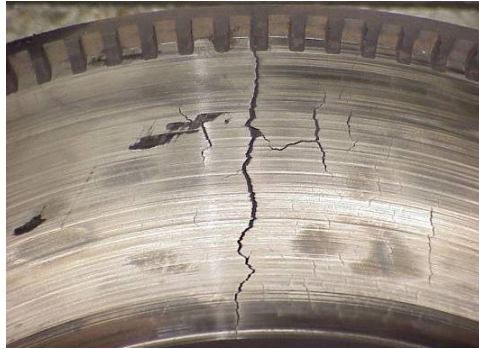
Excessive drum crack

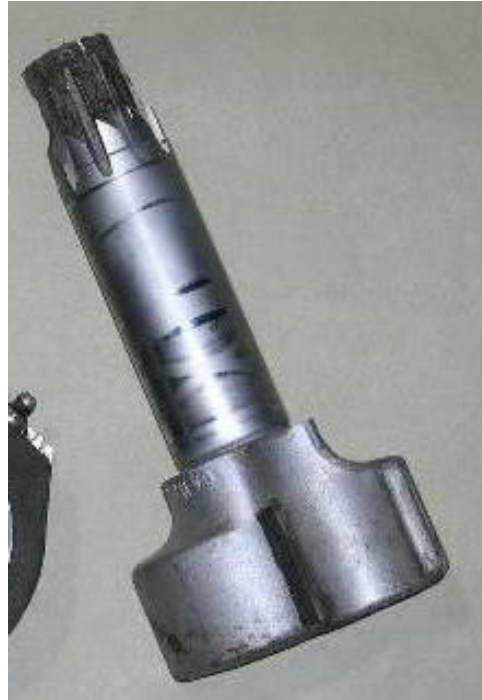
Damaged S-cam

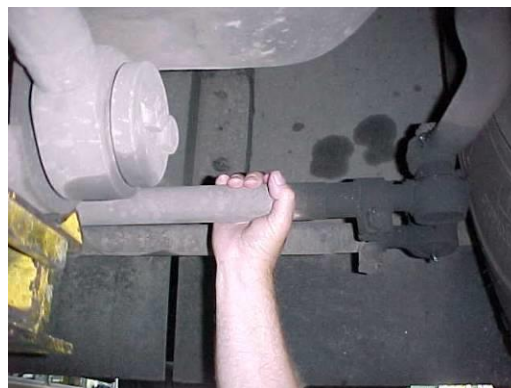
FIGURE 6
Checking Tie Rod Ends

- Check wheel bearings for free, smooth, movement and excessive end play (**greater than 0.005**). If excessive play is found, have a co-worker apply the brakes to isolate the wheel bearing from the king pin end play.
- Check king pins for excessive movement laterally as well as vertically.
- Using hand pressure, check the tie-rod ends and pitman arms for excessive play (**Figure 6**).
